AN EXPERIMENTAL STUDY OF COMPRESSION FAILURE OF FIBROUS LAMINATED COMPOSITES IN THE PRESENCE OF STRESS GRADIENTS

A. M. WAAS,[†] C. D. BABCOCK, JR.[‡] and W. G. KNAUSS
Division of Engineering and Applied Science, Caltech, Pasadena, CA 91125, U.S.A.

Abstract—A series of experiments have been performed to determine the mechanisms of failure in compressively loaded laminated plates in the presence of stress gradients generated by a circular cutout. Real-time holographic interferometry and *in situ* photomicrography of the cutout surface are employed to observe the progression of failure.

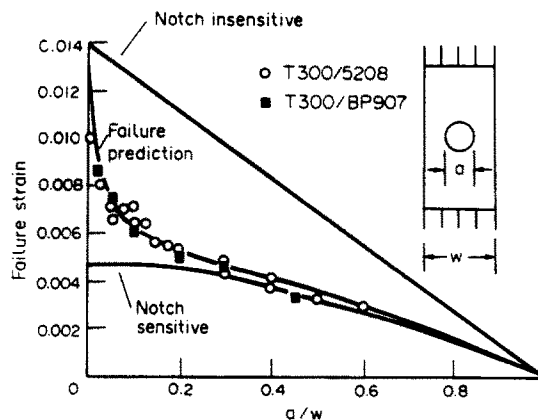
Fig. 1. Summary of test results for T300/BP907 and T300/5208 composite laminates, $w = 13$ cm (from Starnes and Williams, 1982).
