AN EXPERIMENTAL STUDY OF COMPRESSION FAILURE OF FIBROUS LAMINATED COMPOSITES IN THE PRESENCE OF STRESS GRADIENTS

A. M. WAAS,[†] C. D. BABCOCK, JR.[‡] and W. G. KNAUSS
Division of Engineering and Applied Science, Caltech, Pasadena, CA 91125, U.S.A.

Abstract—A series of experiments have been performed to determine the mechanisms of failure in compressively loaded laminated plates in the presence of stress gradients generated by a circular cutout. Real-time holographic interferometry and *in situ* photomicrography of the cutout surface are employed to observe the progression of failure.

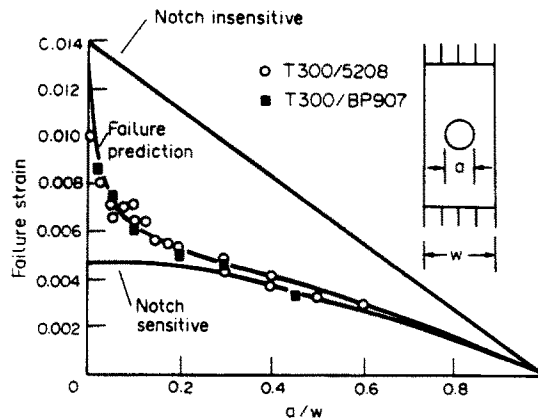
Fig. 1. Summary of test results for T300/BP907 and T300/5208 composite laminates, $w = 13$ cm (from Starnes and Williams, 1982).

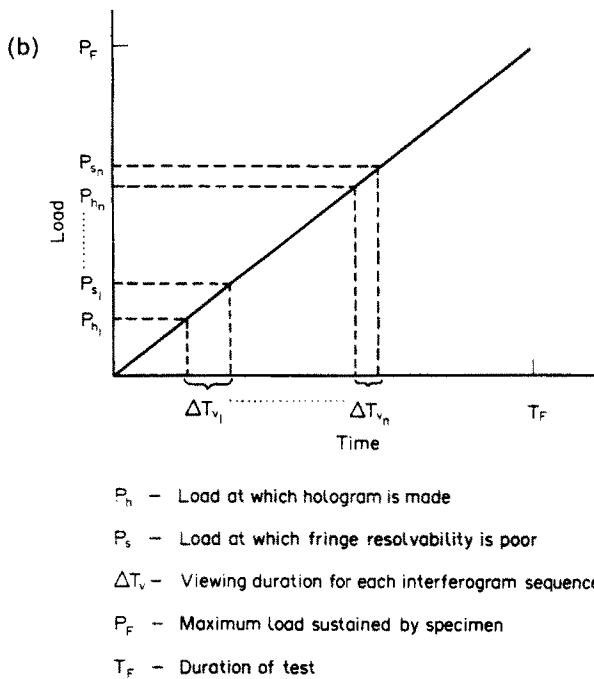
Fig. 3(b). Experimental procedure for generating holographic interferograms.

recording device, the quality of the hologram is insensitive to the exposure time. In the real-time mode, the test specimen is illuminated in a state, say S_1 , with coherent light transmitted from the laser via the object wave path. This path contains the beam splitter, a beam expander-spatial filter, and a collimating lens. The corresponding load is P_1 [refer to Fig. 3(b)]. A hologram is then recorded by exposing the thermoplastic plate positioned at the junction of the reflected light and reference beam. Upon completion of the first exposure, the specimen, which is continuously loaded, is viewed through a camera attached to a VHS recording system (a VCR and a monitor). The resulting image consists of fringes which are dynamical in nature representing contour maps of the changes in the out-of-plane displacement component w of the specimen, with respect to the state S_1 . These fringes, together with the load cell reading are recorded. The load cell reading is obtained by focusing the display of the voltmeter, exhibiting the load cell reading, at the position of the circular hole in the plane of the test specimen. With increasing load on the specimen the fringe density becomes high, so that the resolution of the interferogram becomes poor. At this stage a new hologram of the test specimen is made and the above cycle of events is repeated. Thus, at the end of each experiment we obtain an interferometric record of the complete out-of-plane displacement history of the specimen as well as the corresponding loading.
