# Fatigue Fracture of Reaction Injection Molded (RIM) Nylon Composites

D. C. MARTIN,\* G. E. NOVAK, and M. G. WYZGOSKI, *Polymers Department, General Motors Research Laboratories, Warren, Michigan 48090-9055*

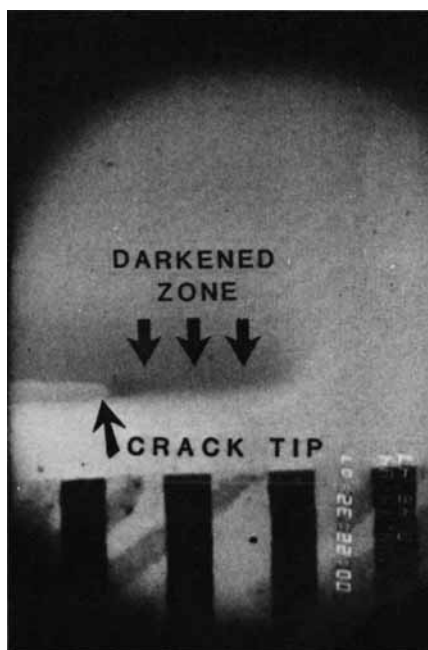
Fig. 7. Fatigue crack appearance in unfilled RIM nylon 6 showing: (a) initial stage of cracking; (b) crack open position during stable propagation stage; (c) high magnification view of crack tip.

**Unfilled RIM Nylon 6.** Photographs of the growing fatigue crack taken from the video recording are shown in Figure 7. For the unfilled nylon 6 the crack propagated perpendicular to the applied oscillating load in a relatively stable manner up until the transition to fast fracture. From a review of various crack open and crack closed video images, it was apparent that the overall crack length was in reality composed of a true crack plus a darkened zone ahead of the crack tip [Fig. 7(c)]. Although it is tempting to associate the darkened zone with a deformation zone, the fractography results suggest that the zone is due to the thumbnail shape of the crack tip. This is shown in Figure 8(a), where the thumbnail shape of the crack front is evident at the transition to fast fracture. The fatigue fracture surface of the reaction-molded nylon 6, as seen in Figure 8(b), exhibits a characteristic patchy morphology similar to that reported by Bretz et al. in their study of injection-molded

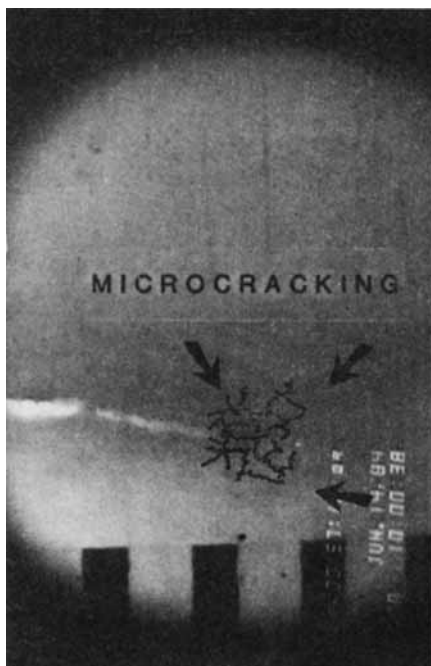
Fig. 10. Fatigue crack appearance in glass-filled RIM nylon 6 showing: (a) initial stage of cracking; (b) crack open position during stable propagation stage; (c) high magnification view of crack tip with microcracking pattern artificially enhanced.

**Glass-Filled RIM Nylon 6.** Figure 10 shows the propagation of a fatigue crack in RIM nylon 6 reinforced with 33% by weight of the untreated 1/32 in. milled glass fibers. Compared to the unfilled material, the crack propagated in a much more irregular manner, although the overall direction of crack growth is still perpendicular to the applied load. In addition, Figure 10 shows that there is significant damage in the matrix surrounding the crack with an intense zone of damage (darkening) at the crack tip. At higher magnifications the damage zone near the crack tip was seen to be composed of feathery-like microcracking, also illustrated in Figure 10. It was not possible to clearly focus the microcracking pattern, perhaps indicating that it was internal to the sample rather than on the surface. The microcracking is randomly oriented and occupies a symmetrically shaped area in the immediate vicinity (1 mm) of the crack tip. There was no evidence of a line-shaped zone of darkening as was observed in the unfilled sample. Thus the presence of the glass fibers dramatically modifies the macroscopic appearance of the deformation in advance of the propagating fatigue crack.

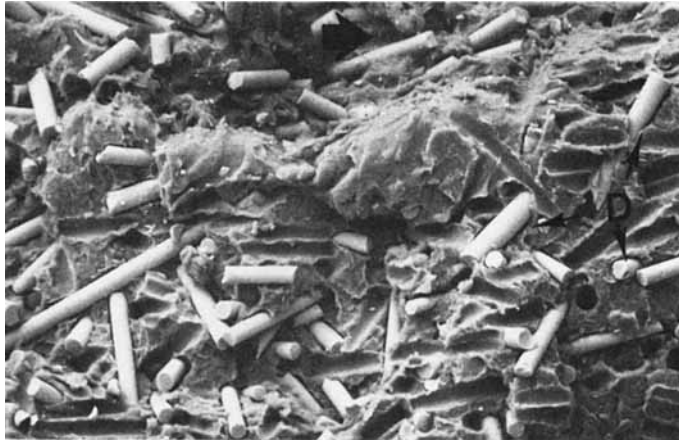
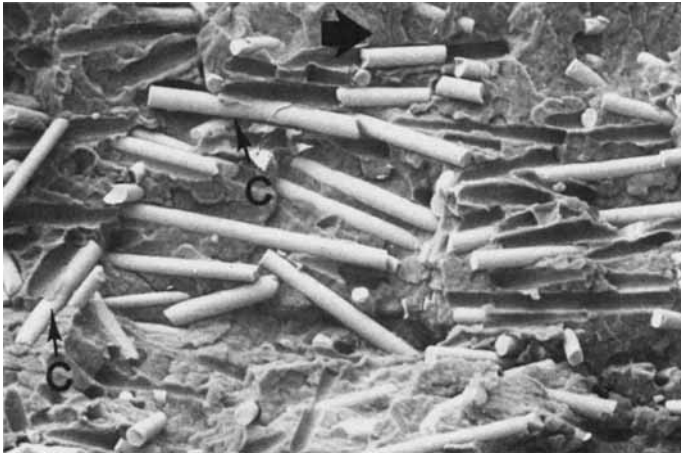
Fig. 11. Fatigue fracture surface for RIM nylon 6 containing untreated milled glass fibers showing: (a) initiation; (b) propagation; (c) fast fracture regions. Arrows demonstrate: (A) matrix drawing; (B) deformed holes after fiber pullout; (C) fiber-matrix bonding; (D) voided regions around fibers. Magnification:  $220\times$ .

The nature of the damage events in the milled glass-filled RIM nylon 6 was investigated by examining the fracture surfaces as shown in Figure 11. Little or no adhesion between fiber and matrix is suggested in the initiation and propagation regions of the stable fatigue fracture surface. The propagation region is distinct in showing more plastic deformation of the nylon matrix (points labeled A). Even the holes from glass fiber pullout are deformed (points labeled B), and the holes are enlarged compared to the initiation region. In the fast fracture region the cleavage is more brittle with occasional indications of adhesion of matrix material to the glass fibers (points labeled C) and much less indication of voided regions (points labeled D) or wells around the fibers.

Figure 13 also shows the stable fatigue crack propagation region of the fracture surface for the nylon 6 containing treated glass fibers. In spite of the silane treatment on the glass fibers, it is difficult to distinguish this fracture surface from the one shown in Figure 11 for nylon containing untreated fibers. Clear evidence of fiber-matrix debonding, fiber pullout, and deformation (enlargement) of the holes around the fibers can be seen. Extensive ductile tearing of the nylon matrix is also noted. The results suggest that debonding occurred prior to fiber pullout; otherwise smaller holes would be evident. In marked contrast to the propagation region, the fast fracture shows the brittle nature of the final cleavage. The micrograph shown in Figure 13(c) indicates that ductile tearing of the nylon matrix is no longer apparent nor is there evidence of debonding of fibers. In fact, excellent fiber-matrix adhesion seems to be the case. This differs from the results shown in Figure 11(c) for the untreated glass. These results confirm the uniqueness of the fracture surface for fatigue failure in the glass-filled RIM nylon materials and further demonstrate that the extensive fiber debonding is not due to poor initial fiber-matrix adhesion.

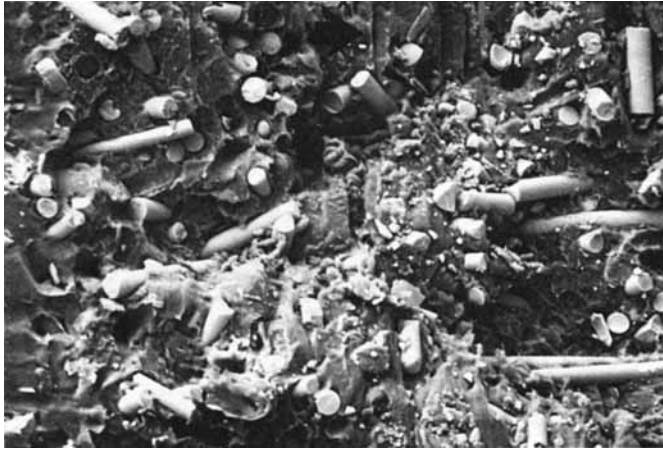
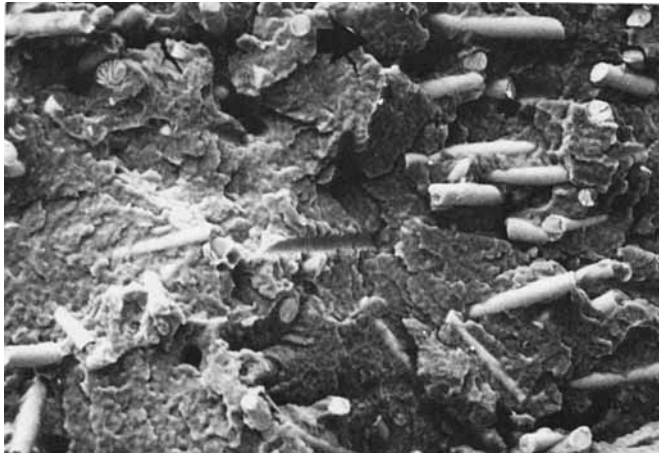
Fig. 13. Fatigue fracture surface for RIM nylon 6 containing silane-treated glass fibers showing: (a) initiation; (b) propagation; (c) fast fracture regions. Magnification:  $275\times$ .

containing milled glass fibers treated with a silane coupling agent. As mentioned earlier, this sample did not exhibit a large damage zone. Figure 13 shows the fractography results with views of the initiation, propagation, and fast fracture regions. The initiation region is quite similar to that observed in Figure 11 for the sample containing untreated fibers with the exception that a considerable amount of debris, presumed to be particles of broken glass fibers, is noted. A closer examination of the entire fracture surface indicated that the debris was confined to an area in the center of the sample adjacent to the razor blade cut precrack. Although at first thought to be an anomaly, debris was also observed in a review of other micrographs near the initiation site. However, it was not possible to clearly define the size of the debris region or amount of debris in repeated fatigue experiments. The debris seen on the
