## Local repair procedure for carbon-fiber-reinforced plastics by refilling with a thermoset matrix

**ABSTRACT:** Textile-reinforced composites have given rise to an increasingly important key technology for lightweight construction in aerospace, automotive, civil engineering, and many other industries. Because there exists no suitable repair procedure for carbon-fiber-reinforced plastics (CFRPs), damaged parts have to be replaced completely; this is extremely disadvantageous both ecologically and economically. With fiber-reinforced composites used being more and more often, fast and efficient methods for the local repair of damaged CFRPs are essential. In this article, a novel repair procedure for CFRP is presented. The thermal activation by IR radiation of oxide semiconductors was used to locally degrade the thermoset matrix of the damaged CFRP through the maintenance of its structural stability and properties. The matrix-free textile structure was then refilled with a thermoset epoxy matrix. Carbon fibers from the treated area were characterized with scanning electron microscopy, IR spectroscopy, thermogravimetric analysis, and subsequently, tensile strength for single fibers t

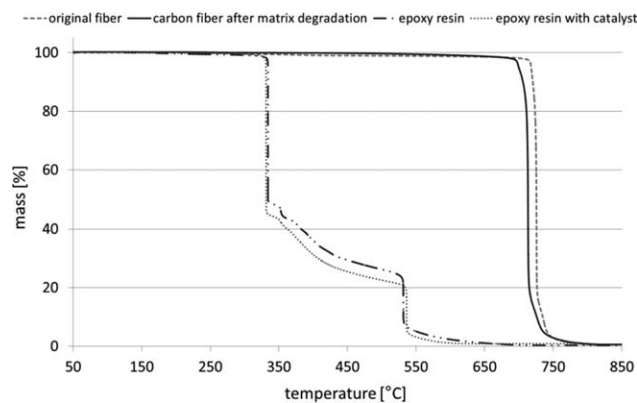
Figure 6. Characterization of the physicochemical treatment with TGA.

After the optical microscopic investigation of the exposed CFs, the thermal analysis was carried out as a second step. To characterize and understand the reduction of the thermoset matrix, thermogravimetric measurements were done on the used epoxy resin, as shown in Figure 6. All of the TGA measurements were conducted two times without any significant differences.

In general, the oxidation of amine compounds is a very complex process. The TGA curves of the bisphenol A resin hardened by amines without textile reinforcement exhibited various thermal decomposing stages between 300 and 450°C. For the TGA on the used epoxy resin, the measurement was done under synthetic air (80% N<sub>2</sub> and 20% O<sub>2</sub>). In various studies, the thermooxidative degradation products of the epoxy resin have been extensively analyzed and described.<sup>16–19</sup>

Adapted from the TGA results, it was obvious that compared to the original CFs, the matrix was completely decomposed by the thermal decomposition exhibited by the underlying woven CFs. Recent research has indicated that thermooxidative degradation of CFs takes place at a temperature of about 600°C.<sup>20</sup> The original CFs were decomposed at a slightly higher temperature of about 730°C compared to that of the CFs recovered from the thermally treated CFRP samples. The temperature difference between the two CF samples was about 15°C; this was within the range of systematic failure of the method. The sizing of the

Additionally, in Figure 6, it is shown that the mixture of catalyst and epoxy resin decomposed in the same way as the pure epoxy and showed no side effects. Accordingly, this proved that the IR radiation and catalyst were important for the degradation of the matrix.

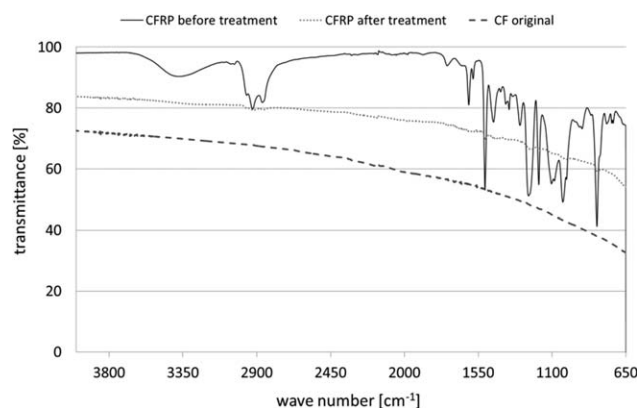
Figure 7. IR spectra before and after the physicochemical treatment.

in the IR region were recognizable because of the change in the reflectivity (Figure 7).

Typical CH— and CH<sub>2</sub>— stretching was observed between 2800 and 2900  $\text{cm}^{-1}$ . The epoxy resin was identified by a small band of C—H oscillation, which was represented by a wavelength of

3050  $\text{cm}^{-1}$ . Additional information about the resin was provided at 1508  $\text{cm}^{-1}$  by the characteristics of the aromatic groups, in particular the stretching vibrations of C—C bonding. The C—O—C stretching at 1034 and 826  $\text{cm}^{-1}$  were associated with ether groups.<sup>23</sup> After 10 min of treatment with the OSC, the IR spectrum in Figure 7 was obtained, and this is illustrated by the dotted line. The spectrum exhibited a significant change in general and showed a total absence of the resin; consequently, this was typical of a spectrum of a CF without any sizing.

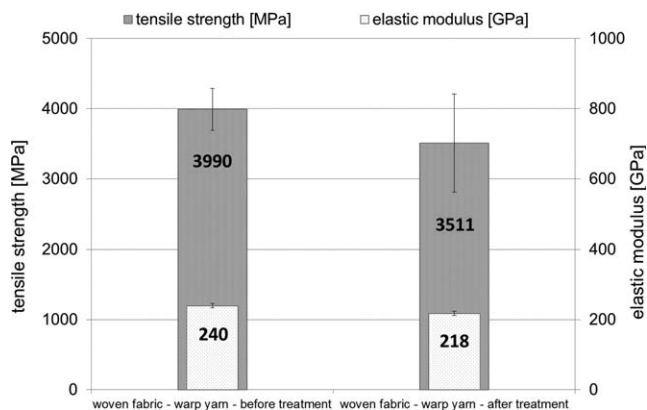
Figure 8. Single-fiber tensile tests on a fiber specimen of the textile fabric before and after matrix degradation.

Textile physical investigations of single-fiber tensile strength were also carried out (Figure 8). We observed that the single fibers of the treated composite still had a remaining tensile strength of up to 88% after matrix removal. We assumed that the loss was due to a high thermal load combined with the decomposition of the sizing; this led to reduced mechanical stability in the CFs. The elastic modulus was also affected by the treatment; this resulted in a decrease from 240 to 218 GPa (91%). From the variation, we observed that the individual fibers were affected by different intensities. The influence of the thermal treatment and the chemical interactions taking place are the topic of ongoing investigations. The subsequent aim is to develop a more controlled and gentle treatment to assure a minimum loss of textile strength of reinforcing CFs during the decomposition of the matrix.
