### Letter Quality Impact Printer Hammer Impressions

**REFERENCE:** Anthony, A. T., "Letter Quality Impact Printer Hammer Impressions," *Journal of Forensic Sciences*, JFSCA, Vol. 33, No. 3, May 1988, pp. 779-786.

**ABSTRACT:** While acquiring typewriter standards, an unusual mark was encountered. Scrutiny of the mark and the electronic typewriter (ET) that produced it disclosed that the impression was a reproduction of the ET's hammer. This was the result of a missing character as a result of a broken spoke. Initially, it was thought that encountering such a mark would assist in the identification process. Subsequent examination of hammer marks from various manufacturers shows them to be highly distinguishable. Potential therefore exists for dating, classification, and make and model determinations when impressions of this type are present in typescript cases. Hammer marks from letter quality (LQ) impact printers are illustrated, and their value in case work is discussed.

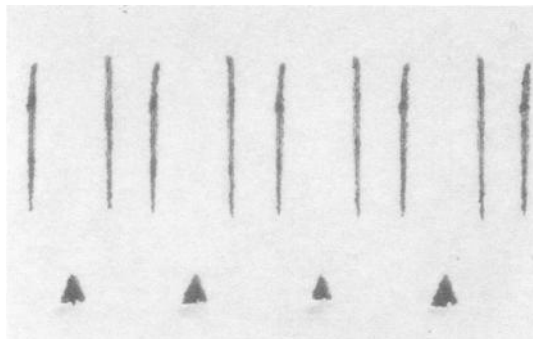
FIG. 12—*Royal 5000 series hammer marks. The triangular images below the marks are caused by a remnant of the spoke.*

Figures 5 through 14 are sample hammer impressions from ETs and computer printers obtained by removing spokes from printwheels and thimbles purchased for that purpose. Figure 15 is a portion of a strike-up from a Collegiate ET given to the author.
