Floods from tailings dam failures

M. Rico^{a,*}, G. Benito^b, A. Díez-Herrero^c

Abstract

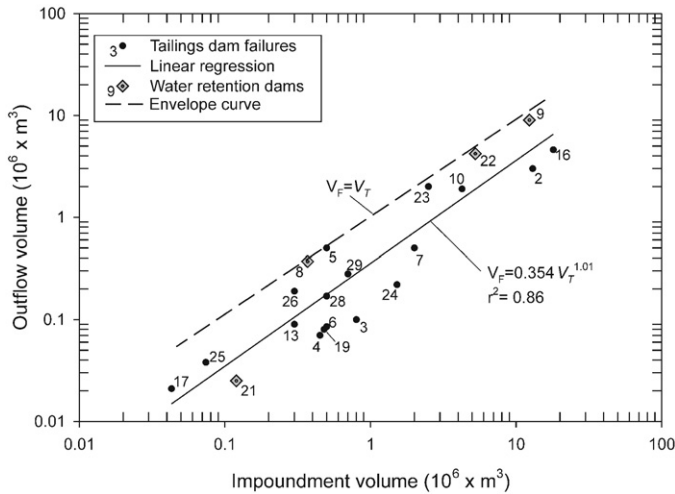
Fig. 4. Graph showing the tailings outflow volume from the tailings dam (V_F in $10^6 \times m^3$) vs. the volume of tailings stored at the dam (V_T in $10^6 \times m^3$) at the time of the incident.

A major limitation to the application of this equation to risk analysis of standing tailings dams consists of the uncertainty of potential tailings outflow volume (V_F) in the case of failure. Another empirical relationship (Fig. 4) was found between the tailings storage volume and the tailings released at the incidents (using incident cases of Table 1), which has the equation:

The above equation shows, that in average, one-third of the tailings and water at the decant pond is released during dam failures. The envelope curve represents the maximum tailings volume that can be released in the most extreme situation in which pond volume was emptied following the dam break, as is the case of water-storage dam accidents or those of industrial (diluted) waste ponds.

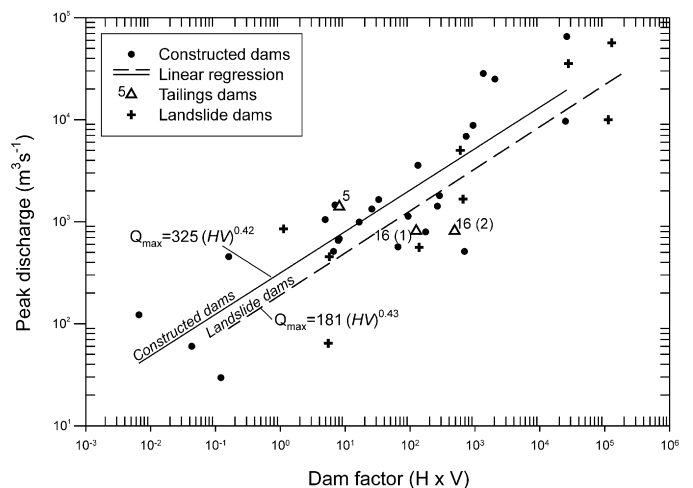
Fig. 6. Graph the dam factor ($H \times V$) vs. peak discharge ($m^3 s^{-1}$) for constructed and landslide dams (data from Costa [10]) and tailings dams (Case 5: Buffalo Creek, USA; Case 16: Los Frailes, Aznalcollar, Spain (numbers keyed to Table 1). Dam factor ($H \times V$) for Los Frailes was plotted using both the total tailings volume at decant pond (case 16 point 2) and the tailings outflow volume (case 16 point 1). In the Los Frailes incident, a discharge-dam factor relationship similar to landslide dams is obtained from a dam factor calculated from the spilled tailings volume instead of the total dam tailings volume which is used on water-retention dam failures relationships.

Fig. 6 shows the empirical relationship between dam factor and peak discharge of historical dam failures of constructed and natural dams by Costa [10], in which dam factor ($H \times V$) for Los Frailes tailings dam failure was plotted using both the total tailings volume stored at the decant pond (case 16 point 2) and the outflow volume (case 16 point 1). It is shown that for tailings dam failures more robust results are obtained considering the spilled tailings volume than the ones applying
