Accumulation of Microstructural Damage Due to Fatigue of High-Strength Aluminum Alloys

The microstructural features of aluminum alloy 7050-T7451 in the vicinity of fatigue cracks and on the crack path were studied to determine which of these features influence fatigue crack propagation. The studies included characterization of the full spectrum of microstructural and fracture surface features—from the largest (e.g., roughness and grain type) to the smallest (e.g., second-phase particles and dislocations). Of all the features studied, only the second-phase particles were shown to have a definite influence by causing crack deflection. The number of particles encountered by the fatigue cracks were significantly higher than the expected average. The fatigue crack path was predominately transgranular, and there was no change in the dislocation and precipitation structures in the crack-affected zone.

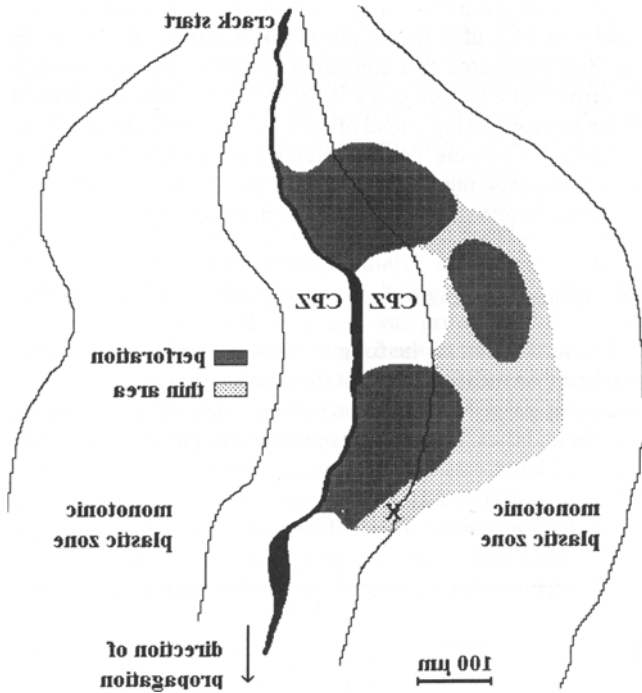
Fig. 4 Schematic of thin foil used for dislocation study. The thinned area examined is marked with an X

4, we were able to obtain a foil with perforation approximately 0.7 mm from the crack initiation site and 100 μm from the crack surface. The CPZ in this area was about 100 μm (Fig. 10). Hence, the area examined was not in the CPZ, but on the border between the CPZ and the monotonic plastic zone. Examination of that particular sample revealed no evidence of changes in the precipitate structure or debonding at the grain boundaries. Also, the dislocation structure was no different from that of the bulk material. Figure 11 compares the microstructure of the matrix in the bulk 7050-T7451 material and in the area indicated in Fig. 4. Although the dislocations are difficult to locate, there clearly are no tendencies to grouping and/or banding in the area nearest the CPZ.

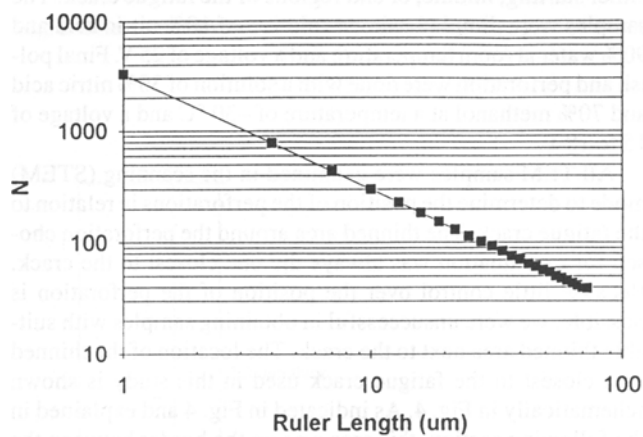
Fig. 5 Plot for determining fractal dimensions of fatigue crack 2, upper profile, surface region

Profiles of crack 2 at the surface section opposite that used in Table 1 were analyzed using an automated fractographic and fractal analysis system. Both the upper and the lower surfaces of the crack were examined. The crack length for the upper profile was 3128 μm ; for the lower surface profile, 3028 μm . Roughness parameters were 1.27 and 1.25, respectively (a difference of only 1.35%). Results of the fractal analysis for the upper surface profile of crack 2 are shown in Fig. 5. The slopes

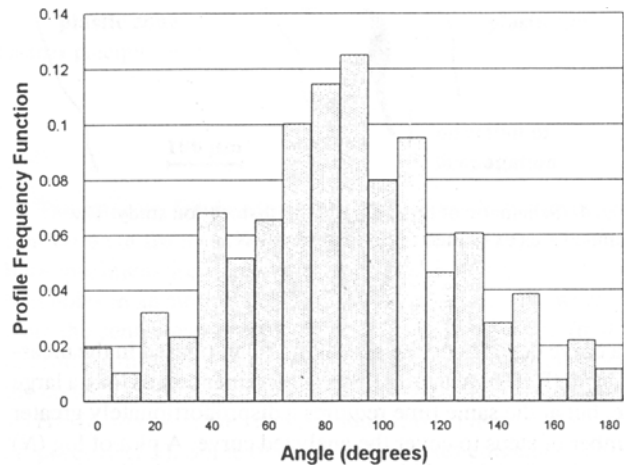
Fig. 6 Distribution of angular orientation of crack segment, crack 2, surface section

The distribution of the crack segment orientations for the upper profile of crack 2 is shown in Fig. 6. As expected, the most frequent angle for the upper profile is at about 90°, which is the general crack propagation direction. The lower profile exhibited a similar symmetrical trend. Both distributions were relatively flat, indicating a considerable amount of crack deflection in both profiles.

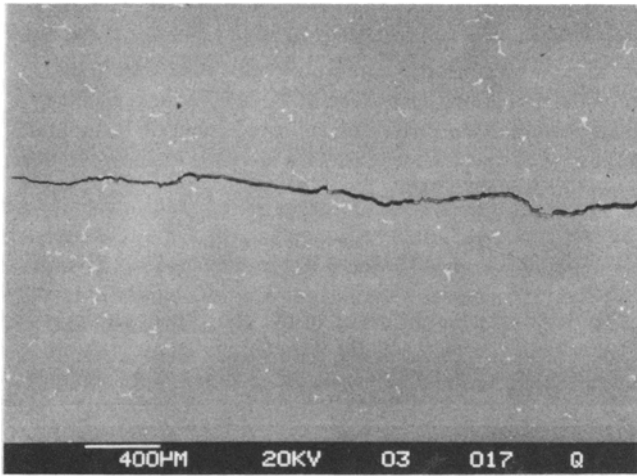
Fig. 9 Example of the type of micrograph used to calculate the number of particles intercepted by scan lines and the crack

To determine the influence of the constituent particles on the crack path deflections, the expected number of particle intercepts along a straight line through a sample were compared with the number of particles intercepted by the actual crack path. As described earlier, the measurements were taken from enlarged photographs (e.g., Fig. 9) that enhanced the details. The results are summarized in Table 3. For each section the number of particle intercepted by the crack was always greater than the expected average for the straight line. To determine whether the values were significantly different, the null hypothesis that they were the same was tested using Student's t-distribution (Ref 10). In all cases the null hypothesis

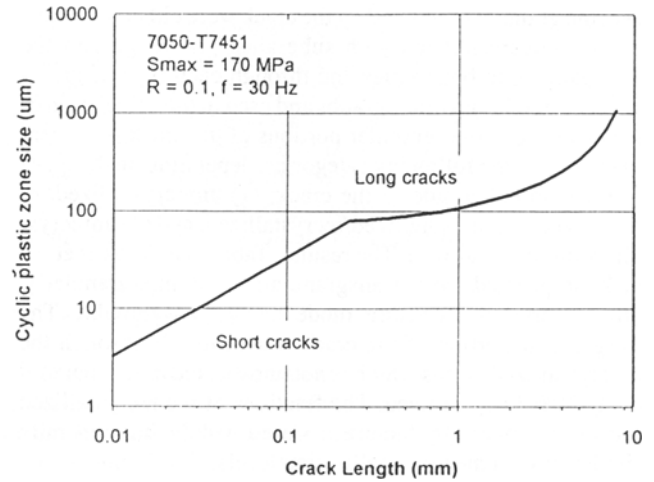
Fig. 10 Changes in CPZ size with crack length

The change in the CPZ size, r_c , with crack length using Eq 1 is shown in Fig. 10. Two cases had to be considered. The first involved small through-thickness cracks, each of length L , emanating from the fastener hole of radius R . In this case, the stress-intensity factor can be approximated as (Ref 13, 14):

where W is the double-hole specimen width. As Fig. 10 shows, the size of the plastic zone at the crack initiation site was about 10 µm. At the termination point, when the cracks were 2.5 to 3.5 mm long, the zone increased to about 250 µm. This is comparable to the typical grain size, which for the studied 7050-T7451 alloy is 138 µm for unrecrystallized grains. Thus, to observe any possible damage due to fatigue, the TEM sample had to be perforated in a grain adjacent to the fatigue crack. Such accuracy is difficult to achieve. However, as shown in Fig.
