Comparison of Corrosion-Fatigue Properties of Precorroded 6013 Bare and 2024 Bare Aluminum Alloy Sheet Materials

J. Chaudhuri, Y.M. Tan, V. Gondhalekar, and K.M. Patni

The corrosion-fatigue resistance of precorroded 6013 bare and 2024 bare aluminum alloy sheet materials was evaluated to compare the effect of corrosion on initiation and propagation of fatigue cracks. The specimens were precorroded in 3.5% NaCl water solution per ASTM G 44 for periods of 4 and 30 days, and then were subjected to cyclic testing to failure in a 3.5% NaCl corrosive environment. The notched 6013 specimens showed better corrosion-fatigue resistance for the longer exposure time only. In all other cases, the 2024 material had better resistance. Fractographic and microstructural examinations suggested that the lower corrosion-fatigue life of the 6013 alloy is due to intergranular corrosion. Although the surface corrosion (pitting) on the 2024 alloy appeared severe, there was little evidence of intergranular corrosion in this alloy.

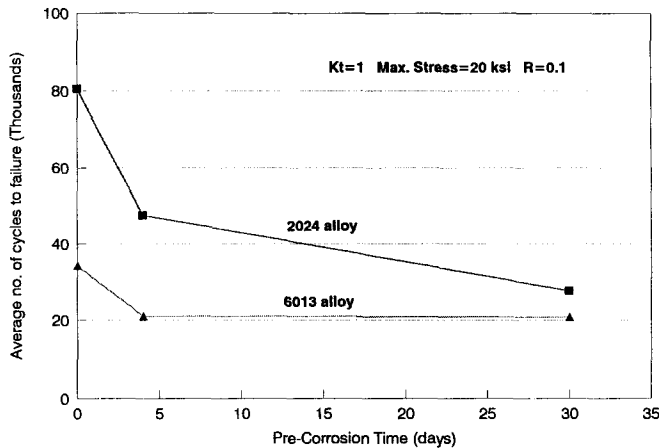
Fig. 5 Average number of cycles to failure versus length of pre-corrosion at a maximum stress of 140 MPa (20 ksi) and $K_t = 1$

The corrosion-fatigue test data for the precorroded specimens are listed in Table 2 and shown in Fig. 3 to 6. On average, compared to the 2024 bare alloy, for $K_t = 1$ and a stress level of 140 MPa (20 ksi), the 6013 bare alloy showed a reduction in corrosion-fatigue life by 56% for 4 days of pre-corrosion and by 24% for 30 days of pre-corrosion. For $K_t = 3$ and a stress level of 105 MPa (15 ksi), the corrosion-fatigue life of the 6013 bare alloy was reduced by 42% for 4 days of pre-corrosion, but increased by 87% for 30 days of pre-corrosion when compared to

the 2024 bare alloy. For comparison, Fig. 5 and 6 also contain corrosion-fatigue data for 2024 bare and 6013 bare alloys without pre-corrosion (Ref 3).

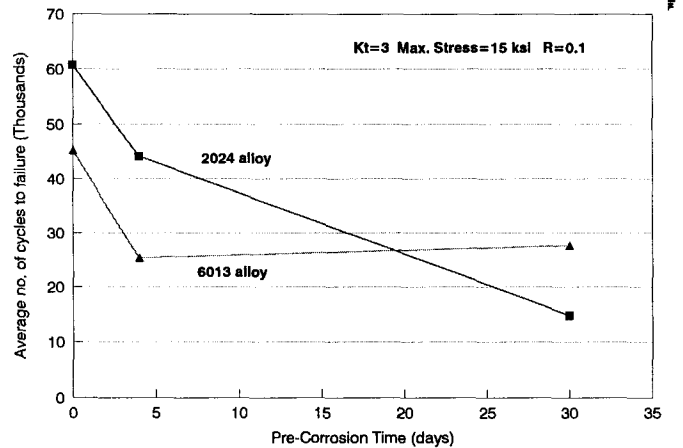
Fig. 6 Average number of cycles to failure versus length of pre-corrosion at a maximum stress of 105 MPa (15 ksi) and $K_t = 3$

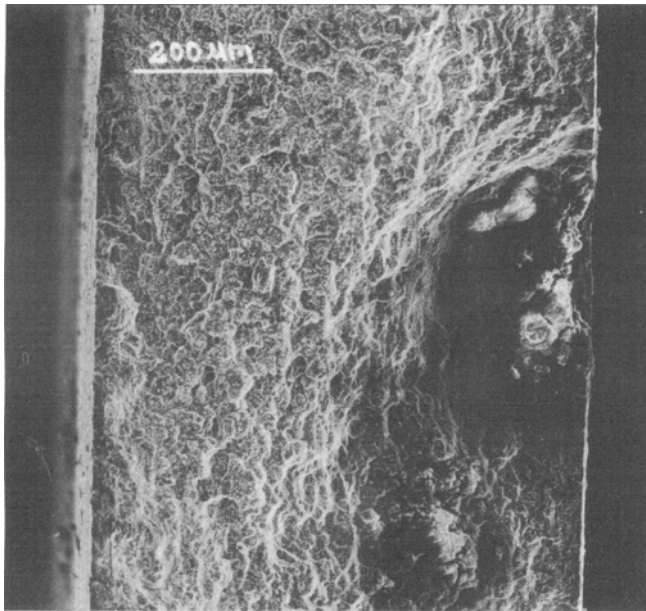
Fig. 17 Scanning electron micrograph of the same specimen in Fig. 15, showing secondary intergranular corrosion on the specimen surface

Microscopic examination of the fracture specimens with $K_t = 3$ and 30 days of pre-corrosion primarily revealed similar features, but the severity of the corrosion increased. Intergranular primary cracking at the tip of the notch was observed in the 6013 bare alloy specimen with $K_t = 3$ and 30 days of exposure (Fig. 15 to 17). Corrosion pits were observed at the notch as
