# Influence of Laser Hardening and Resulting Microstructure on Fatigue Properties of Carbon Steels

I. Cerny, I. Fürbacher, and V. Linhart

**Keywords** carbon steels, fatigue life, laser hardening

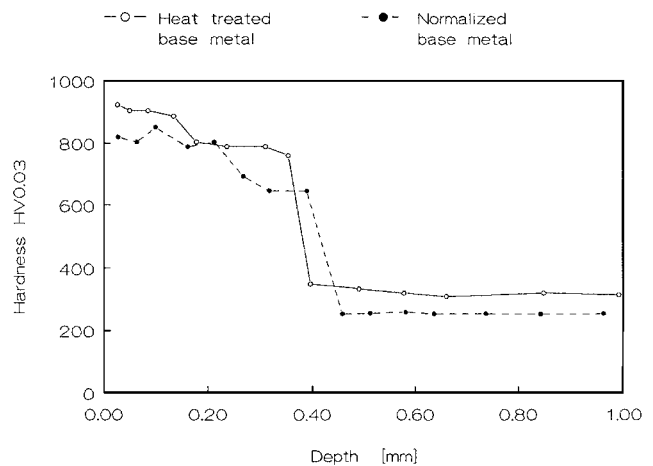
**Fig. 3** Hardness as a function of distance from the sample surface through the laser-affected zone

All specimens were examined by fluorescent magnetic particle inspection before fatigue tests. Metallographic analysis and surface examination in the region of laser-treated zones by scanning electron microscope were carried out. No surface microcracks were found on any specimen. The maximum depth of laser-treated zones was  $0.35, \pm 0.05$  mm (Fig. 2). The sharp interface between the laser-treated material and bulk material connected with the sudden changes of the subsurface microhardness (Fig. 3) is very typical for laser-treated materials. A large increase in hardness values was reached: 3.2 times for the heat-treated steel and 3.8 times for the normalized steel.

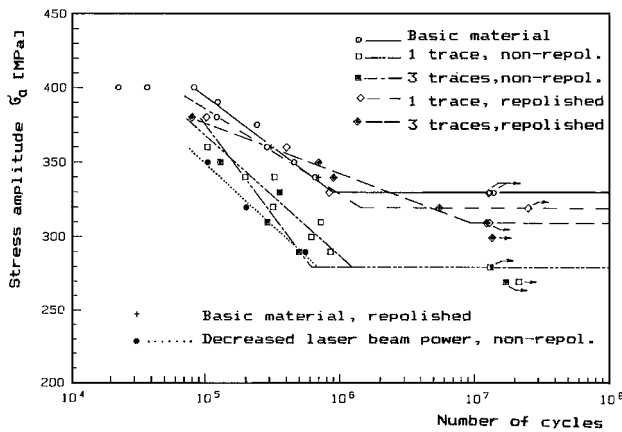
**Fig. 6** Fatigue life of all groups of normalized specimens

Figure 6 shows results of the fatigue tests for normalized material, and Fig. 7 shows results for heat-treated basic material. It is evident that the most important factor affecting the fatigue properties is repolishing after laser processing. The fatigue life of the unrepolished laser-treated specimens is

significantly lower in comparison with the specimens, not laser treated, in both cases of bulk materials and both configurations of the runs. The differences are particularly distinct at the lower region of loading amplitudes, near the fatigue limit. In the case of the heat-treated basic material, the fatigue life of the laser-treated unrepolished specimens is very short,  $\sim 10^5$  cycles even for the loading amplitude  $\pm 360$  MPa, which corresponds to the fatigue limit of the basic material. Fatigue curves of these specimens are very steep, almost vertical, which is typical for high-strength steels with sharp notches. The fatigue limit of the normalized material after the laser processing is  $\sim 16\%$  lower in comparison with the material not laser treated. The fatigue properties of the unrepolished specimens are practically independent of the number of laser runs.

Significantly different results were obtained for the specimens repolished by abrasive papers using 280, 400, and 600 grit at the final step. The fatigue limit was only 5 to 7% lower (no more than 20 MPa) in comparison with the untreated material in all cases. In the region of higher loading amplitudes exceeding the fatigue limit, the fatigue life of the laser-treated specimens was slightly higher.

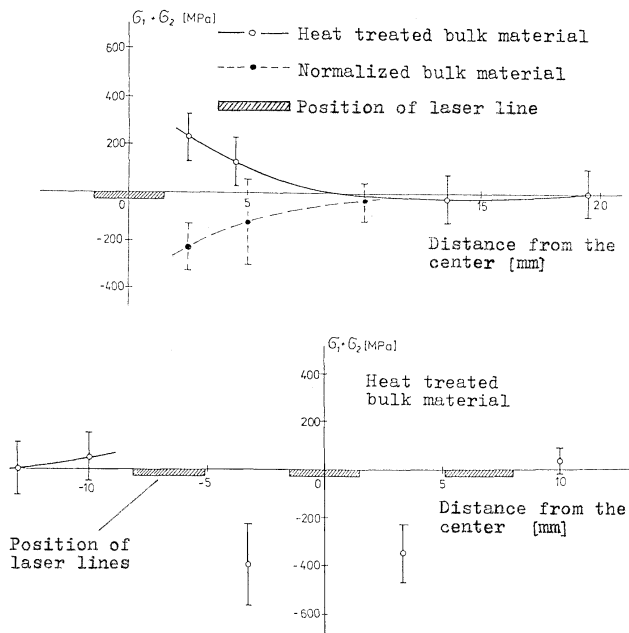
**Fig. 9** Residual stresses  $\sigma_1 + \sigma_2$  outside laser-treated lines as a function of axial distance from the specimen center along the surface. (a) Specimens with a single line. (b) Specimens with three lines

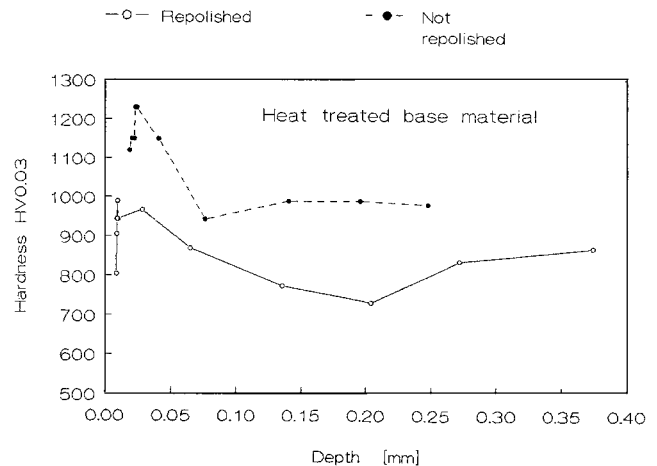
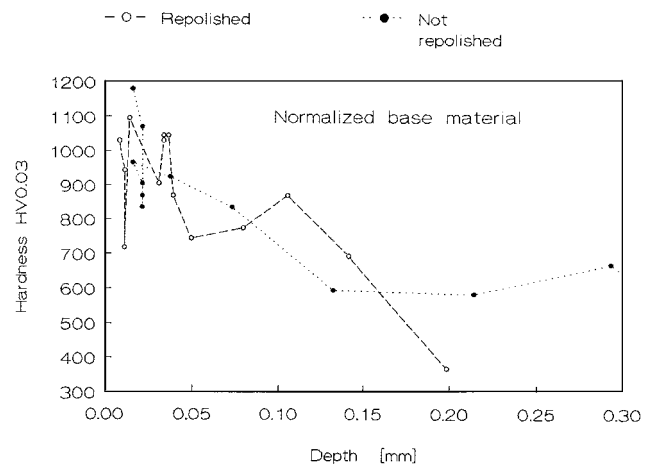
**(a)**

**(b)**

**Fig. 11** Subsurface microhardness inside laser-treated zone on specimen with (a) heat treated and (b) normalized bulk material

hardness demonstrated that the central very near-surface layer of the laser-treated lines on unrepolished specimens (layer 1 in Fig. 10) had higher values of hardness in comparison with central parts of these zones (Fig. 11a). It indicates surface martensite to be significantly more oversaturated in comparison with the subsurface martensite. Consequently, the redistribution of surface residual stresses due to repolishing was probably similar to the normalized laser treated specimens. Looking at Fig. 11, where the values of subsurface microhardness for the laser-treated zone on a normalized specimen are shown, and comparing the differences of the hardness with those for heat-treated specimens (Fig. 11a), it can be concluded that differences of residual stresses on specimens with the heat-treated bulk material before and after repolishing, respectively, are probably greater in comparison with the normalized specimens. This could explain why unrepolished laser-treated specimens with the heat-treated bulk structure had poor fatigue resistance and why the fatigue properties were significantly improved by repolishing.
