# Performance of Repair Welds on Aged Cr-Mo Piping Girth Welds

R. Viswanathan and D.W. Gandy

This article documents the results of an industry survey of weld repair practices and describes the results of experimental evaluations performed on service-aged 2¼ Cr-1Mo steel piping using SMAW with both conventional postweld heat treatments and temper bead repair techniques. The overall results of this program provide substantial evidence that service-aged piping systems can be successfully weld repaired with and without postweld heat treatments and that life extension by several decades is achievable under the right design and repair conditions. Weld repairs performed on degraded exservice welds resulted in restoration or improvement of tensile and creep properties. Microhardness test results within the heat-affected zone of each weldment indicated that the temper bead weld repairs produced only slightly higher peak hardness values than those measured for the fully postweld heat treated repairs. Finally, in terms of toughness, temper bead weld repairs consistently produced higher impact properties than those measured for the postweld heat treated weldments. Gas tungsten arc weld repai

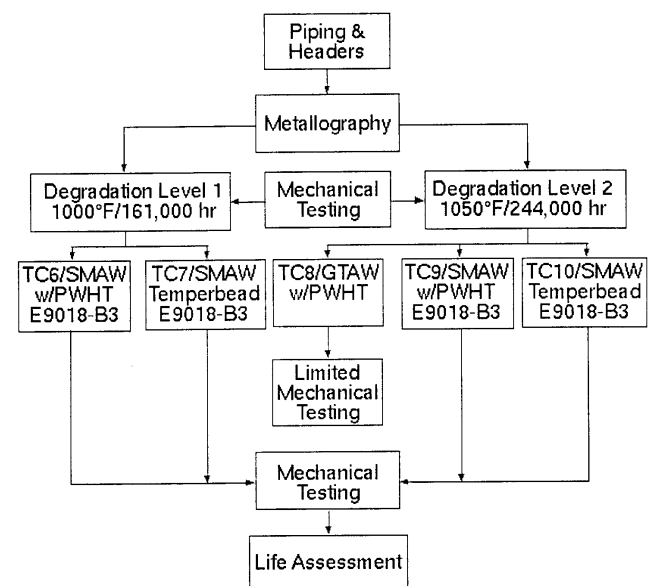
**Fig. 1** Flow chart outlining the scope of the weld repair evaluations on aged 2 1/4 Cr-1Mo steel

The overall scope of the test program on 2¼ Cr-1 Mo steel piping/header material undertaken in this study is shown in Fig. 1. Girth welds removed from header/pipe sections that had been exposed in service to two different levels of degradation were chosen for the study. The initial metallographic and me-

As shown in Fig. 1, five service-removed girth weldments are discussed in this report, along with five weld repairs performed to these weldments. Two specific levels of degradation were selected to represent repairs performed on component materials at different stages in service life. These girth weldments include two pipe weldments, TC6 and TC7, which represent level 1 degradation, and three header girth weldments, TC8, TC9, and TC10, which represent level 2 degradation.

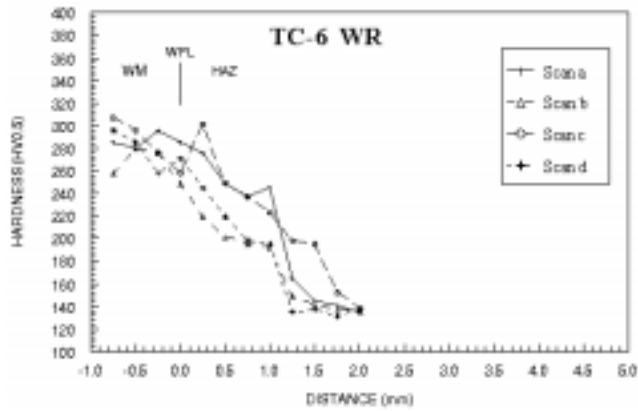
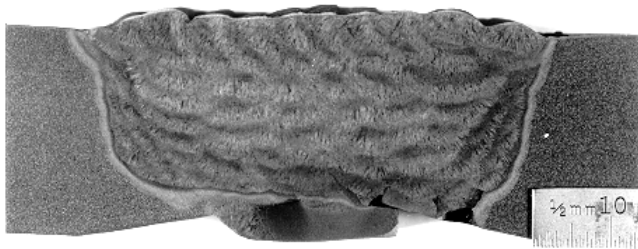
**Fig. 3** Illustration of a plug sample and microhardness profiles. The profiles for service removed (SR) and weld repaired (WR) conditions are typical of the other SR and WR specimens.

Microhardness tests were performed for each of the service-removed girth weldments and repair weldments (PWHT and temper bead). Figure 3 provides an illustration of the microhardness scans beginning within the actual weldment and moving outward through the HAZ and into the actual base material. Four scans were performed for each weldment including scan a and scan d, which were located on opposite sides of each weldment within the upper two-thirds of the through-wall section, and scan b and scan c, located near the root area of the through-wall section. Table 3 lists average values from the four scans for each weld.

All service-removed girth weldments demonstrated essentially flat (uniform) hardness profiles. Specimens TC6SR and TC7SR exhibited a uniform hardness of approximately 150 HV, while TC9SR and TC10SR exhibited a slightly higher uniform hardness of 170 HV. After weld repair, a hardness gradient is established with a peak hardness being reached in the weld (Fig. 3a). The temper bead repairs result in higher peak hardness than the PWHT repairs. For instance, 330 HV results for TC7WR versus 290 HV for TC6WR, and 320 HV results for TC10WR versus 310 HV for TC9WR. In view of the fact that hydrogen embrittlement, stress corrosion, and other environmentally induced failure mechanisms are not important in header/pipe applications, the higher microhardness due to temper bead repairs are not considered significant.

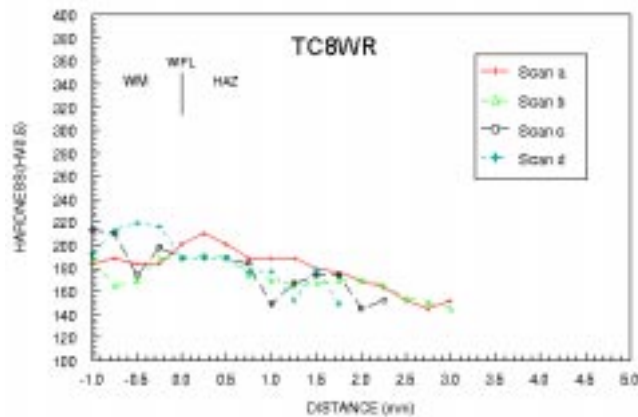
**Fig. 4** Microhardness test results for weld repair TC8WR with a macrograph depicting the locations of the microhardness scans

The GTAW repair (with PWHT) resulted in very low, uniform microhardness values, as shown in Fig. 4. The maximum value recorded for this weldment was approximately 200 HV

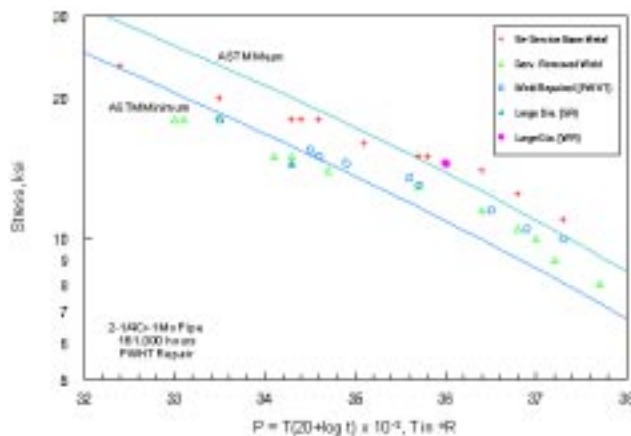
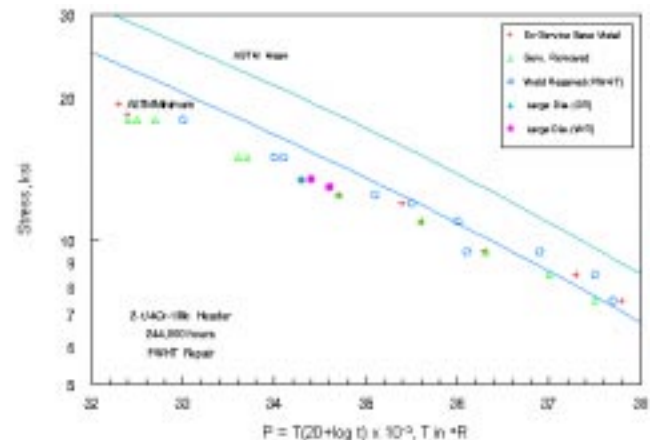
**Fig. 5** Larson-Miller rupture data plots for TC6 and TC9 with ASTM reference curve for annealed 2¼Cr-1Mo steel. Figure shows the effect of degradation level (a) 1 and (b) 2. (Note: 1 ksi = 6.89 MPa)

Larson-Miller plots for TC6 and TC9 are shown in Fig. 5 (a) and (b) against the reference curve for annealed  $2\frac{1}{4}$  Cr-1Mo steel published by Smith for ASTM (Ref 1), principally to contrast the effect of the degradation level. In the degradation level 1 material TC6, the base metal properties fluctuate about the mean while the SR weld properties lie between the mean and the minimum. In the degradation level 2 material TC9, the base metal and weldment properties are clearly below the ASTM minimum curve, as is to be expected from the service history. In both cases the weld properties are below that of the respective base metal, while weld repair seems to restore the properties to a level approximately that of SR weld in TC6 and to a level on a par with base metal in TC9.
