Improved Impact Toughness of 13Cr Martensitic Stainless Steel Hardened by Laser

L.W. Tsay, Y.M. Chang, S. Torng, and H.C. Wu

Keywords impact toughness, intergranular fracture, laser-hardening, temper embrittlement

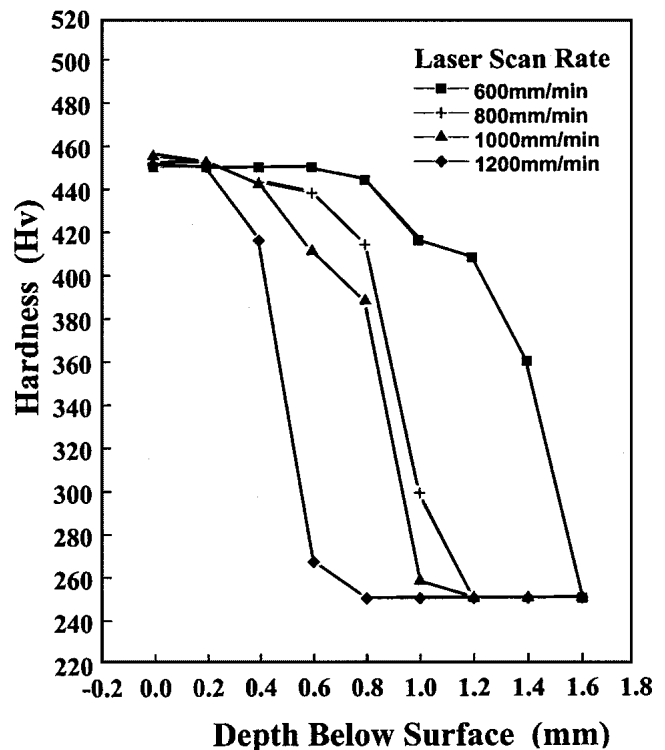
Fig. 2 The microhardness profiles of the laser-hardened specimens with different scan rates

Figure 2 displays the microhardness depth profiles for laser-hardened specimens with various laser scan rates. The laser power was 1200 W, and the scan rates were set at 600, 800, 1000, and 1200 mm/min, respectively. In general, the hardened zone was semi-elliptical in cross-section because the surface heat was dissipated more rapidly via conduction at the boundary of the hardened zone (not shown here). The microhardness

was measured at the centerline of the hardened zone from the hardened surface into the interior base metal. This revealed that hardness decreased with increasing depth below the surface. The result also indicated that the hardened depth decreased with an increasing laser scan rate. Also, the as-hardened surface hardness in the hardened zone scanning at different rates could exceed 440 vickers hardness (HV).

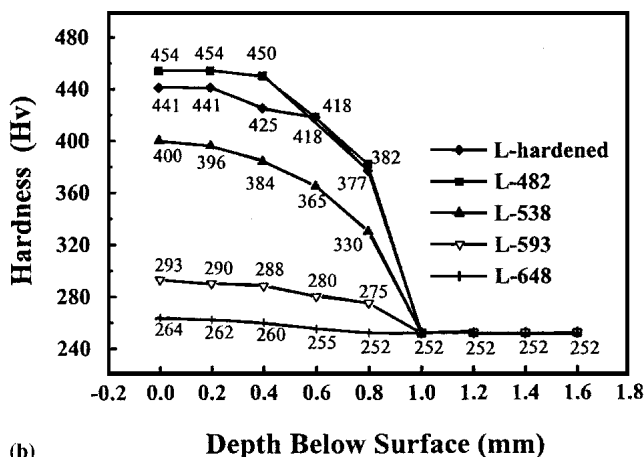
(a)

(b)

Fig. 3 The effect of tempering temperature on hardness: (a) the Rockwell hardness of the quenched steel plate tempered at various temperatures; and (b) the microhardness profiles of the laser-hardened specimens with various tempering conditions

Hardness vs the tempering temperature profiles for the steel plate and laser-hardened specimen are shown in Fig. 3. Figure 3(a) displays the Rockwell hardness of the steel plate after austenizing, quenching, and tempering treatments at various temperatures. The as-quenched steel plate primarily consisted of untempered martensite with a Rockwell hardness of HRC 42.8 (Fig. 3a). After the specimen was tempered at 482 °C (900 °F) for 2 h, the carbide precipitation caused a slightly secondary hardening effect with a hardness of HRC 43.1. It was noted

that the decline of hardness for AISI 403 stainless steel subjected to a 538 °C (1000 °F) tempering treatment was quite obvious, in comparison with a hardness between the steel plates tempered at 482 °C and 538 °C. A further decrease in hardness was found for these specimens that were tempered above 593 °C (1100 °F).

The curves for microhardness versus depth for laser-hardened specimens tempered at various temperatures are displayed in Fig. 3(b). The specimens had been treated previously at a laser scan rate of 1000 mm/min. Increasing the distance below the hardened surface to a depth of about 1 mm into the specimen interior, the hardness declined to the level of base metal hardness for variously tempered specimens. The surface hardness of the hardened zone in the as-hardened condition was about 460 HV. For the laser-hardened specimen after tempering at 482 °C (L-482 specimen), a secondary hardening effect could also result in a slight increase in surface hardness, as shown in Fig. 3(b). It displayed the same tendency for a change in hardness as did the steel plate. A progressive decrease in the surface hardness was found for the laser-hardened specimen

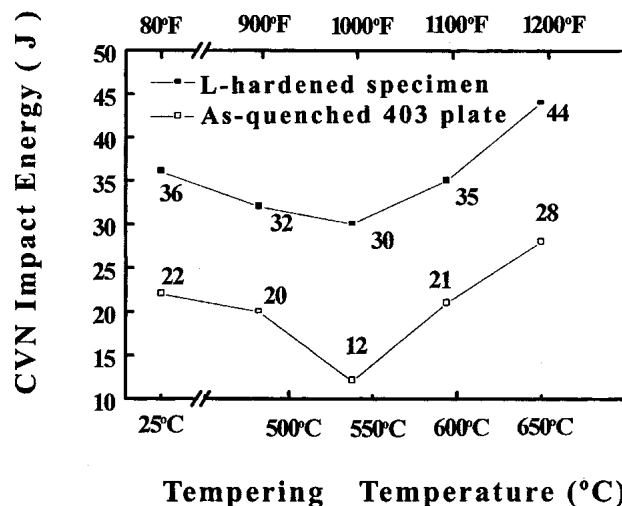
Fig. 4 Impact energy of the quenched steel plate and the laser-hardened specimens tempered at various temperatures

To compare the difference in impact energy between the steel plate and the laser-hardened specimen tempered at the same temperature, the profiles of Charpy impact energy vs. tempering temperature for two types of specimens are shown in Fig. 4. The laser-hardened specimen was processed at a laser power of 1200 W and a laser scan rate of 1000 mm/min. It was noted that the structure of the laser-hardened specimen is quite similar to that of a composite material. It consisted of hardened zones on the specimen's outer surfaces and a soft interior base metal. As the crack propagated along the laser track, the measured impact energy actually represented the overall effects contributed by both the hardened zones and the interior base metal. As shown in Fig. 3(b), the additional tempering treatment below 648 °C had little influence on the decrease in base metal hardness. Regardless of the tempering temperatures, the laser-hardened specimens always had a higher impact energy than the steel plate tempered at the equivalent temperature. In addition, the impact toughness trough was found in both the steel plate and the laser-hardened specimens that had been tempered at 538 °C.

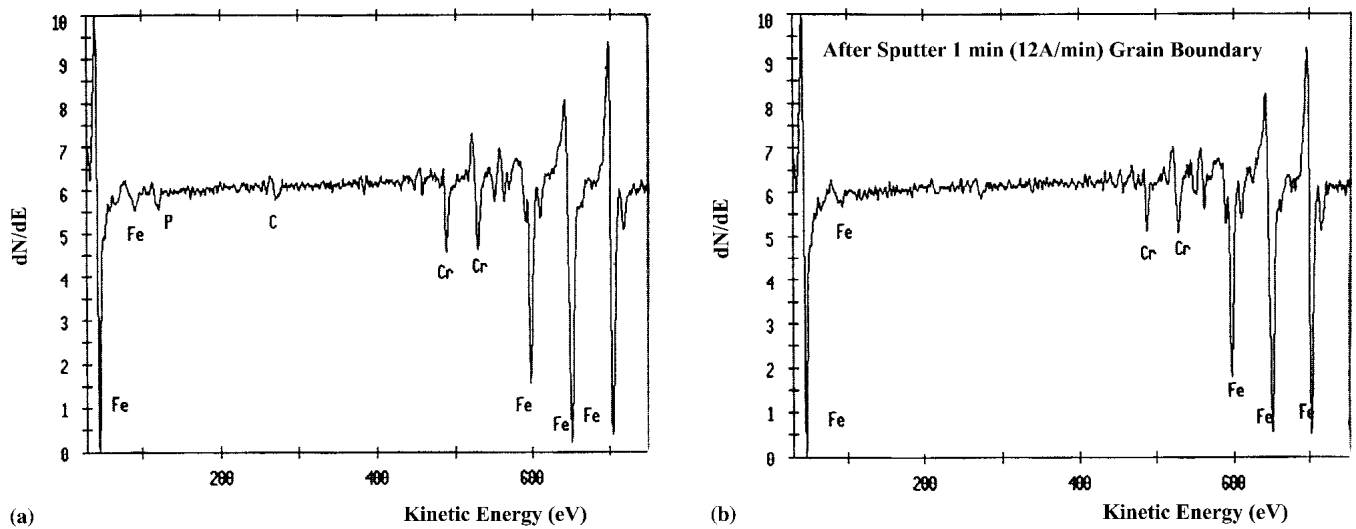
Fig. 7 Auger spectrum obtained from the fracture surface (a) as the fractured grain surface and (b) after argon sputtering

An Auger spectrum from a freshly fractured specimen before and after argon ion sputtering is shown in Fig. 7. The Auger spectrum obtained from an intergranular fractured surface exhibited a considerable amount of P and C segregation for the 538 °C tempered steel plate (Fig. 7a). After sputtering, the grain boundary segregation of P and C diminished, as displayed in Fig. 7(b). Thus, P was the main residual impurity responsible for the embrittlement of this alloy. Metallographs of various regions for the laser-hardened specimens tempered at 538 °C are shown in Fig. 8. It was found that the microstructure of the hardened zone was much finer than that of the base metal (Fig. 8a). The microstructure in the hardened zone was too fine to be resolved by the optical microscope (Fig. 8b). In the future, further work remains to be done to identify the microstructure by transmission electron microscope (TEM). However, relatively coarse grain size was found in the base metal when comparing Fig. 8(b) and (c). It was deduced that the embrittling species distributed more uniformly in the refined microstructure, and their concentration can be greatly reduced along the grain boundaries owing to the increased boundary area. Consequently, the improved impact toughness of the laser-hardened specimen was primarily attributed to the refined microstructures in the hardened zone.
