# Diagnosis of Oxide Films in Cast Aluminum Alloys

Yeong-Jern Chen, Hwei-Yuan Teng, and Yuo-Tern Tsai

**Aluminum (Al) alloy castings often contain many defects, such as micro-shrinkage, gas pores, shrinkage pores, hot tearing, and oxide film entrapment. When oxide films are entrapped in Al alloy castings, they are very difficult to identify simply by optical observation. In this study we used an auto-scanning eddy current testing method to detect oxide films entrapped in Al alloy castings. The detection signal and the measurement data were confirmed by scanning electron microscope (SEM) observation and partly backed-up by the ultrasonic-vibration method.**

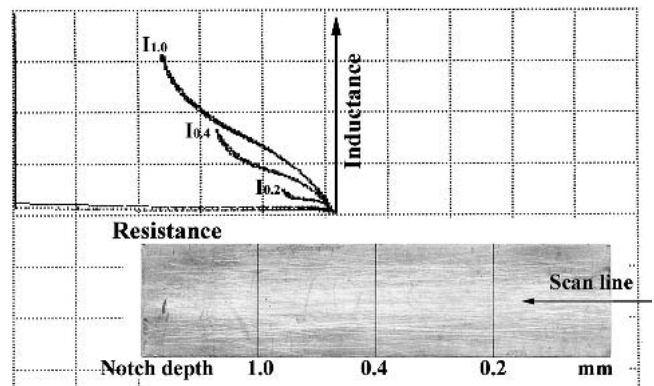
**Fig. 5** Standard reference discontinuities detected via eddy current testing: (a) detected signals and (b) defect depth-phase angle curve

specimen configuration. In the present work, a standard Al reference block containing three linear notches was used to simulate the specimen. The detection signals and the defect depth-phase angle curves are shown in Fig. 5(a) and 5(b), respectively.

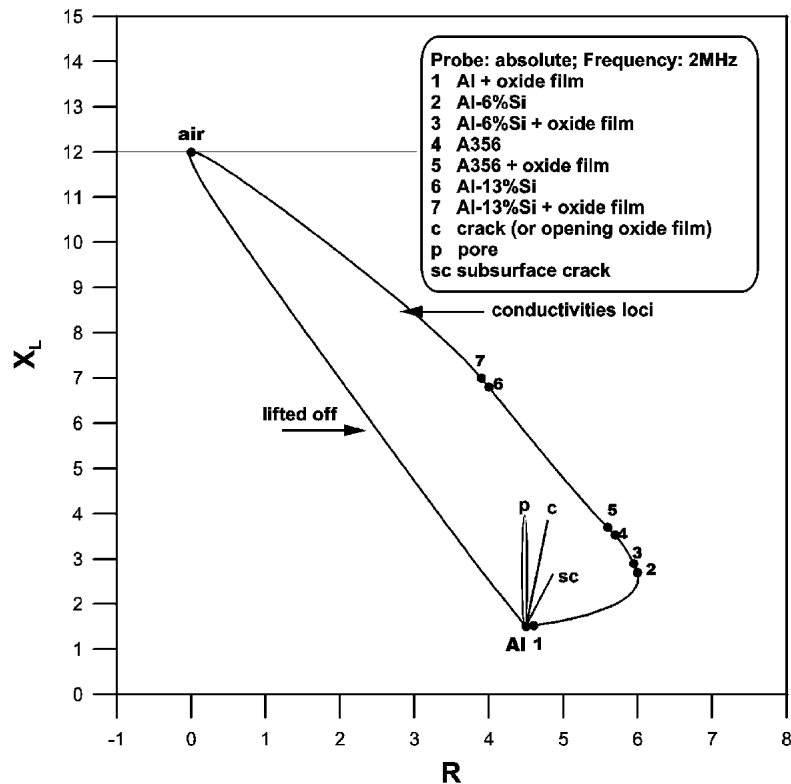
Fig. 10 Impedance changes in relation to different defects on the impedance plane

Figures 6-9 show individual changes on the impedance plane for various types of defects, such as oxide films, shrinkage, cracks (or oxide film openings), and pores. Figure 10 illustrates the relationships (position and phase) of different defects on the impedance plane. The figure data may be used to determine how each defect responds on the impedance plane and what results are to be expected before any tests are performed. The probe-to-sample spacing is referred to as the lift-off, and the different Al alloy conductivities can be seen in the conductivity loci on the impedance plane. The polished surface of the chilled aluminum samples is detected using an absolute ECT probe. The signals detected from different defects, such as oxide films, cracks (or oxide film openings), and pores are shown on the impedance plane. Pure Al, Al-Si, and A356 al-

loys will respond to different conductivities on the impedance plane. Oxide films that show a small variation in the conductivity loci compared with Al matrix, which is shown in Fig. 10. Figure 11 shows that, for the A356 aluminum alloys, the scatter diagram of the defect for the response the impedance and phase angle will change on the impedance plane. Oxide films compared with other types of defects show a small impedance and phase angle.

alescing in the aluminum matrix, a detected oxide film signal is caused by a reduction of conductivity in the specimen, as shown in Fig. 10. Since eddy current testing the oxide film produces a weak signal, all dubious signals need to be carefully identified during the eddy current testing.

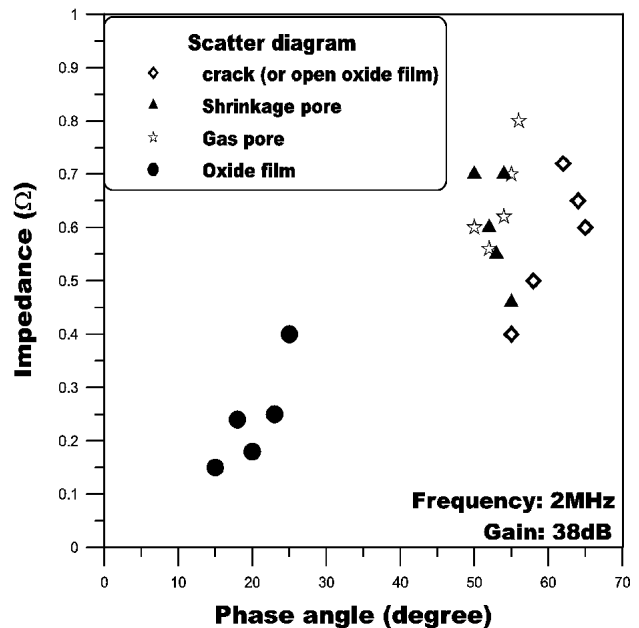
Fig. 11 Scatter diagram of the detected signal of different defects in the A356 aluminum alloy
