Experimental Investigation of Low-Velocity Repeated Impacts on Glass Fiber Metal Composites

The aim of this study was to experimentally investigate the effect of repeated low-velocity impacts on tensile strength of fiber metal laminates (FMLs) using instrumented drop weight impact tester. FMLs were fabricated layer by layer intercalating three layers of aluminum 6061 and two layers of glass fiber-reinforced epoxy. The FMLs were subjected to repeated low-velocity impacts (<10 m/s) at the same location on the FML. The degradation of mechanical property due to impact(s) was studied using Zwick UTM at distances of 0, 20, 40, and 60 mm from the impact point. Results indicate that ultimate tensile strength, failure strain, and ductility of all specimens initially decrease, and then remain constant with increase in number of impacts. A closer examination of impacted FML by scanning electron microscope indicates that thinning and shear fracture in aluminum layers, as well as delamination, and fiber failure in composites plies were present.

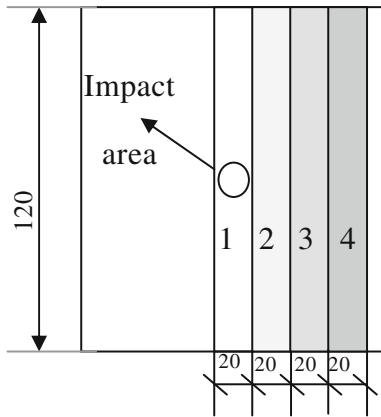
Fig. 1 Schematic representation of selection of tensile test samples

Impact parameters, such as energy at maximum load, deflection at maximum load, and impact velocity, are evaluated from the data acquisition system. The photographs of the front and back face of the impacted specimens were taken to study the failure modes. As per Wu and Wu (Ref 8), the four tensile, straight-sided specimens (120 mm × 20 mm × 4.5 mm) were cut as shown in Fig. 1 after impacts. The tensile strength test for each strip was carried out on Zwick/Roell Z-100 universal testing machine at strain rate of 10^{-3} /s up to failure of the specimen.
