Crystal imperfections in silicon epitaxial layers grown on ion-implanted substrates

Ion implantation is now being introduced into many semi-conductor manufacturing processes. Generally, it is extremely successful, but recently Moline et al. have observed that crystal defects can be generated in an epitaxial layer grown on an ion-implanted substrate [1]. They grew epitaxial layers by silane pyrolysis on substrates implanted with arsenic ions at 150 kV. The general perfection of growth was monitored by Berg-Barret X-ray topography but the individual defects were not identified. We have investigated a similar experimental system and have found the same imperfect growth. Further, we have used transmission electron microscopy (TEM) to identify the defects present as edge dislocations and epitaxial stacking faults.

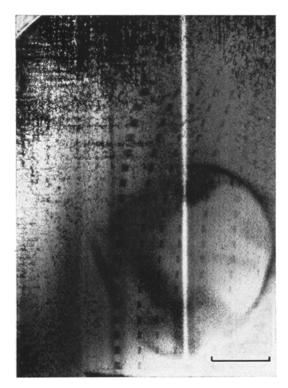
Fig. 1 is a transmission X-ray topograph of part of a slice with $0.5 \,\mu\text{m}$ epitaxial layer grown from silane at 1050° C. The ion implantation gives rise to bands of contrast running approximately parallel to the direction of movement of the slice as it passed under the ion beam. These bands are cut by the fingers of the oxide mask

Figure 1 220 MoK α_1 , transmission X-ray topograph. Bar = 500 μ m.

and result in the rectangles of high contrast seen in Fig. 1. Each of these rectangles contains defects too closely spaced to be individually resolved by X-ray techniques. TEM has high resolving power but requires specimens with a relatively high concentration of defects. We used XRT as a non-destructive method of selecting areas of high defect density for thinning for TEM. Fig. 1 also shows "swirling", which is believed to be due to point defects in the substrate [2] and dislocations generated by thermal slip. Fig. 2 is a transmission electron micrograph of one of the regions of high contrast seen in Fig. 1. The micrograph shows dislocation loops lying on (110) planes perpendicular to the (001) substrate plane. A complete Burgers vector analysis showed that they were sessile in nature with $\frac{1}{2}\langle 110 \rangle$ Burgers vectors lying in the plane of the slice. Most of these dislocation loops penetrated > 1 μ m into the substrate so that only the outer ends of the loop are seen in the micrograph. Similar dislocations are observed in heavily doped emitters and it has been suggested [3] that these dislocations are produced by a climb process using vacancies moving from

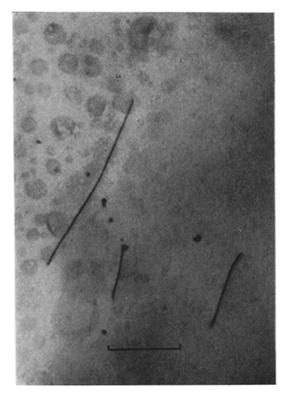
Figure 2 Transmission electron micrograph of dislocation loops. 220 type reflection, bright-field. Bar $\equiv 1 \ \mu m$.
