# Laser-induced fracture in silicon

L. E. MURR, W. A. SZILVA

Utilizing the scanning electron microscope, the laser-impact zone on irradiated P-type silicon wafers has been characterized by a central region of compressive stress which decreases to zero and becomes tensile in character with increasing radius from the impact centre, with symmetrical fracturing occurring around the impact centre at a point of maximum tensile stress. The effect of surface flaws on the fracture of brittle Si wafers and their interaction with the impact zone were observed to be small for scratch widths of 60  $\mu\text{m}$ , and lengths of 1 cm. Direct observations of advancing crack tips were made in the transmission electron microscope, and shown to have associated arrays of partial and total dislocations. The presence of numerous precipitates in the P-type Si wafers possessing long-range strain fields which overlapped along the  $\{111\}$  cleavage planes was observed to have a direct influence on the fracture process. Fracture was observed to occur in wafers containing cleavage-oriented scratches or scratches deviating by  $\sim 5^\circ$  from a cleavage-plane orientation, but little influence was n

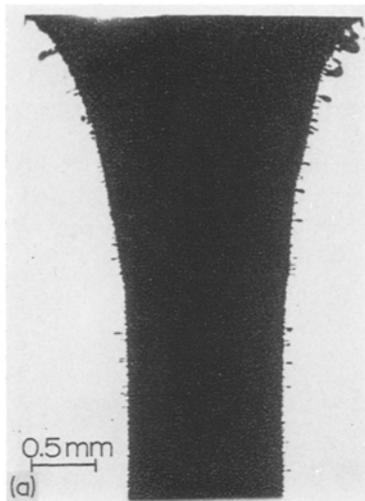
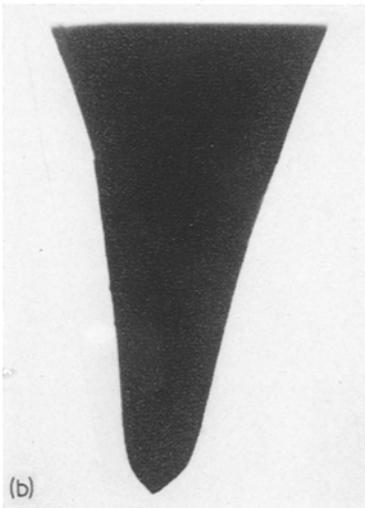
Figure 1 GTE Sylvania 10.6  $\mu\text{m}$  laser burn patterns in plexiglass. (a) Complete burn-through showing approximate beam size. (b) Partial burn through showing beam symmetry and burn profile. (200 W power level.)

Specimens were irradiated with a GTE Sylvania 971 CO<sub>2</sub> (10.6 μm) laser operated at 200 W, utilizing an external focusing lens to attain a 1 mm spot size on the specimen surface. Irradiation times were varied between 1 and 5 sec; nominal times of 5 sec were used preferentially. In most samples fracture was observed to occur after roughly 5 sec of laser irradiation. The beam size was observed to be roughly 1 mm diameter as illustrated in a typical plexiglass burn pattern in Fig. 1a. Fig. 1b also illustrates a partial burn

through in a thicker plexiglass specimen, which illustrates the beam symmetry. An essentially perfect beam symmetry is depicted in Fig. 1. The impact zone and its relationship to experimental surface flaws was established on the test specimens using a low-energy He-Ne laser.

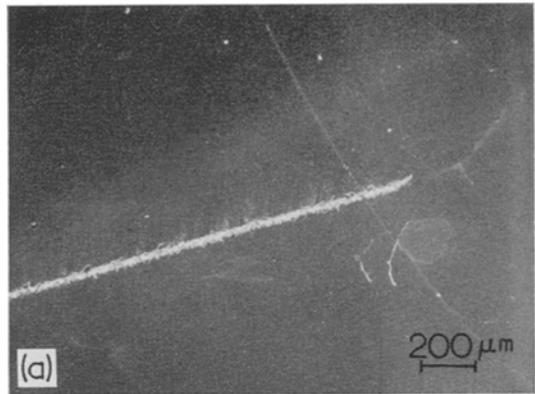
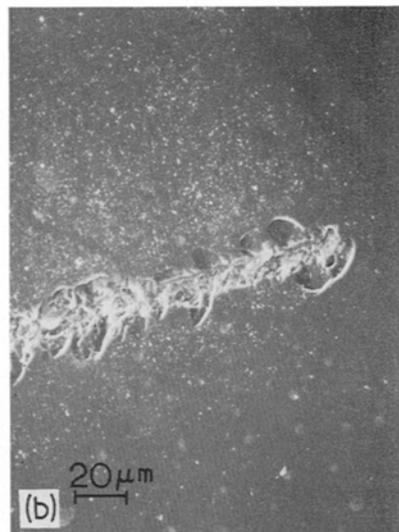
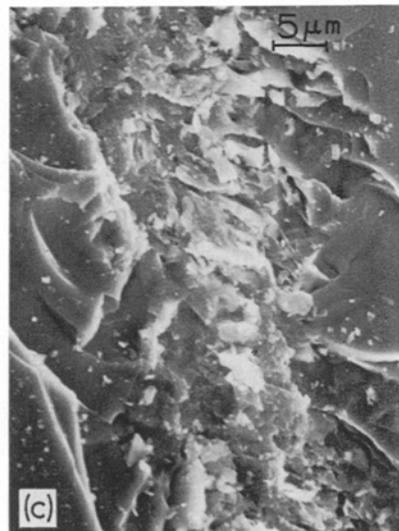
Figure 2 Scanning electron micrographs of typical scratches on the surface of P-type silicon wafers. (a) Scratch flaw, (b) scratch tip, (c) high magnification of flaw structure.

Flaws were placed on the surface of the Si test specimens after establishing a final surface polish, using a metal rule and a diamond stylus which produced an irregular scratch having a width and depth which could be varied according to the exerted pressure. Reasonably consistent scratches were made which measured approximately 50 to 60  $\mu\text{m}$  width and 6 to 10  $\mu\text{m}$  depth, having a structure illustrated typically in Fig. 2. The scratches, measuring approximately 1 cm in length, were placed either along a diameter through the impact point located near the centre of the sample, or along a cord normal to this diameter. The diameter, however, was oriented either along a cleavage plane (in a  $\langle 022 \rangle$  direction) or at some angle to a  $\langle 022 \rangle$  direction.

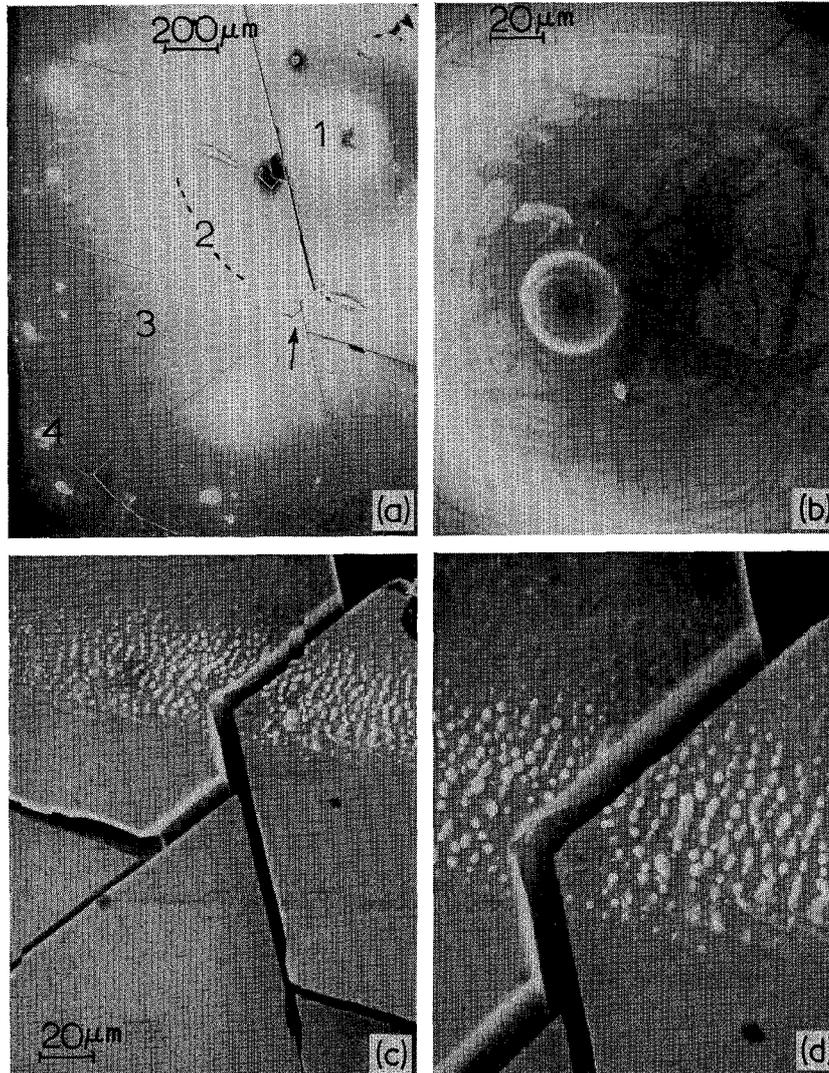
Figure 3 Laser impact zone on a silicon wafer (200 W-5 sec). (a) Low magnification view showing central melt zone (1), vapour redeposition ring (2), deformation zone (3) and terminal crack ring (4). (b) Magnified view of central impact zone (1) in (a). (c) Magnified view of crystallographic cracks (along  $\langle 110 \rangle$ ) at arrow in (a). (d) Magnified view of (c).

The principal features of the laser impact-zone morphology and fracture-related structural phenomena are illustrated in Fig. 3. The impact zone consists of a melt region (1 in Fig. 3a), with a deposition ring (2 in Fig. 3a), where vapourized Si was redeposited onto the surface in a manner similar to that observed previously for laser damaged Be [12]. Some deformation and fracturing was observed within regions 1 and 2 in Fig. 3a, while the bulk of the deformation appeared to be concentrated in the zone marked 3 in Fig. 3a, and was characterized by a terminal boundary consisting of continuous cracks. Zone 3 (Fig. 3a), while not observable in the SEM, was observed in the metallograph to consist of heavy slip-lines or fault traces terminating on the crack ring (4 in Fig. 3a). These features are illustrated in the optical micrographs in Fig. 4. Only a few cracks were observed to exist beyond the crack zone 4, and those which did appeared to nucleate at the crack zone.

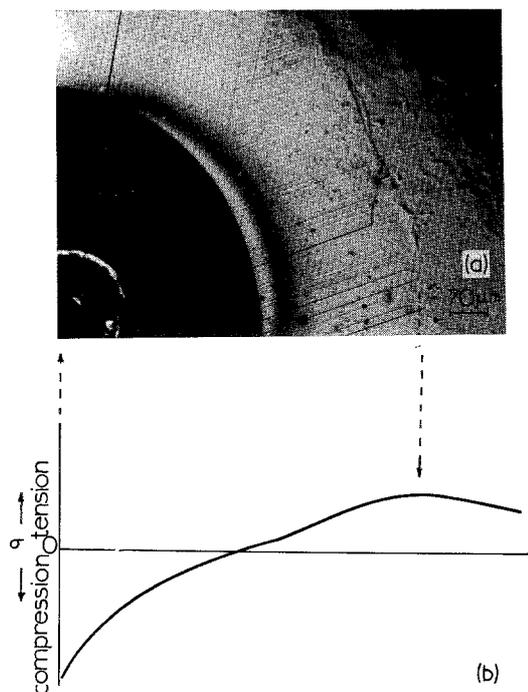
Figure 4 Optical micrograph of laser impact zone and corresponding theoretical stress situation. (a) Micrograph impact of zone similar to Fig. 3a showing slip line field and fracture perimeter. (b) Calculated stress-radius profile corresponding to impact zone in (a).

Fig. 4 shows the central impact zone to be characterized by a region of very high compressive stress which decreases radially to zero and then becomes tensile in character. Fracture around the perimeter of the impact zone occurs at the point of maximum tensile stress; slip lines and microcracks propagate predominantly back from this zone (4 in Fig. 3a) in the direction of decreasing tensile stress. The calculated curve in Fig. 4a is based upon a theoretical treatment of Timoshenko's thermal stress model [13, 14]. The prominent conical uprise associated with the impact zone centre could be explained as a response to the intense compressive stress at the centre, and the transition from a melt zone (and some attendant vapourization) to plastic phases which exhibits a viscosity change which reacts to the compressive stress by pushing the molten and plastic material toward the centre, and in a direction of maximum flow (toward the front or impact surface). A smooth cone emerges from the impact (irradiated) surface exhibiting a series of rings. These rings, illustrated typically in Fig. 5, are due to contours of constant dilatation formed along additive lines of principal strains as previously depicted in computed profiles [14]. These contours appear in the scanning electron

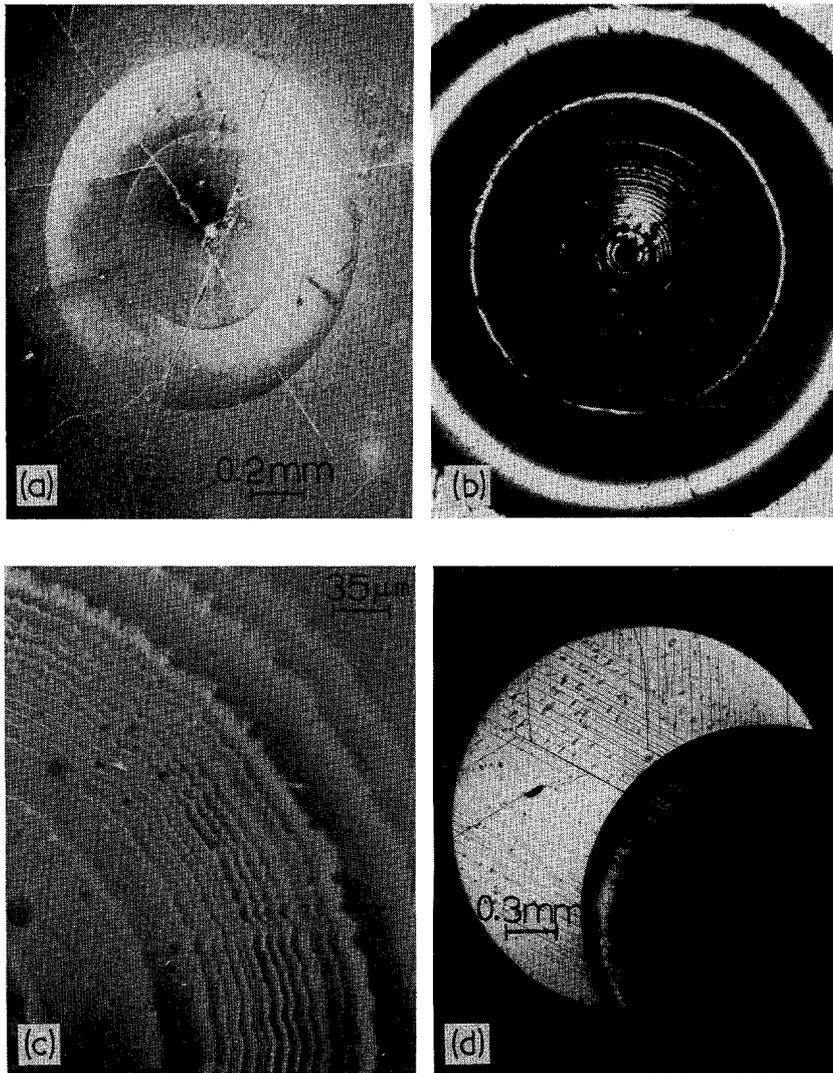
Figure 5 Dilatation contours on the laser impact cone. (a) Scanning electron micrograph of impact cone. (b) Optical micrograph of impact cone. (c) Magnified optical micrograph of dilatation contours. (d) Optical micrograph showing impact cone and cleavage lines associated with cone base.

microscope as smooth transitions rather than steps, in support of this explanation.

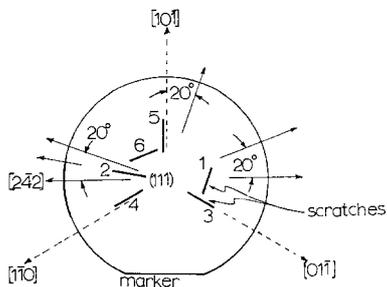
Figure 6 Scratch geometry for laser fracture experiments on Si wafers. Numbers refer to experimental scratch geometries. The cleavage planes are denoted by the  $\langle 011 \rangle$  directions.

Figs. 6 to 9 illustrate the results of two series of flaw interaction studies. Figs. 6 and 7 depict scratch geometries and residual damage features of laser-irradiated wafers. It can be observed in Fig. 7 that in wafers which actually fractured, there was no direct interaction with the surface scratches, as evidenced by cracks running through the scratch, but each of the fractured wafers were observed to have scratches which were coincident with a cleavage-plane orientation

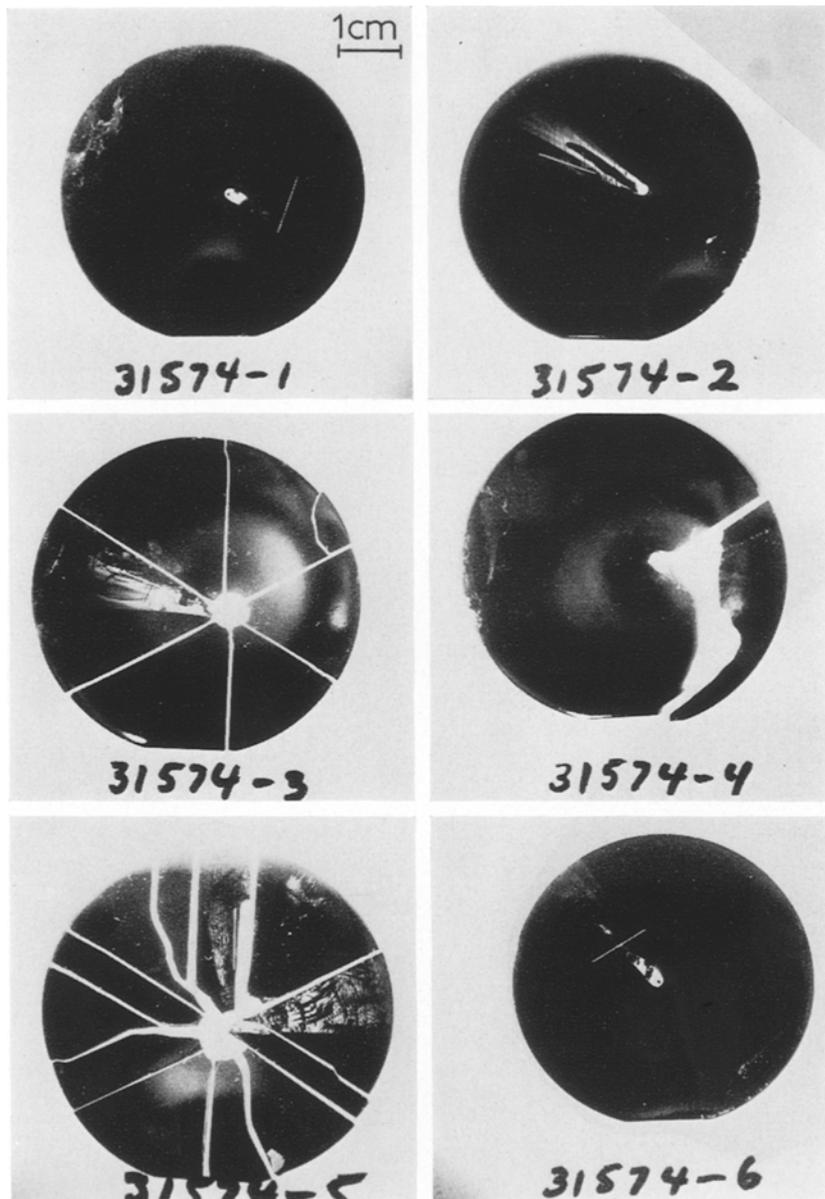
Figure 7 Experimental fracture series: laser-induced fractures in B-doped Si. Reconstructed wafer sections according to the code numbers shown in Fig. 6.

( $\langle 022 \rangle$ ), c.f. Figs. 6 and 7. Detailed examination of the scratch regions in both the scanning and transmission electron microscopes failed to indicate any evidence of dislocation build-up, cracks, or cleavage (slip) traces. There was an apparent lack of direct coupling of the laser-induced fracturing and the scratches, a feature prominently illustrated in sample 31574-5 of Fig.

7. The fracture is in most cases observed to be cleavage fracture, and to be associated in whole or in part with the  $\langle 022 \rangle$  directions ( $\{111\}$  planes).

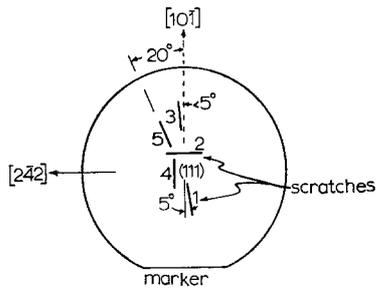
Figure 8 Scratch geometry for laser fracture experiments on P-type Si wafers. Numbers refer to experimental scratch geometries in Fig. 9. Cleavage planes are denoted by the  $\langle 011 \rangle$  directions. The scratch distances from the laser impact zone were roughly 1 mm.

As shown in Figs. 8 and 9, the scratches were moved closer to the laser impact zone, within the tensile stress region depicted in Fig. 3. In this way, it was assumed that if direct coupling were

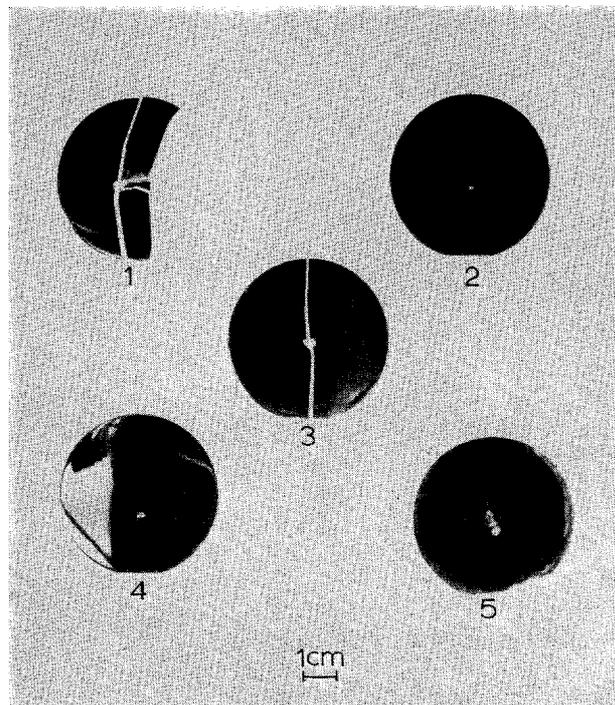
Figure 9 Experimental fracture series corresponding to Fig. 8 Reconstructed wafer sections according to code numbers shown in Fig. 8.

to occur, it would do so within this stressed zone. The results shown in Fig. 9 illustrate that very little interaction between laser-induced cracks and the flaws occurred even for those close-proximity scratches. This feature is illustrated in Figs. 10 and 11, which show the details of scratch-crack interactions, as observed in the

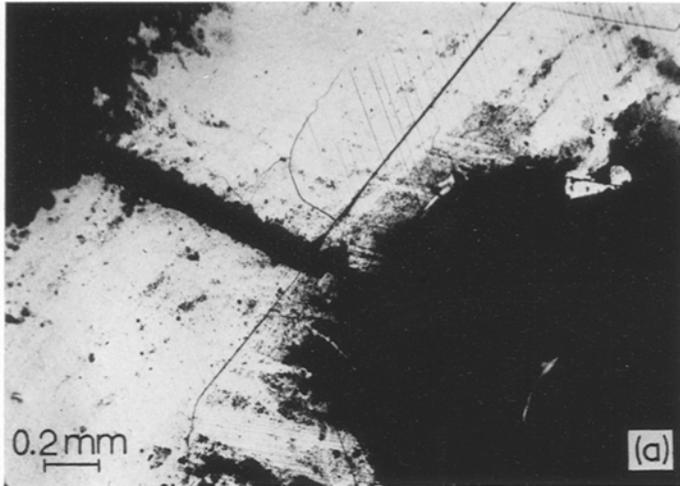
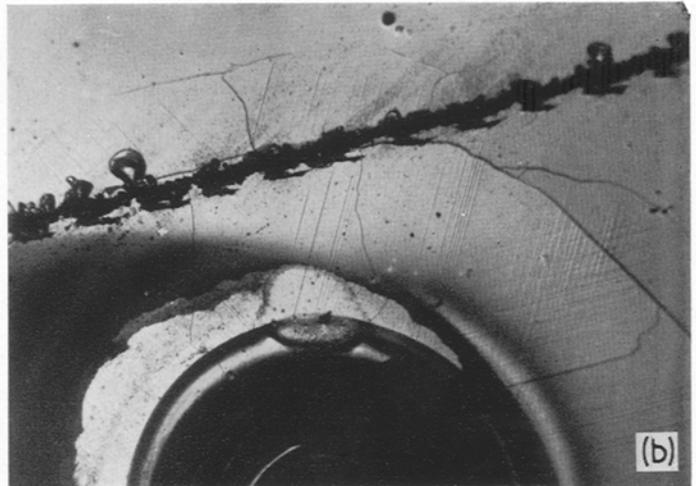
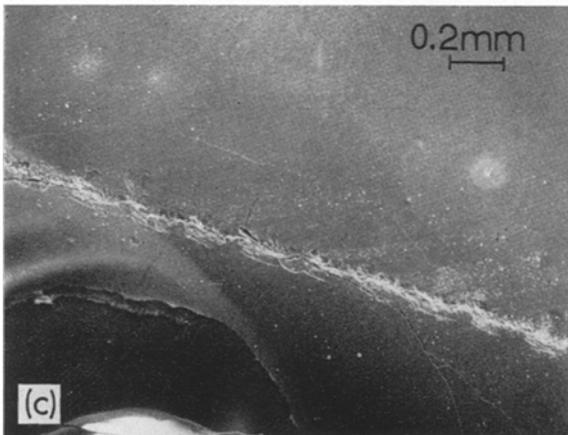
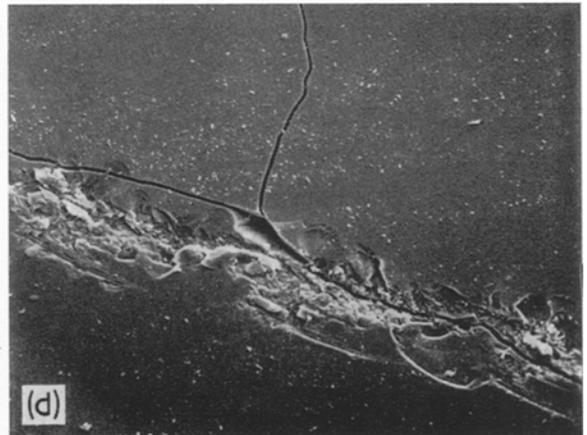
Figure 10 Scratch-crack interactions in laser-irradiated P-type silicon wafers. (a) Diametral scratch extending into impact zone depicted in Fig. 11 (sample 5). (b) Cord-oriented scratch extending into impact zone depicted in Fig. 9 (sample 4). (c) SEM view of scratch-crack interaction zone in (b). (d) Magnified view of (c).

optical metallograph and the scanning electron microscope. Fig. 10a and b show that the scratches cause slight distortion of the cleavage zone (slip zone shown as region 3 in Fig. 3a). However, the scratches do not contribute significantly to fracture in the region in which they intersect the zone, although there is some non-systematic (non-cleavage) cracking associated with the scratches. Fig. 11 shows a magnified view of the scratch in sample 1 of Fig. 9. The by-passing of the scratch by the cleavage crack is clearly illustrated. Again, while there is no strong coupling with the scratch, there is a definite effect on the by-passing cleavage fracture as indicated by the fact that the fracture line runs parallel to the scratch along a major part of its length. In addition, the fractured wafers in Fig. 9 are observed to be either those containing scratches oriented in the cleavage directions or scratches which deviate from a cleavage direction by about  $5^\circ$ . This was also shown previously in Fig. 7. The effect of cleavage-oriented scratches is, therefore, observed to enhance fracture.

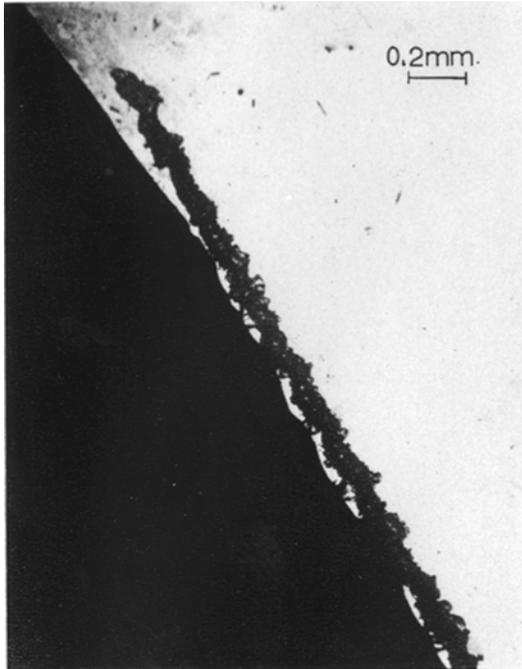
Figure 11 Fracture by-pass of scratch in Fig. 9 sample observed in the optical metallograph.

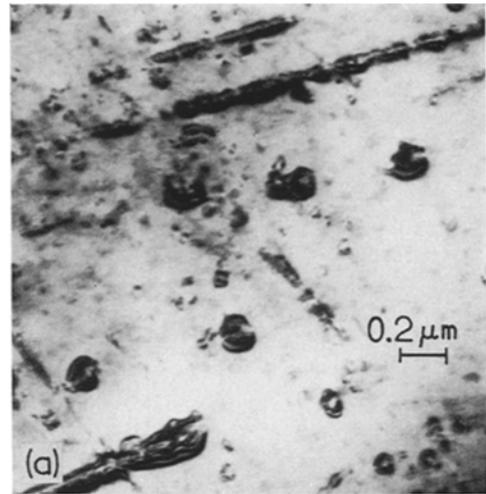
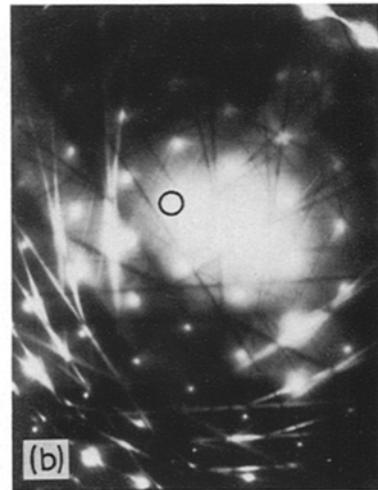
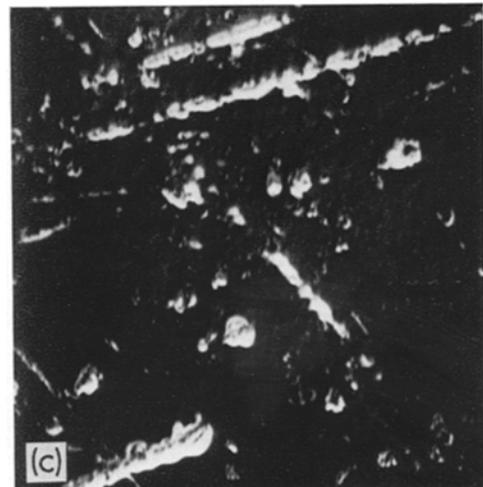
Figure 12 Arrays of precipitates in P-type silicon specimen. (a) Bright-field electron micrograph showing strain-field contrast at linear precipitate arrays. (b) Selected-area electron diffraction pattern of (a). (c) Dark-field electron micrograph of (a) showing strain field contrast reversal and overlapping strain fields using Si  $[022]$  reflection shown circled in (b).

In an attempt to investigate the detailed structure of cleavage cracks and related fracture phenomena in the laser-irradiated P-type silicon wafers, selected-areas from various test specimens were systematically isolated from specific regions over the surface and were examined by transmission-electron microscopy. Fig. 12 illustrates the appearance of the P-type boron-doped silicon wafer specimens following polishing and surface preparation prior to placing a scratch and laser irradiation. The sequence of bright- and dark-field electron micrographs in Fig. 12a and c are indicative of extended arrays of precipitates, presumably borides ( $\text{SiB}_2$ ) oriented along the cleavage planes (in the  $\langle 022 \rangle$  directions). The image reversal in Fig. 12c using a silicon  $\langle 022 \rangle$  matrix reflection, shown circled in (b).

in Fig. 12b, attests to the occurrence of large, overlapping, strain fields associated with the tiny precipitates. Precipitates in the doped-silicon test wafers were observed as individual particles imaged by their associated strain-field contrast [15]. The density of both individual and continuous linear arrays of precipitates was observed to vary from specimen to specimen, but was usually prominent when compared with the structure (or absence of it) in a pure silicon wafer illustrated for comparison in Fig. 13.

in the P-type silicon specimens, as illustrated in Fig. 12, presented a case of internal microscopic flaws. Since cleavage cracks occur by weakening of bonds along the  $\langle 111 \rangle$  directions in the  $\{111\}$  planes of silicon, the presence of precipitates and associated large strains localized along the cleavage planes would be expected to act as an intrinsic flaw, giving rise to preferential crack-propagation along these linear arrays, or initiated by them. The effects of such intrinsic flaws on crack initiation and fracture would be expected to be enhanced by cleavage-oriented external scratches as observed in Figs. 7 and 9.

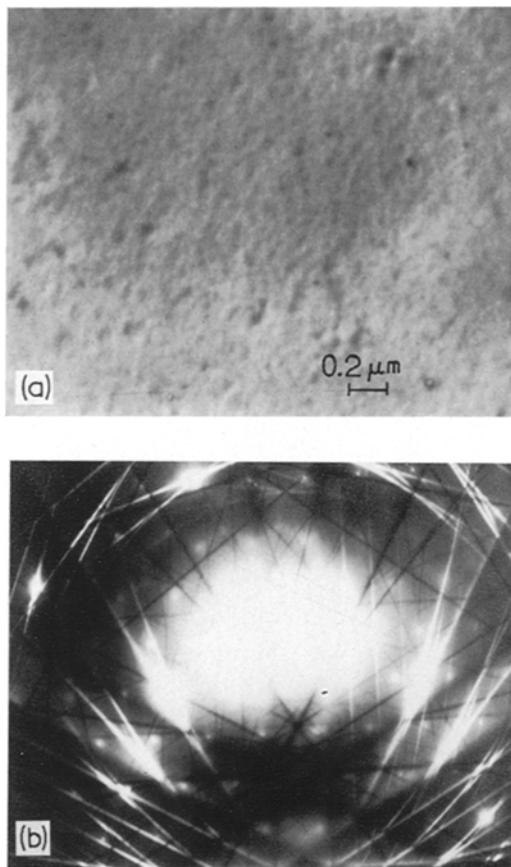
Figure 13 Pure Si wafer section. (a) Bright-field transmission electron micrograph of pure silicon section. (b) Selected-area electron diffraction pattern of (a) showing [111] orientation similar to Fig. 12b.

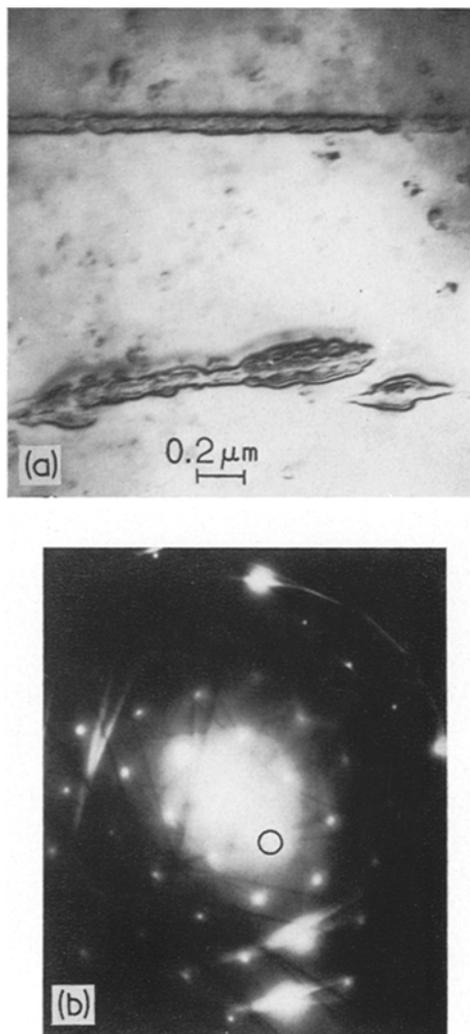
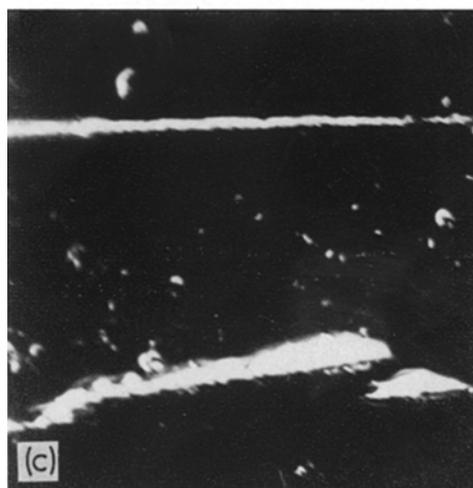
Figure 14 Closely overlapping precipitate strain fields forming continuous cleavage flaw in doped silicon test specimen. (a) Bright-field transmission electron micrograph. (b) Selected-area electron diffraction pattern of (a). (c) Dark-field image of (a) using  $[0\bar{2}2]$  reflection shown circled in (b).

closely spaced precipitates forming a continuous, linear strain-field flaw in a cleavage plane along a  $\langle 022 \rangle$  direction as shown for example in Fig. 14. The propagation of what appears to be a microcrack along such a cleavage array is suggested in the electron micrographs in Fig. 15, which shows an area extracted from a test wafer (wafer 3 of Fig. 7 near region 4 in Fig. 3a, outside region 3).

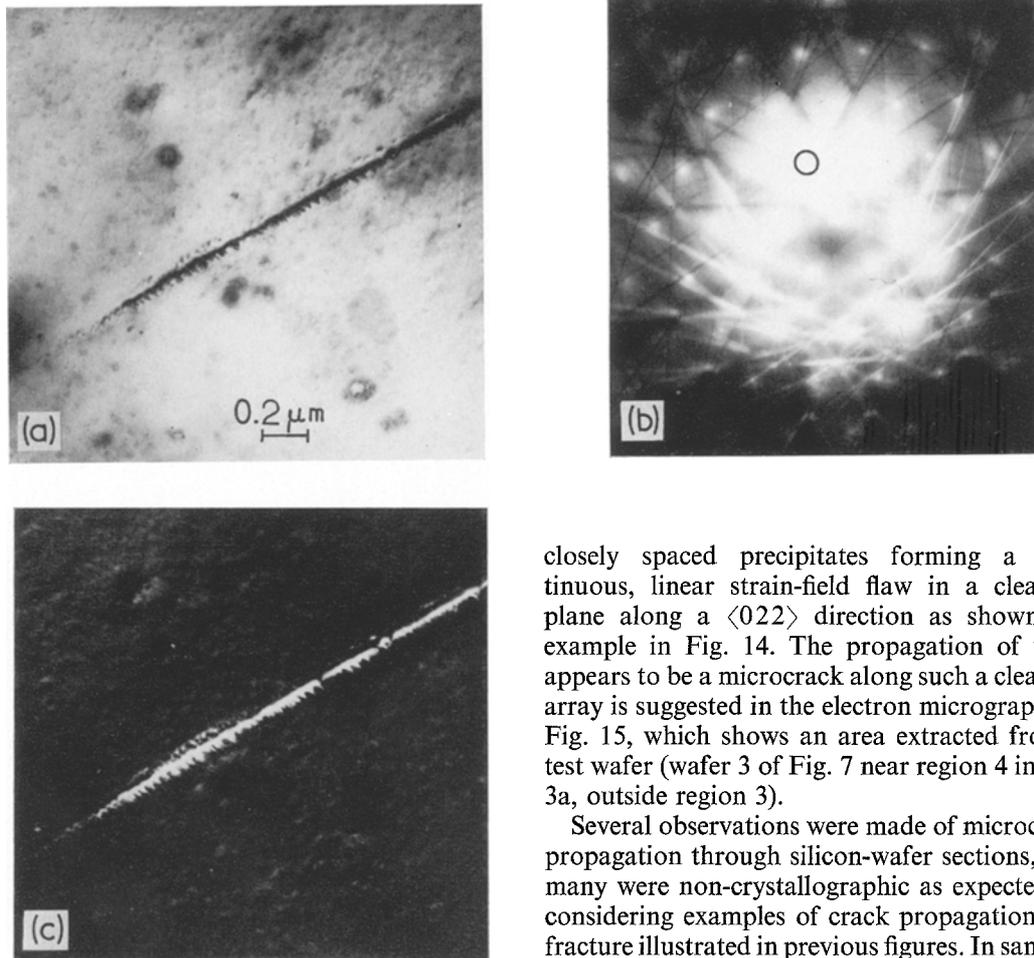
*Figure 15* Apparent microcrack propagation along cleavage plane containing precipitates. (a) Bright-field transmission electron micrograph. (b) Selected-area electron diffraction pattern of (a). (c) Dark-field image of (a) using  $[20\bar{2}]$  reflection circled in (b).

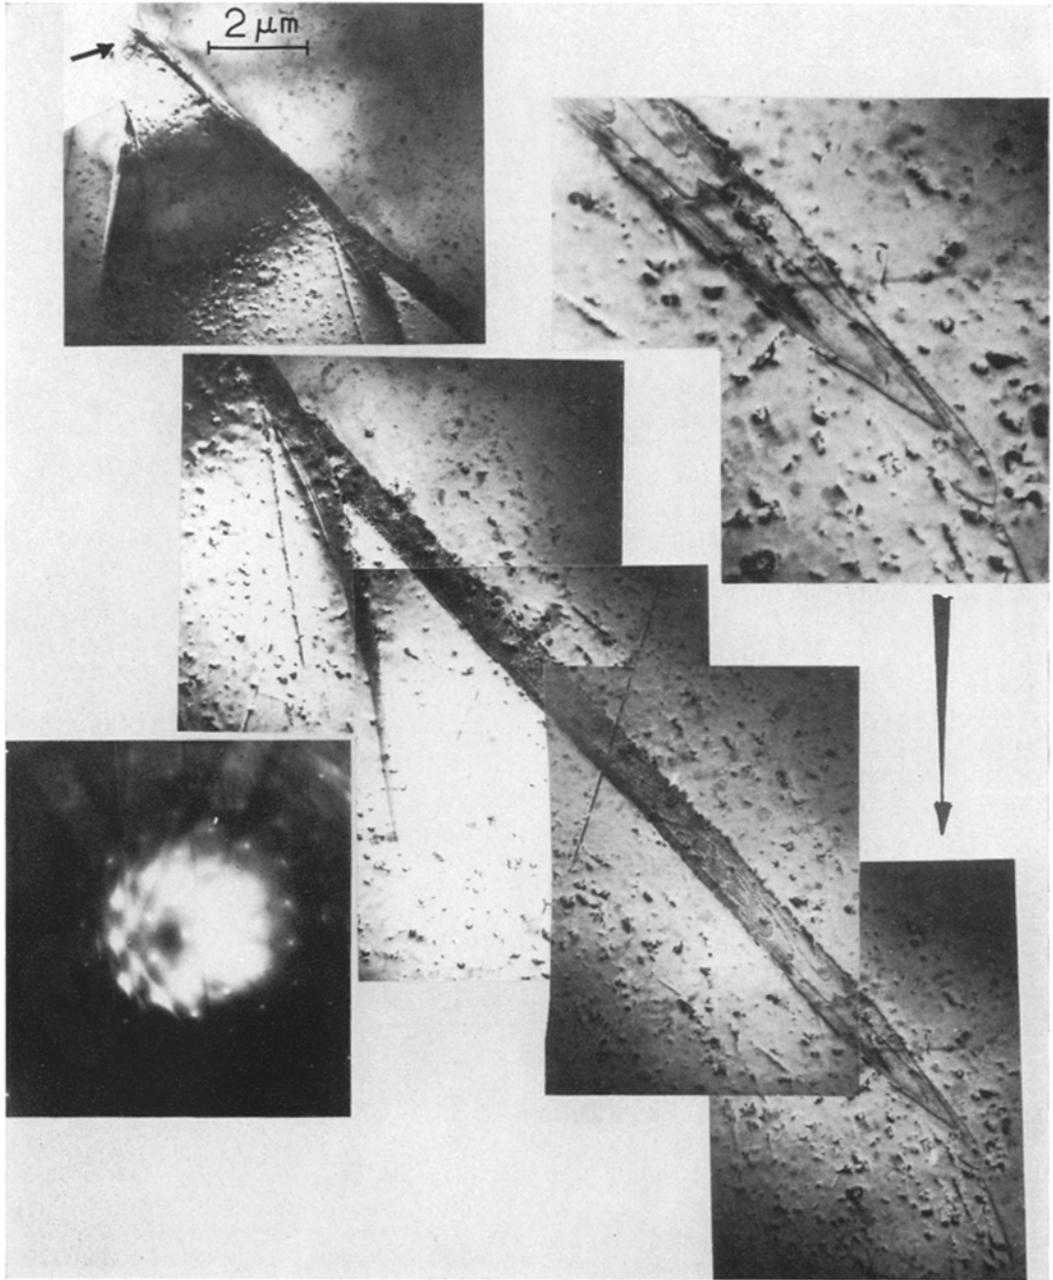
*Figure 16* Transmission electron micrograph composite showing advancing microcrack in P-type boron-doped Si test sample. The crack advances from the edge of the sample (arrow) into the matrix. The crystallographic branch is followed to observe the crack tip, which is composed of dislocations and overlapping stacking faults as illustrated in the magnified insert.

Several observations were made of microcrack propagation through silicon-wafer sections, and many were non-crystallographic as expected on considering examples of crack propagation and fracture illustrated in previous figures. In samples extracted from areas in test wafers near the fracture ring, cracks could be followed into the matrix, and the crack tip examined in detail. Most crack tips were characterized by dislocations (total and partial dislocations) leading the advancing crack. These features are illustrated in the composite transmission electron micrographs shown in Fig. 16. Fig. 16 illustrates the non-crystallographic branching which occurs and the dislocations associated with the advancing crack tip. The crack is observed to be advancing in a heavily precipitated region. It is of interest that dislocations are associated with the advancing crack tip and appear in a form similar to that predicted by classical dislocation theories. It is particularly significant to note that while dislocations have been postulated to accompany crack-tip advance, there have been only a few direct observations of this feature. However, similar results have recently been observed by Bethge [16] at crack tips in MgO.

Advancing crack-tips were observed directly in the transmission electron microscope and shown to have associated with them arrays of partial and total dislocations, in agreement with classical theories of brittle fracture, which postulate the presence of dislocations to advance the crack tip [17].
