Failure mechanisms and acoustic emission amplitude distributions in automotive finishes

A complete automotive finish consists of a steel substrate with a phosphate coat and three paint coats. The complete finish and several sub-systems of the finish have been tested in tension and the acoustic emission monitored. The results of the acoustic emission, complemented with information from other techniques, such as scanning electron microscopy, have enabled the identification of a number of failure mechanisms and the strain ranges over which they occur. Analysis of the amplitude distributions in terms of overlapping Lorentzian peaks has demonstrated that each failure mechanism is associated with emissions of a characteristic amplitude.

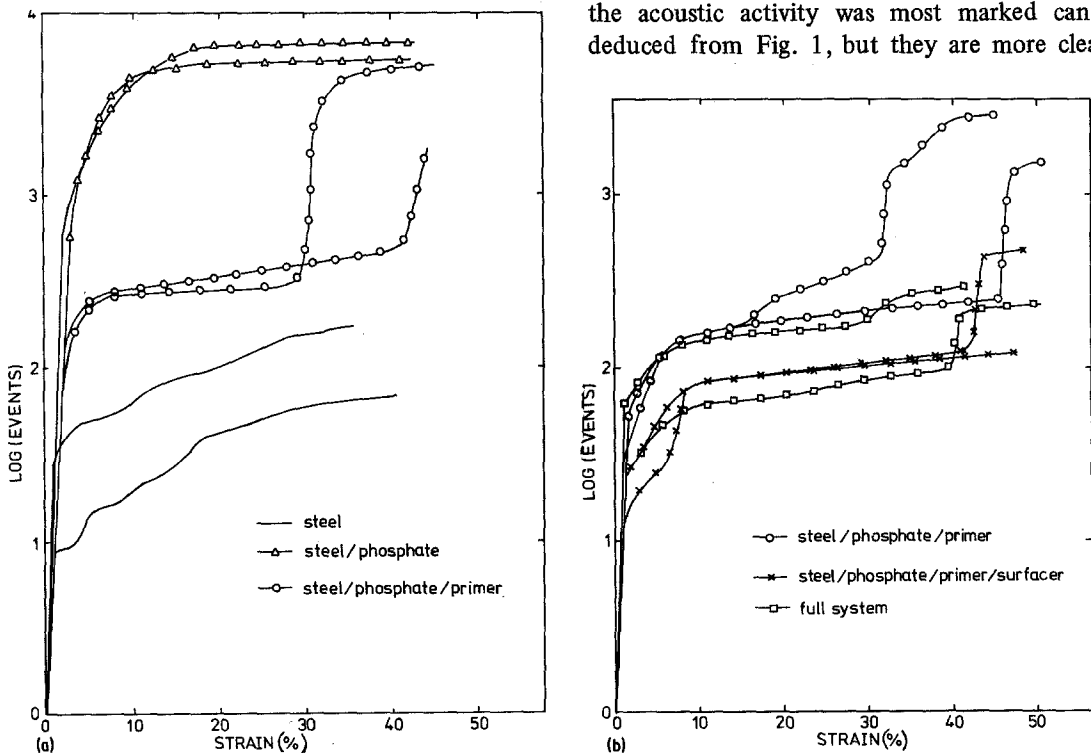
Figure 1 The accumulative event count as a function of strain. The two curves for each system represent the maximum and minimum recorded. (a) Coated both sides; (b) coated one side.

The events against strain curves for the systems tested are shown in Fig. 1. Although there are large variations in the number of events for a given system, the differences between systems can be readily detected. The strain ranges during which the acoustic activity was most marked can be deduced from Fig. 1, but they are more clearly

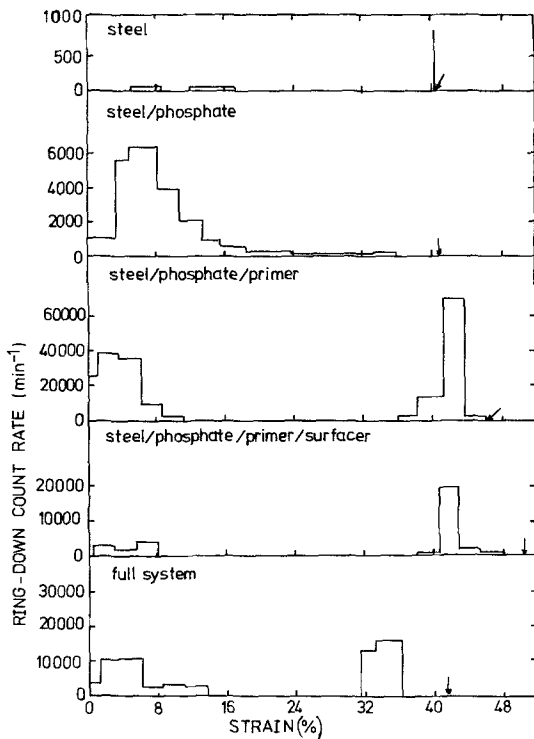
Figure 2 Typical plots of the ring-down count-rate as a function of strain, showing the strain ranges over which there was acoustic activity. The arrows mark the fracture strain. All specimens coated on both sides except the full system and steel/phosphate/primer/surfacer.

shown in the ring-down count-rate against strain curves (see Fig. 2). Steel and steel with a phosphate coat exhibited only one peak in the acoustic emission which occurred at a strain of $< 10\%$. The other systems in which paint coats were present showed two peaks, one at strain $< 10\%$ and one at strain $> 30\%$. The limited amount of published information is consistent with these results. For example, the reported [2] strain dependence of the ring-down count-rate for a cathodic electrocoat on a phosphated steel substrate also showed two distinct maxima. Furthermore, Moslé and Wellenkötter [3] found that emissions for a phosphated steel were produced mainly in the early stages of a tensile test.

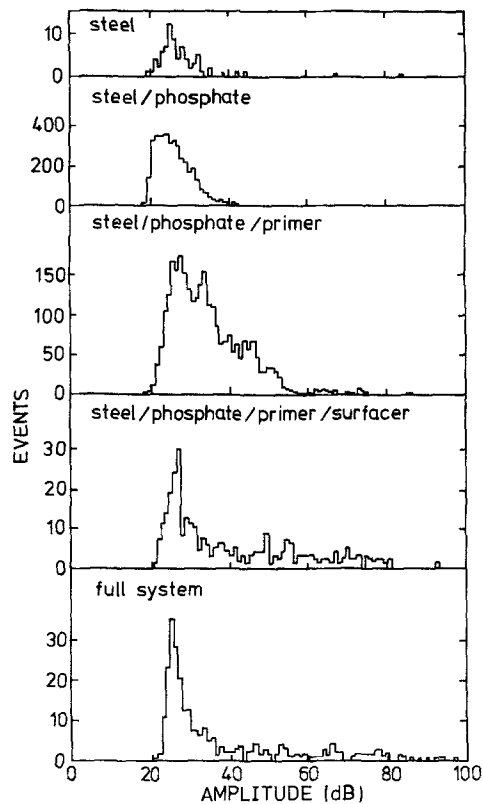
Figure 3 Typical amplitude distributions at failure (full system and steel/phosphate/primer/surfacer coated on one side only).

Amplitude distributions at failure are shown in Fig. 3. The steel and steel/phosphate show emissions with amplitudes only below 40 dB. The addition of further coats resulted in more complex distributions with amplitudes extending to 80 dB. In Fig. 4 amplitude distributions recorded at about 10% strain are compared with those at fracture (full system and steel/phosphate/primer/surfacer coated on one side only). It

(c) The high amplitude emissions (> 60 dB) can be accounted for by the second low-strain failure process, microcracking in the paint coats, which was detected in the low-strain distributions for the systems with paint coats. From Figs 3 and 4 it seems possible that microcracking in the top-coat may give higher amplitude emissions than microcracking in the surfacer.

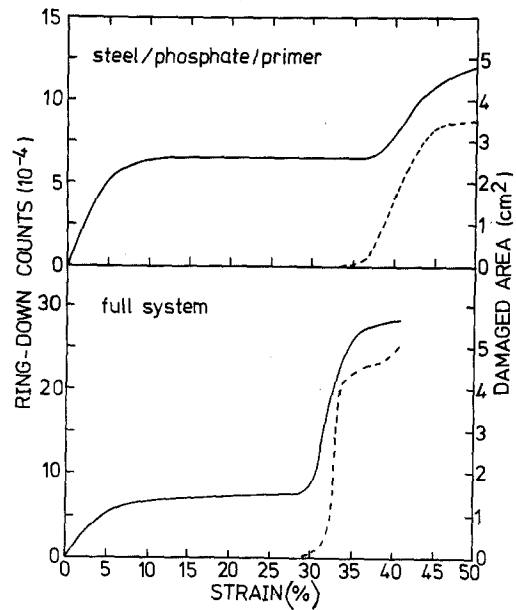
Figure 8 Graphs showing the good correlation between the extent of surface damage, given by the broken curve, and the accumulative ring-down count at high strains.

damage on the surface of the specimens [6]. This is shown in Fig. 8 where the strain dependencies of accumulative ring-down count and area of visible damage are presented. It can be seen that there is good correlation between the degree of damage and the ring-down counts.

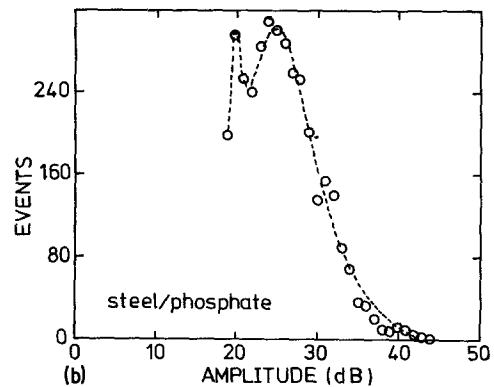
Figure 9 Typical results from the analysis of the amplitude distributions in terms of overlapping Lorentzian peaks. The broken lines represent the computer fit to the experimental data given by the circles. (a) Steel/phosphate/primer; (b) steel/phosphate.

A computer program that distinguished and quantified a series of overlapping Lorentzian peaks was used to analyse the amplitude distributions (except those for untreated steel which gave too few events for a satisfactory analysis). Typical examples of the fit are shown in Fig. 9. The results of the analysis are given in Table I.
