The microstructure of the steel fibre-cement interface

The microstructure of the steel fibre-cement paste interface was studied by scanning electron microscopy. The interfacial zone surrounding the fibre was found to be substantially different from the "bulk" paste further away from the fibre surface. The interfacial zone consisted of (a) a thin (1 or 2 μm thick) duplex film in actual contact with the reinforcement, (b) outside of this, a zone of perhaps 10 to 30 μm thickness, which, in reasonably well hydrated systems, is largely occupied by relatively massive calcium hydroxide crystals, with occasional interruptions of more porous regions, and (c) outside of this, a highly porous layer parallel to the interface. The interaction of cracks initiated in the matrix with this interfacial zone was observed.

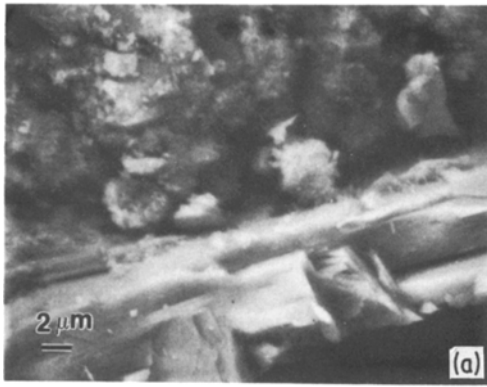
Figure 10 Higher magnification of the CH rim.

thickness of 5 to $15\ \mu\text{m}$, could be clearly seen (Fig. 9). In some instances the material in the rim was so massive that it was difficult to resolve the orientation of the crystals (Fig. 10a), but in other locations CH platelets could be observed, with the c -axis parallel to the plane of the interface (Fig. 10b). In some cases there were clear indications that the CH rim was not in direct contact with the steel surface and a thin layer ($\sim 1\ \mu\text{m}$) of hydration products could be observed (upper right-hand side of Fig. 10b).

It is interesting to note that the area backing the CH rim tended in many cases to be very porous (Figs. 10 and 12). A transition zone could be observed, which was very porous at the CH surface and became denser as the bulk paste was approached (Fig. 12). This transition zone was about 10 to $20\ \mu\text{m}$ thick, and beyond it the usual features of a dense structure with

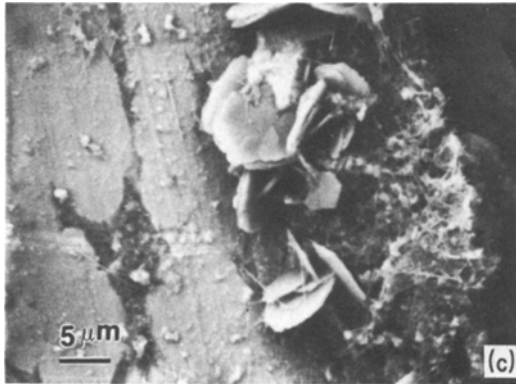
Figure 15 The surface of the steel fibre before being cast into the cement paste (a) and after being removed from the hardened paste (b), (c).

A typical surface of a fibre before it was cast in a cement matrix is shown in Fig. 15a. The surface is generally smooth, but frequently defects which are oriented along the fibre axis can be observed. After removal from the paste, most of the fibre surface seemed to be free from any deposit of hydration products, and only occasional local “pockets” of adhering paste

could be observed (Fig. 15b) which consisted of plate-like crystals and fibrous and particulate material (Fig. 15c).
