Accelerated fatigue fracture mechanism of medium density polyethylene pipe material

J. J. STREBEL, A. MOET

Department of Macromolecular Science, Case Western Reserve University, Cleveland, OH 44106, USA

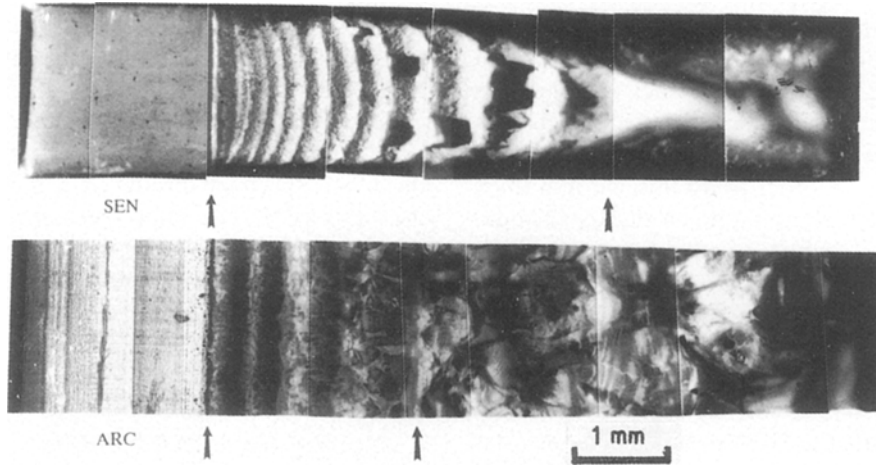
Figure 17 Montage of the complete SEN fracture surface and partial arc fracture surface. The vertical arrows mark the notch position and the beginning of complete ductile failure. The crack propagation direction is from left to right.

Although it is not surprising that the thicker (more plane-strain contribution) block specimen produced a more brittle failure than the SEN specimen, it is surprising that the arc, which is the same thickness (28 mm) as the block, produces a shorter brittle crack propagation region than does the SEN (Fig. 17). If the
