Microstructural aspects of weld repair in 18 nickel 1800 MPa maraging steel

K. SREE KUMAR, A. NATARAJAN, P. P. SINHA, K. V. NAGARAJAN
Materials and metallurgy group, Vikram Sarabhai Space Centre, Trivandrum 695 022, India

The study of the microstructural aspects of the maraging steel weld repair has become important as this material finds extensive applications in aerospace and other strategic areas. The details available on these at present are very limited. During one of the fabrication trials of a large pressure vessel made of 18 Ni 1800 MPa maraging steel plates, 7.8 mm thick, defects were observed in the welds which were to be repaired. This called for simulated experiments. The microstructural variations observed in the repaired areas were the result of the repeated thermal cycles they had undergone. Based on this microstructural evidence, a new diagram depicting the newly formed weld zones is constructed from which the mechanical properties of the repair welds can be predicted.

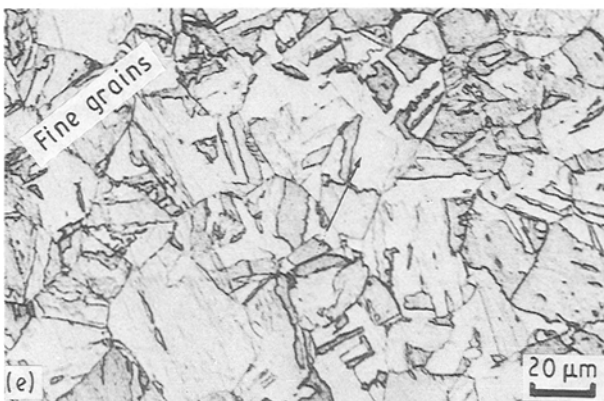
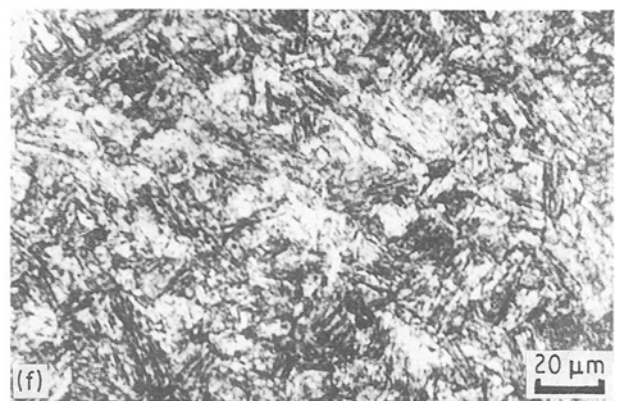
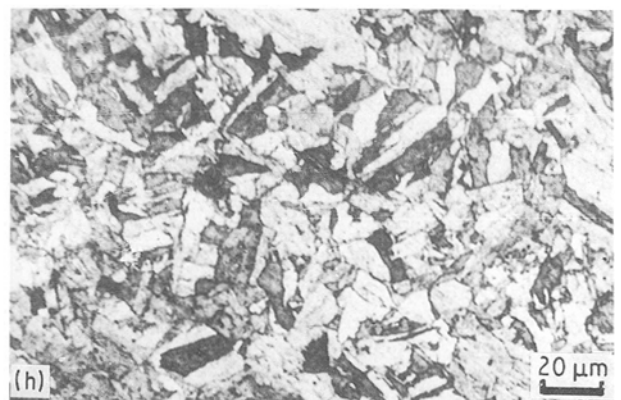
Figure 4 Microstructures at various zones after repair welding.

A metallographic traverse across the repair weld clearly delineated the gradual change in the microstructures from the repair weld pool to the parent metal. Fig. 4a–h are the typical micrographs from the regions marked in Fig. 3. It can be seen that the repaired weld pool had equiaxed grains with minute specks of uniformly distributed austenite (Fig. 4a). This was in contrast to the dendritic structures with some austenitic films in the interdendritic boundaries, in the virgin weld (Fig. 2). The origin of dendritic arms, at the fusion boundary of the repaired pool, is evident from Fig. 4b. Considerable change in the microstructures of the original weld pool, which had not been gouged out, resulted from imposition of high-temperature thermal cycles. The partially recrystallized structures in Fig. 4c and the enlarged grains in Fig. 4d resulted from the variations in the thermal conditions.

It was observed in Fig. 2 that a coarse dendritic structure existed on the side of the fusion line facing the virgin weld, while coarse grains were seen on its other side. Both these coarse structures were refined during repair weld, resulting in a microstructure consisting of fine grains (Fig. 4e).

On moving further away from the fusion line of the virgin weld to its HAZ I, it was observed that this region turned darker on etching after repair welding (Fig. 4f). The microstructural features of this area were similar to those observed at the dark etched second heat-affected zone (HAZ II) of the virgin weld (Fig. 2). Adjacent to this dark etched region was an area that was not affected by the etchant used. Beyond it lay another dark etched region. Thus an almost unetched region was found to be sandwiched between the two dark etching regions. The transition from the first dark etched region to the second was gradual, passing through a light region, an unetched region (Fig. 4g), and a second light etched region. X-ray diffraction analysis of the unetched region (Fig. 5) showed an austenite, γ , content of 12%–13% which was measured by comparing the integrated intensities of (1 1 1) austenite and (1 1 0) martensite, α , peaks. Extending beyond the second dark etched region was the parent metal (Fig. 4h).

($\alpha + \gamma$) two-phase region. The repair weld pool, which was much smaller than the virgin weld pool, contained almost fine equiaxed grains (Fig. 4a). Examination of the microstructure revealed that the austenite, γ , con-

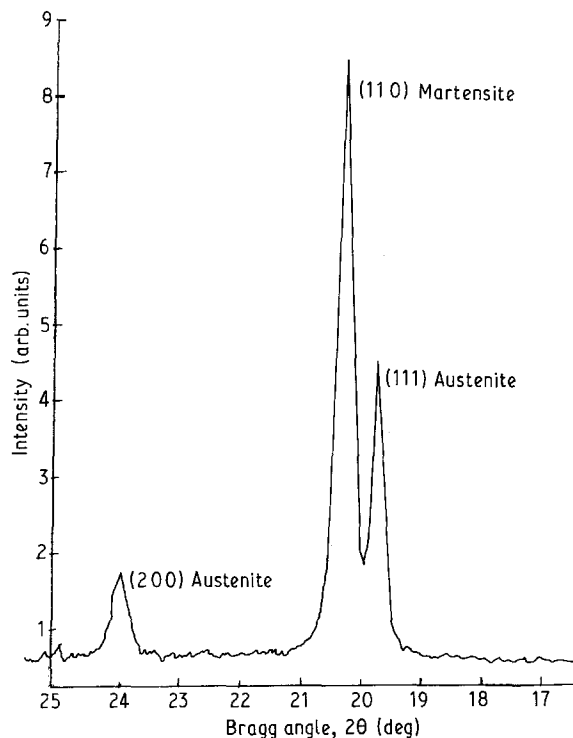
Figure 5 X-ray diffraction pattern of the "unetched" region (radiation MoK_{α} , 35 kV, 20 mA).
