Evaluation of the mechanisms of water migration through honeycomb core

Thirteen commercial wing panels were fabricated and flown on a commercial aircraft to investigate the mechanisms of water migration through various honeycomb cores. A 12.2 J impact damage was not observed to cause damage propagation in aluminum and Korex[®] honeycomb materials. This was attributed to the ability of the cores to localize the impact damage. In Nomex[®] and glass fiber cores a different damage propagation mechanism was observed. In these cores, the damage was not confined to the localized area around the impact. Instead, core damage was seen as far as 2.0 cm from the point of impact. This increased core damage allowed the core to retain water. The retained water helped propagate the impact damage through a freeze thaw mechanism. Speed-tape repairs were only found to be statistically significant when water migrated through the core. Filling the honeycomb core with foam was shown to be an effective method for minimizing the damaging effects of water ingress. Slotting and draining the core also offered some relief from water accumulation in the core, but foaming damaged core was established as the mo

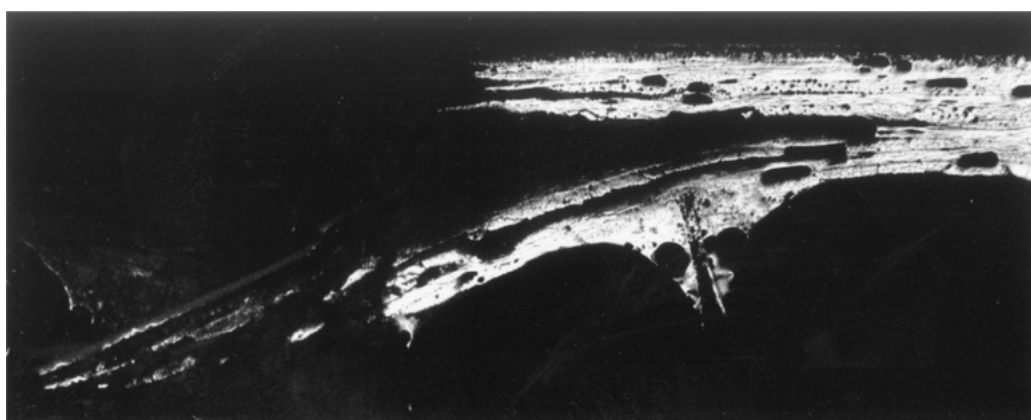
Figure 4 Photomicrograph of a Nomex core bay impacted with 8.1 J at 25 \times magnification.

structure. This is attributed to the mechanism of damage propagation through the core. When the Nomex honeycomb composite structures were impacted, both the core and facesheet sustained a great deal of damage, as shown in Fig. 4. In this figure, only the area immediately surrounding the impact location is shown, however, small microcracks could be observed in the Nomex honeycomb core as far away as 1.5 cm from the impact location. This damage allowed water to migrate significant distances away from the ingress point and into the core. At altitude, the pressure gradient for water removal is largest around the point of ingress. As the distance from the impact location increased, the pressure drop from cell-to-cell decreased and the effective driving force for water removal decreased. The net result was a greater amount of water retained by the honeycomb core. Water retained in the core is known to cause freeze-thaw damage in the core, which further damages and fractures the core, and ultimately increases the water retention volume of the core.
