# The effect of excimer laser surface treatment on the pitting corrosion fatigue behaviour of aluminium alloy 7075

An excimer laser (KrF) operating at a wavelength of 248 nm was used to modify the surface microstructure of 7075-T651 aluminium alloy. The aim was to improve both the corrosion resistance and the pitting corrosion fatigue resistance of the alloy by means of laser surface melting (LSM). The microstructure and the phases of the modified surface structure were analysed, and the corrosion behaviour of the untreated and the laser-treated specimens were evaluated by immersion test. The fatigue resistance of the 7075 alloy has been presented in the form of S/N curves.

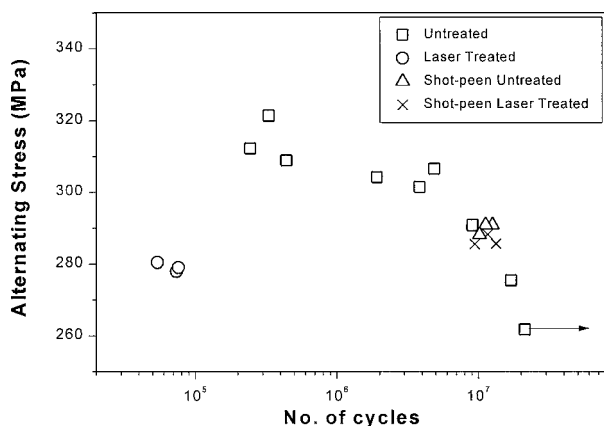
Figure 11 Dry fatigue S/N curves for the untreated and laser treated specimens.

The results of the dry fatigue test of the untreated and the laser treated specimens are presented in Fig. 11. A comparison of the fatigue strength of the untreated and laser treated specimens with shot peening was made at a stress level of about 280 MPa. The results showed that the fatigue life of the alloy was significantly reduced after laser treatment, a reduction of two orders of magnitude in the number of cycles to failure being recorded. Low glancing angle XRD was employed to determine whether laser treatment had caused the presence of tensile residual stresses at the surface of the specimen. Any such stresses appear in the surface layer would certainly reduce the fatigue strength of the specimen.

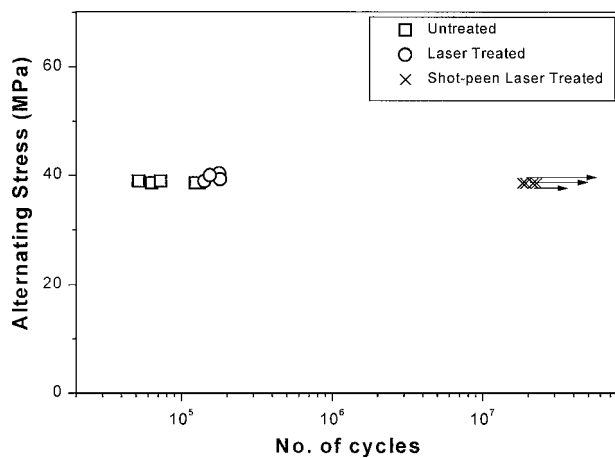
Figure 17 Corrosion fatigue S/N curves of the untreated and the laser treated specimens.

The results of corrosion fatigue testing are presented in Fig. 17. To make a comparison of the pitting corrosion fatigue resistance of the laser treated and the

untreated materials, all the pre-corroded specimens were tested at a stress level of 40 MPa. The results indicated that the pitting corrosion fatigue resistance of the laser treated specimens was slightly better than the untreated specimens. This shows that despite the presence of microporosity in the melted layer, the lives of the laser treated specimens were some 30% to 50% longer than those of the untreated specimens. One of the reasons must be due to the greater pitting resistance of the laser treated material as shown in the immersion tests. Unlike the laser treated specimens, numerous corrosion pits were found in the surface of the untreated fatigue specimens (cf. Figs 18 and 19), and there is no doubt that these defects would act as fatigue initiation sites and cause early fatigue crack growth. Such an effect had caused a large difference in fatigue strength between the dry fatigue and the pre-corroded
