Fatigue behaviour of beta Ti-22V-4Al alloy subjected to surface-microstructural modification

The present paper describes a surface-microstructural modification due to cold work and the fatigue behaviour of the surface-modified specimens in beta Ti-22V-4Al alloy. As-solution treated specimens were shot peened and then aged to achieve the modification. The obtained microstructure was first characterized and rotating bending fatigue tests were then performed using the surface-modified smooth specimens. The fatigue behaviour was evaluated and compared with the results of the conventional solution treated and aged specimens without modification. Surface-microstructural modification was successfully achieved within the region of 350 μm underneath the surface where hardness increased significantly compared with the core of the specimen, although there were some inhomogeneous precipitation areas in the modified region. The specimens without modification showed a step-wise *S-N* curve with the transition stress of approximately 600 MPa below which subsurface fracture occurred, while the surface-modified specimens did not exhibit step-wise *S-N* curve, but both surface-related and subsurfac

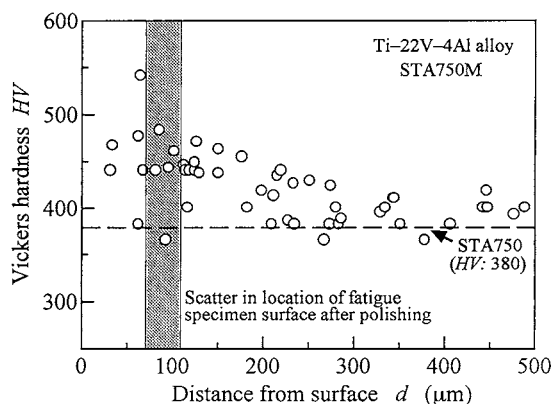
Figure 4 Vickers hardness profile for surface-modified material (STA750M).

Vickers hardness profile of STA750M is represented in Fig. 4 as a function of distance from the surface. Corresponding to the microstructure shown in Fig. 2b, hardness increases within the region of approximately 300 μm from the surface. It decreases with decreasing the distance from the surface and coincides with the core hardness that is almost the same as STA750. As described previously, surface roughness produced by shot peening was removed by polishing. Consequently, the fatigue specimen surfaces of STA750M are located between 70 μm and 110 μm from the surface shown in Fig. 2, which is indicated by gray band in Fig. 4.

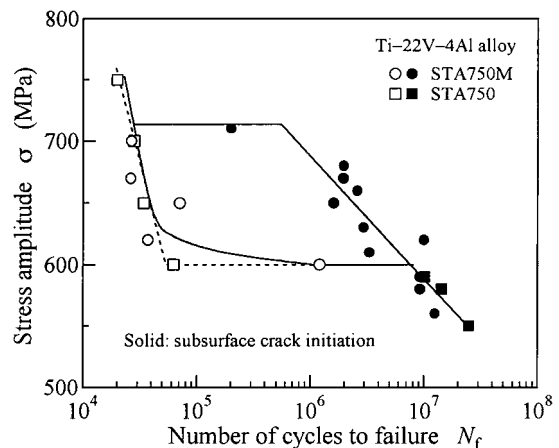
Figure 5 $S-N$ diagram.

The $S-N$ curves of STA750M and STA750 are shown in Fig. 5. STA750 exhibits a definite step-wise $S-N$ curve consisting of short life regime less than 10^5 cycles and long life regime more than 10^7 cycles. In the former region cracks initiated at the surface, while in

the latter region, the crack initiation site was the interior of the specimens. The step-wise $S-N$ curve results from different crack initiation mechanisms. As can be seen in the figure, the transition stress below which subsurface fracture takes place is approximately 600 MPa.

On the contrary, the surface-modified material, STA750M, does not show step-wise $S-N$ curve, but both surface-related and subsurface fractures appear in the wide range of applied stress levels. For the surface-related fracture, fatigue lives are nearly the same as or longer than STA750, at higher stress levels and near the transition stress, respectively. For the subsurface fracture below the transition stress of 600 MPa of STA750, fatigue lives are identical because crack initiation and subsequent crack growth are not affected by surface-microstructural modification. However, it should be noted that the stress below which subsurface fracture occurs shifts to 720 MPa from 600 MPa, thereby fatigue lives increase significantly.

In STA750M, fatigue lives increased significantly because subsurface fracture took place up to a higher stress level than in STA750. In surface-related fracture, fatigue lives are almost the same as STA750, but tended to increase at lower stress levels near the transition stress (Fig. 5). From these results, it is concluded that fatigue strength can be improved by the surface-microstructural modification even though some inhomogeneous precipitation areas are present. If surface-microstructural modification are perfectly achieved without inhomogeneous precipitation area, then surface-related fracture would be suppressed, in other word, only subsurface fracture would occur up to a much higher stress level depending on stress gradient. As a result, fatigue strength would be greatly improved.

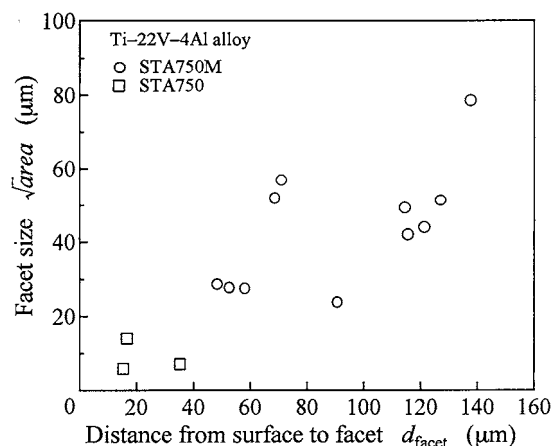
Figure 8 Relationship between facet size and distance from surface to facet.

As shown in Fig. 7b, several facets were always seen at the subsurface crack origin. The size and the distance from the surface to facet were measured. Square root of area of the facets projected onto the plane perpendicular to the specimen axis was employed as facet size. Fig. 8

shows the relationship between facet size and distance from the surface to facet. In this figure, the following points can be identified:

- subsurface crack initiation sites are much deeper in STA750M than in STA750,
- facet sizes are larger in STA750M than in STA750,
- facet sizes increase with increasing the distance from the surface to facet.

The subsurface crack origins in STA750M are between $50\ \mu\text{m}$ and $140\ \mu\text{m}$ from the fatigue specimen surface, i.e. between $120\ \mu\text{m}$ and $250\ \mu\text{m}$ from the surface after shot peening, which corresponds to the inhomogeneous precipitation areas ($150\ \mu\text{m}$ to $300\ \mu\text{m}$ from the surface), from which subsurface fracture has started. In order to further establish the correlation of the subsurface crack initiation site with microstructure, additional fatigue tests have been conducted using specimens whose surface was removed by electropolishing by approximately $200\ \mu\text{m}$ and $300\ \mu\text{m}$. These amounts of removal correspond to the inhomogeneous precipitation zone and the complete removal of the modified microstructure, respectively. The results are demonstrated in Figs 9 and 10. At the test stress level of $590\ \text{MPa}$, subsurface fracture was thought to occur independent

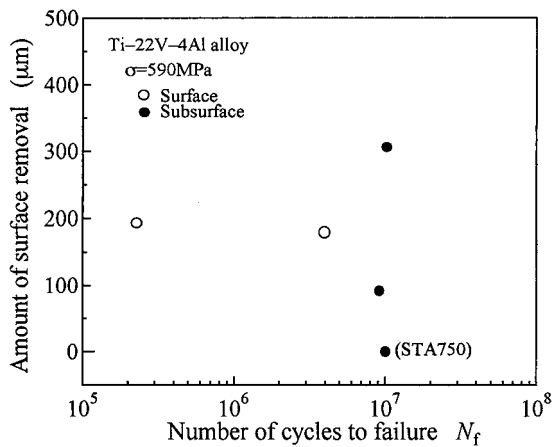
Figure 9 Fatigue test results of specimens whose surface was removed by electropolishing.

of the amount of removal (see Fig. 5), but the specimens with the amount of removal of $200\ \mu\text{m}$ showed surface-related fracture. These results clearly indicate that the subsurface crack origin was closely related to the inhomogeneous precipitation areas in the modified microstructure as suggested in the previous section. Therefore, it is believed that subsurface cracks were generated by slip deformation within soft and weak grains in which precipitation delayed, because many straight patterns seen on the facet surface seem to be traces of slip deformation. As shown in Figs 9 and 10, the distance from surface to facet of the specimen with the amount of removal of $300\ \mu\text{m}$ is nearly the same as that of STA750, which gives very reasonable result.

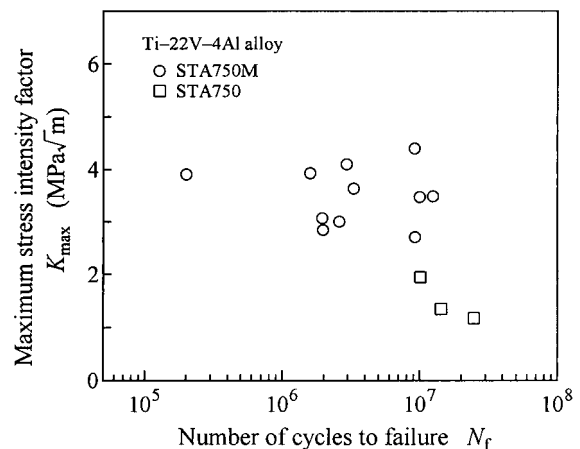
Figure 11 Relationship between maximum stress intensity factor for facets and fatigue life.

where σ_{facet} is the applied stress at the position of facets and $\sqrt{\text{area}}$ is the facet size. Fig. 11 shows the relationship between K_{max} and fatigue life. There is a considerable scatter, but fatigue life tends to increase as K_{max} decreases. This seems to imply that the process to facet formation, i.e. the crack initiation dominates the subsurface fracture process.
