# Residual toughness of poly(acrylonitrile-butadiene-styrene) (ABS) after fatigue loading—effect of uniaxial fatigue loading

Toughness variation of non-notched poly(acrylonitrile-butadiene-styrene) (ABS) subjected to uniaxial fatigue loading was investigated. The experiments were conducted by applying fatigue loading to strip specimens first, from which dog-bone specimens were machined. The dog-bone specimens were tested to measure the strain for the on-set of fracture, named cracking strain here, thus to monitor the toughness change due to the fatigue loading.

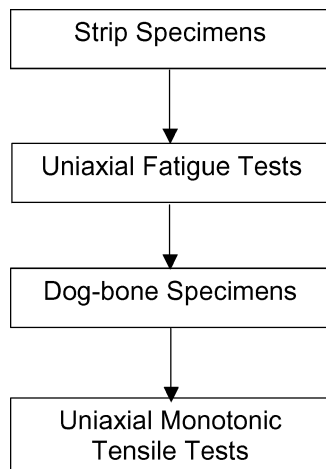
Figure 3 Schematic diagram for the experimental procedure.

Procedure of the experimental study is described in Fig. 3 and the specimens used for this study are shown in Fig. 4. Strip specimens of  $25 \times 145 \text{ mm}^2$  were machined from the plates for the uniaxial fatigue tests, after which dog-bone specimens were machined for the subsequent tensile tests, to remove potentially damaged corners along the specimen edges due to the fatigue loading. The level of fatigue loading was in the range of 30% (15 MPa) and 60% (30 MPa) of the original tensile strength. Even though the plates were extruded, the preliminary tests suggested that the anisotropy was very negligible. Therefore, the ABS was regarded as

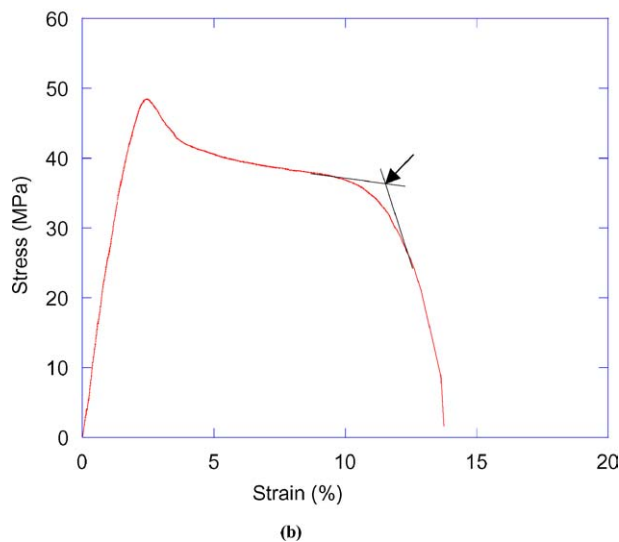
Figure 5 Typical stress-strain curves from tensile tests: (a) after the fatigue loading at 20 MPa for 500 cycles, and (b) without the fatigue loading.

It should be noted that the range of fatigue loading used in this study did not affect the maximum tensile stress or Young’s modulus of the dog-bone specimens. Fig. 5a and b show the typical tensile stress-strain curves of the original and fatigued specimens. The only change caused by the fatigue loading was the strain at the on-set of fracture, named “cracking strain.” The cracking strain was determined by the intersection of

two straight lines that are tangential to the plastic drawing section and the final fracture section of the curve, respectively, as pointed by arrows in Fig. 5. In the following section of Results and Discussion, the cracking strain will be used as a measure of the toughness change by the fatigue loading.

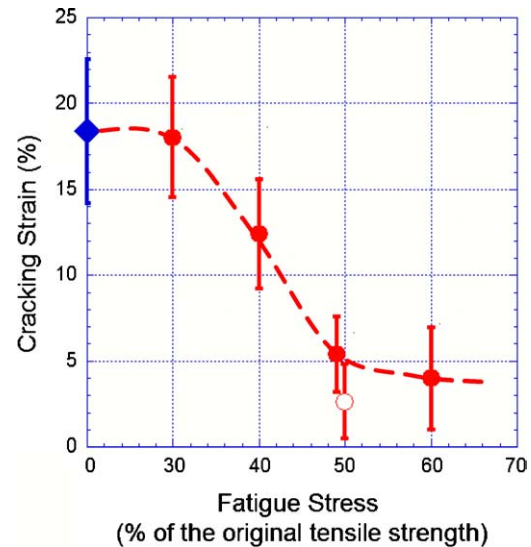
Figure 6 Summary of the variation of fracture strain and standard deviation as a function of the peak stress value under the uni-axial fatigue loading for 500 cycles. Filled circles (●) were from specimens with the original thickness of 3.2 mm, and open circle (○) from the reduced thickness of 1.28 mm.

Summary of the cracking strains after various uniaxial fatigue loadings is presented in Fig. 6 in which a dashed line is used to show the trend. The very left point in the figure (♦ at 0 MPa) is the cracking strain from non-fatigued specimens. All the other points of the solid

symbols (●) are from specimens of original thickness under 500 cycles of the specified fatigue stress levels. As shown by the dashed line, a distinct drop of the cracking strain occurred when the fatigue stress was above 30% of the original tensile strength, and then leveled off to less than 25% of the original cracking strain at a fatigue stress level above 50% of the original tensile strength.

The relatively close positions between the open circle and the solid circle in Fig. 6 at the same fatigue stress level also suggest that the drop of cracking strain, depicted by the dashed line, was not due to the difference in surface roughness of specimens used in these test conditions.

Initiation of a damage zone is believed to be from defects that could be either scratches or contaminants on the specimen surface. For injection-molded specimens, initiation of the damage zones was dominated by the internal defects [3, 4]. Thus, the damage zones were found all over the cross section. For the extruded ABS used in this study, the internal defects were virtually non-existent. Therefore, damage zones were all initiated from the specimen surfaces. As such, the continuous drop of the cracking strain that had been observed in the injection-molded ABS [3, 4] did not occur in the extruded ABS. Instead, a step-wise change of toughness was observed, as shown by the change of cracking strain in Fig. 6.
