Interlaminar fracture toughness and the associated fracture behavior for glass fiber reinforced polymers (GFRP)

T. KUBOKI^{*,‡}, P.-Y. B. JAR^{*}, J. J. R. CHENG[‡]

Department of ^{*}Mechanical Engineering and [‡]Civil & Environmental Engineering, University of Alberta, Edmonton, Alberta, T6G 2G8, Canada
E-mail: tkuboki@ualberta.ca

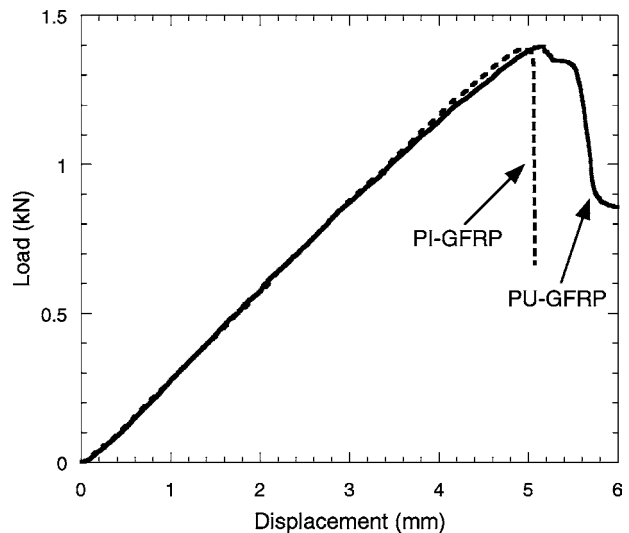
Figure 5 Typical load-displacement curves for the ENF tests.

Further investigation into the ENF test results suggests that the difference between PI-GFRP and PU-GFRP on the load-displacement curves occurs only after the point of the maximum load, as shown in Fig. 5 in which PI-GFRP shows a sudden drop of the load due to unstable crack growth but PU-GFRP shows first a gradual decrease of the load due to relatively stable crack growth before the occurrence of the unstable crack growth. It is believed that the difference in fracture surfaces shown in Fig. 4 reflects the difference of the load-displacement curves after the point of the maximum load. Since all G_{IIc} values in Table I were calculated based on points before or at the

point of the maximum load ($G_{IIc,non-linear}$ and $G_{IIc,5\%}$ for the former and $G_{IIc,max}$ for the latter), these values cannot show the difference in the fracture process that mainly occurred after the point of the maximum load.
