# Mode II delamination testing in uniaxially oriented PVC pipes

The mode II fracture toughness of an oriented PVC pipe was measured using an End Notched Flexure test geometry. A relatively low value of  $G_{IIc}$  was found of  $1.07 \text{ kJm}^{-2}$  and this indicates that it is energetically more favorable for a crack to propagate in the tangential direction rather than radially through the wall of the pipe. Examination of the mechanism of crack advanced showed that although the crack was propagating globally in mode II, micro-cracks were opening ahead of the crack in mode I or in mixed mode. Growth of the crack occurred by linking up of these micro-cracks. This is similar to the mechanism found for mode II cracking in carbon fibre epoxy composites.

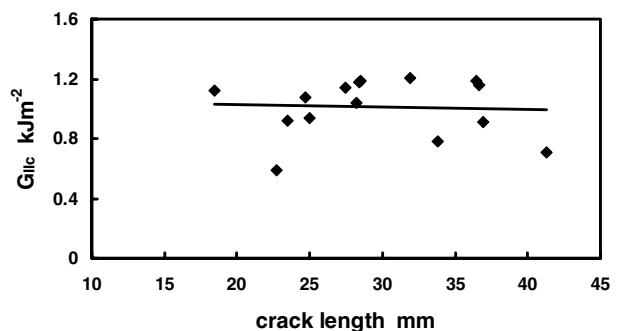
Figure 5 Measured  $G_{IIc}$  as a function of crack length for the oPVC ENF samples.

Fig. 5 shows the calculated  $G_{IIC}$  values for the ENF samples of the oPVC material. The  $G_{IIC}$  values were calculated using Equation 3 and the values of Young's modulus and shear modulus of 2.8 and 1.1 GPa discussed above. Although there is some scatter in the results, there was not a systematic trend with crack length. The scatter resulted largely from the difficulty in accurately identifying visually the point of crack initiation. The average value of  $G_{IIC}$  was  $1.07 \text{ kJm}^{-2}$ . An alternative method of obtaining  $G_{IIC}$  is to fit a polynomial to the compliance data of Fig. 3 and use Equation 1 directly. This approach produced a similar average value for  $G_{IIC}$ .
