Fatigue crack growth of filament wound GRP pipes with a surface crack under cyclic internal pressure

Abstract In this study, fatigue damage behavior of ($\pm 75_3$) filament wound composite pipes with a surface crack under alternating internal pressure was investigated. The specimens were tested at room temperature and exposed to open ended fatigue tests in which the pipe can be deformed freely in the axial direction. The tests were carried out in accordance with the ASTM D-2992 standard. The alternating internal pressure was generated by conventional hydraulic oil. The low cycle tests were performed with 0.42 Hz frequency and $R = 0.05$ stress ratio. Glass reinforced polymer pipes (GRP) are made of E-glass/epoxy and have ($\pm 75_3$) configuration. Surface cracks were machined in the axial direction of the pipes which have depth-to-thickness ratios $a/t = 0.25-0.38-0.50$ and depth to length ratio of $a/c = 0.2$. Tests were performed at three different loads of 50%, 40%, and 30% of ultimate hoop stress strength of unnotched pipes. The failure behavior of GRP pipes during the test was observed and fatigue test results were presented by means of ($S-N$) curves and delamination damag

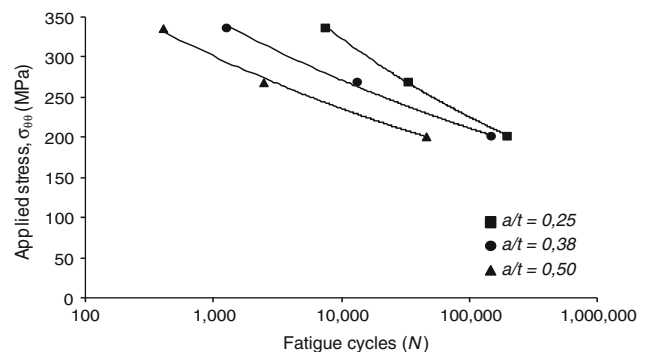
Figure 1 shows the variation of fatigue failure cycles versus applied stress. As shown in this figure, as the applied stress increased the cycles of fatigue failure decreased expectedly. On the other hand, as the a/t ratio increased the fatigue life decreased considerably.

Fig. 1 Stress-life ($S-N$) curves of ($\pm 75_3$) GRP pipe with a surface crack at different a/t ratios

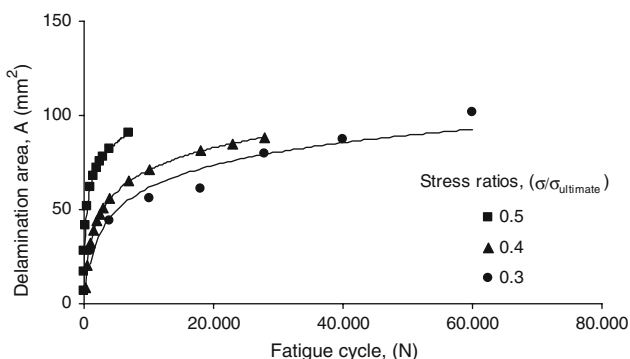
Fig. 3 Delamination area versus number of fatigue cycles ($A-N$) for $a/t = 0.25$

Figures 3–5 show the growth of delamination area versus fatigue cycles. As shown in these figures, as the applied load increased delamination spread faster. After a certain amount of delamination growth, the delamination propagation saturated and did not continue to grow any more until the end of damage process.

It is also seen in Figs. 3–5 that the delamination area rapidly increased at the beginning of the process and then slowed down. At high stress the delamination propagation saturated quickly and then propagation stopped, while at low stresses, delamination takes much more time to attain

saturation. It is also seen that as the a/t ratio increased the cycles to saturation decreased.
