# Nd:YAG laser surface melting of aluminium alloy 6013 for improving pitting corrosion fatigue resistance

**Abstract** Laser surface treatment of aluminium alloy 6013 was conducted with the aim of improving the alloy's resistance to pitting corrosion fatigue. The study showed that laser melting using a high power Nd:YAG laser increased the resistance of the alloy to pitting corrosion and pitting corrosion fatigue. As corrosion pits are favourable sites for the initiation of fatigue cracks, and the process of crack initiation often takes up most of the fatigue life, especially at low stress levels, a high pitting corrosion resistance resulted from the laser treatment improved fatigue crack initiation resistance. With regard to fatigue crack propagation, although interdendritic boundaries are vulnerable to corrosion attacks due to the presence of second phase particles, nonetheless, due to the nature of the rough and undulating fracture surface, fatigue growth would be retarded. Under the present experimental conditions, the improvement in corrosion resistance brought about by laser surface melting was found to prevail over the adverse effect caused by the residual stresses induced

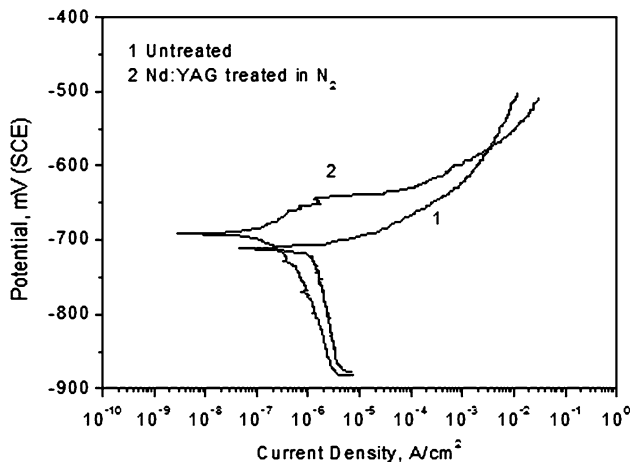
**Fig. 7** Potentiodynamic polarization curves of the untreated laser-treated specimens

The typical polarization curves of the untreated and the laser-treated specimens tested in 3.5% NaCl solution are

presented in Fig. 7. Similar to most aluminium alloys, the untreated 6013 alloy exhibited an active anodic dissolution in the entire range of the anodic potentials, i.e. the pitting potential was virtually the same as the corrosion potential. This strongly indicates the low pitting resistance of the alloy in the 3.5% NaCl solution. In contrast, the corrosion potential of the laser-treated specimen shifted to a more positive direction (from  $-710$  mV to  $-690$  mV), and the pitting potential was also uplifted to  $-643$  mV. In addition, a low corrosion current density was obtained, which was one order lower in magnitude than that of the untreated specimen.

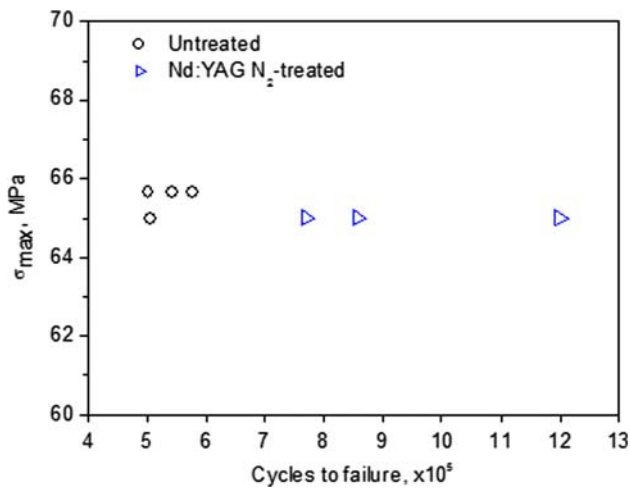
**Fig. 11** Corrosion fatigue life of the untreated and laser-treated specimens tested in 3.5% NaCl solution

Figure 11 summarises the corrosion fatigue life of the untreated and laser-treated specimens. The results reveal that the fatigue life of 6013 alloy was prolonged after the laser treatment. The corresponding corrosion currents recorded for these specimens are given in Fig. 12. The current density of the laser-treated specimen was found to be extremely low, with a value below  $10^{-5}$  A/cm<sup>2</sup> up to the number of fatigue cycles of  $10^5$ . As a whole, the current density of the laser-treated specimen is at least one order

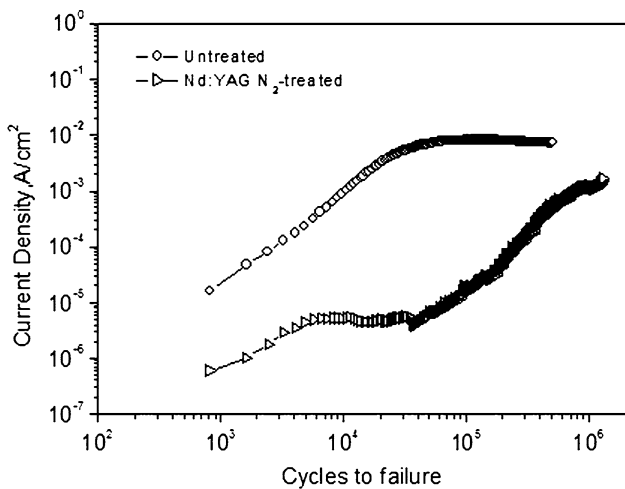
**Fig. 12** Current density as a function of fatigue cycle
