# Disruption tests on repaired tungsten by CVD coating

M. Taniguchi \*, K. Sato, K. Ezato, K. Yokoyama, M. Akiba

*Japan Atomic Energy Research Institute, 801-1 Mukoyama, Naka-machi, Naka-gun, Ibarakiken 311-0193, Japan*

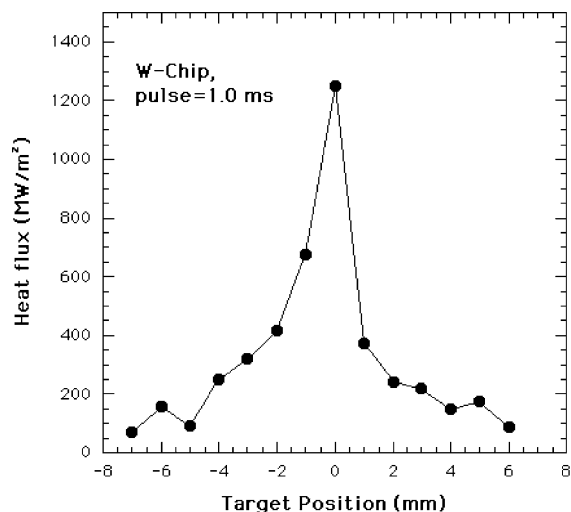
Fig. 1. Typical beam profile used in this work. The heat flux was measured by calorimetric methods using a tungsten cylinder.
