ON THE TESTING OF RENOVATIONS INSIDE HISTORICAL OPERA HOUSES

P. FAUSTI AND N. PRODI

In this paper a case history will be examined, involving major refurbishment and the construction of a new acoustic shell in an outstanding Italian opera house, the Municipal Theatre "Romolo Valli" in Reggio Emilia.

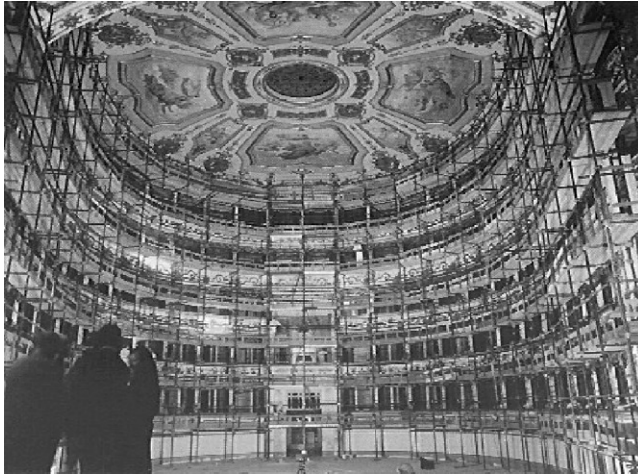
Figure 3. Scaffolding inside the theatre during the refurbishment.

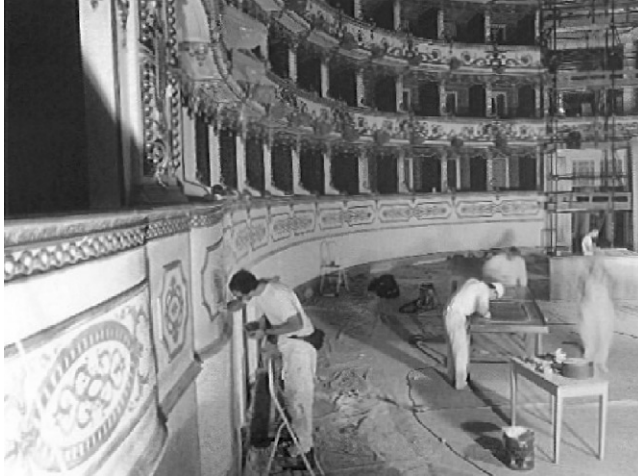
Figure 4. Detail of the wall restoration in the cavea.

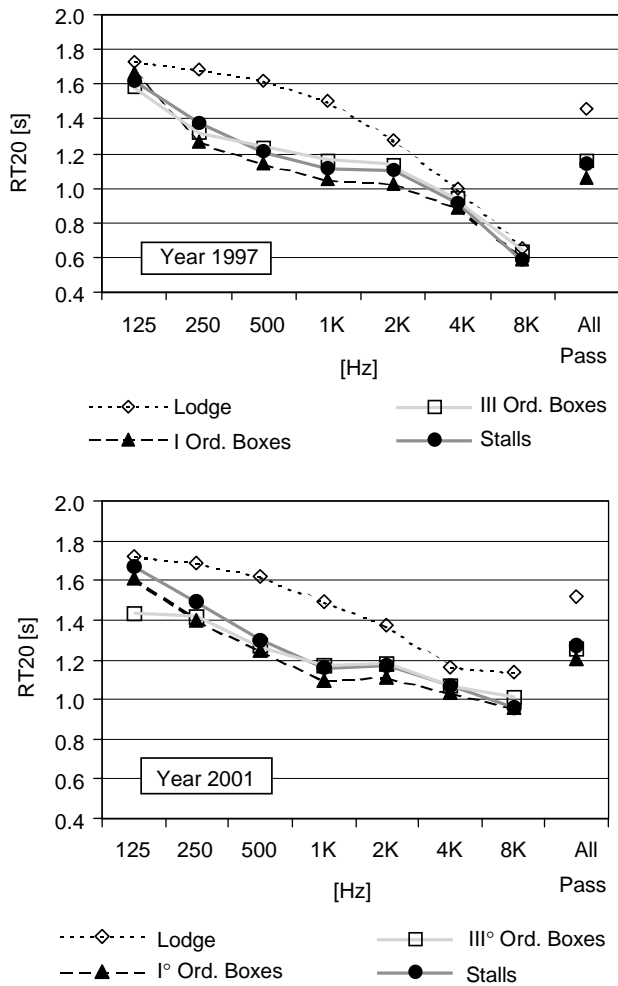
Figure 7. Reverberation time RT20 in the theatre. In the upper graph: values in the different areas as measured in 1997; in the lower graph: values in the same areas of the theatre as measured in 2001.

To show and discuss the results of the measurements made before 1997 and after the renovation 2001, two of the most important parameters described in the standard ISO 3382 [2] were used: reverberation time RT_{20} and clarity C_{80} . The two parameters are partly correlated and the effects of the variations of the physical properties, due to the renovation of materials and surfaces, could be shown, in this case, by using only one of the two parameters. This would not have been the case if the shape of the theatre had been modified by adding new reflecting surfaces. Should this be the case, then a different pattern of the early reflections could be created and a more independent change in clarity could be found. In any case, in the present work both reverberation time and clarity are analyzed to give an objective description of the acoustical properties of the theatre. The plots of the two parameters are shown, respectively, in Figure 7 (reverberation time) and Figure 8 (clarity). Each figure includes the data measured in 1997 (upper graph) and those measured after refurbishment in 2001 (lower graph).

In the present state (year 2001), the acoustics of the theatre can be described as follows. The reverberation of the main hall is rich in the lower range whereas it fits the requirements for opera in the higher range. While the first level of boxes shows a slightly lower RT_{20} than the stalls, the upper gallery has a markedly higher reverberation in almost the whole pass-band. This is the effect of the additional, partly uncoupled, volume of this area. The C_{80} has optimal values in most of the pass-bands.

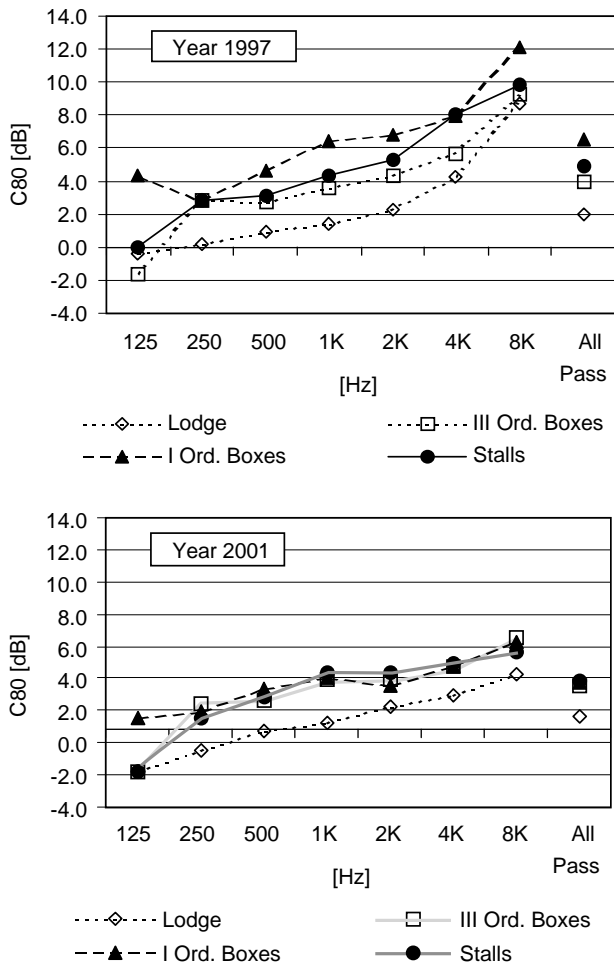
Figure 8. Clarity C_{80} in the theatre. In the upper graph: values in the different areas as measured in 1997; in the lower graph: values in the same areas of the theatre as measured in 2001.

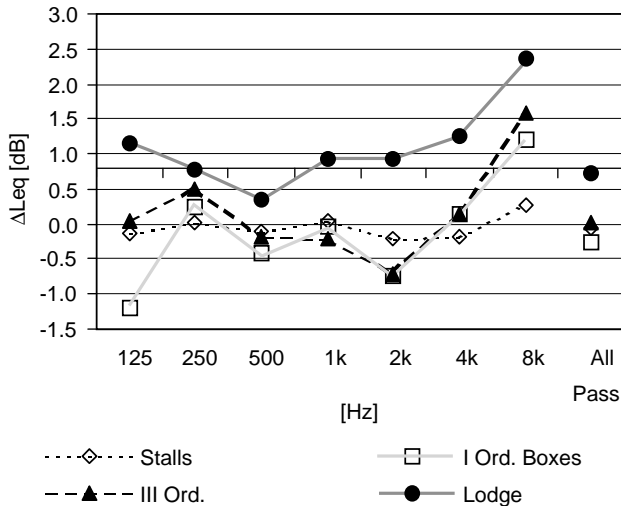
Figure 11. Difference between sound pressure level (Leq) measured in 2001 and in 1997. Data are normalized in the second session.

In addition, the variation of the sound level between the 1997 and the 2001 measurements was considered and the relevant results are reported in Figure 11. The evaluation of this quantity required the sound source to be operated at the same power level during both sessions. As previously explained, this condition was not met. To overcome this problem normalization between the two sets of sound level data was accomplished after the event. In particular, the five points in the stalls closer to the source were considered and a normalization parameter was defined as the average of the level differences between the 2001 and 1997 data at the respective points. The parameter

obtained was applied to all of the 2001 data so that the differences could thus be more accurately attributed to the renovations. As a result, the different areas of the theatre show a similar trend with the exception of the upper gallery. In this part, the level in 2001 has increased especially in the 8 kHz band in a way consistent with the former results for reverberation time and clarity.

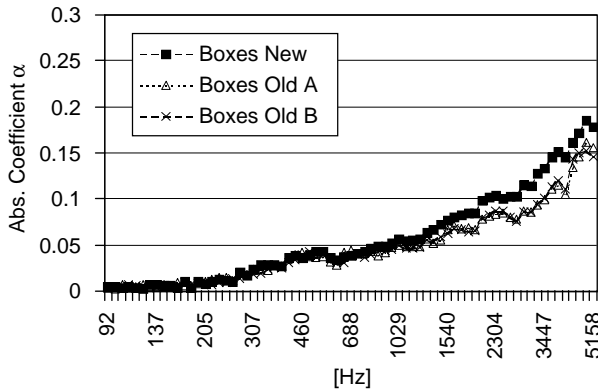
Figure 13. Sound absorption coefficient for normal incidence of the lining of the furniture in the boxes before and after refurbishment. Two types of material were present in the old configuration.

To test this hypothesis, some samples of both old and new velvet lining of the seats in the stalls and of the furniture in the boxes were collected. These were analyzed and their absorption coefficient for normal incidence was measured in Kundt's tube and compared. The measurements did not include the related padding, which had in the meantime been discarded. The results for the linings of the seats in the stalls and for those of the furniture in the boxes (two old types were replaced by one new type only) are presented in Figures 12 and 13 respectively. In the former case (stalls seats) it is found that the old

lining is in fact slightly more absorptive, and the difference is slightly amplified by transforming the data into diffuse field absorption. On the other hand, the data related to the boxes show an inverse trend with the new ones being more absorptive than both old types. Even from a very simple numerical estimate it was found that the change in reverberation time could not be explained by the diffuse field absorption coefficients. This is also true if the effect of the boxes is neglected together with that of painted surfaces and decorations. It is thought that the reason for such an inconsistency can be due mainly to the difference in the padding, which could not be considered.

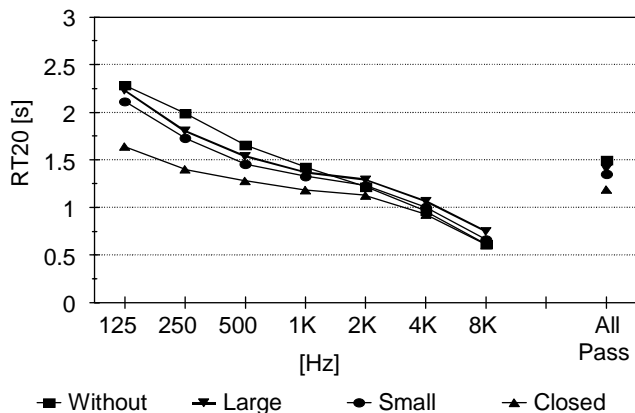
Figure 14. Reverberation time RT20 as measured in 1997 for different configurations of the old orchestra shell (the details of the configurations are explained in the text). The data are averaged among all receivers.

In Figures 14 and 15 the comparisons of RT20 and of C_{80} obtained with four different configurations of the theatre are reported. The following configurations were compared:

(“*Without*”) without the orchestra shell, (“*Large*”) with the large 10 m deep old orchestra shell, (“*Small*”) with the small 6 m deep old orchestra shell, (“*Closed*”) with the curtain closed. The figure also shows that the old orchestra shell gave similar results to those obtained in reference [4] although in this case the differences were not as evident as for other Italian opera houses.

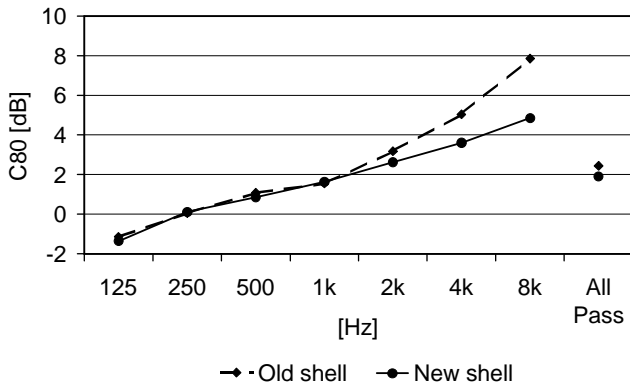
Figure 17. Comparison of C_{80} measured with the old and the new orchestra shell. Data are averaged among all receivers.

The comparison between RT20 and C_{80} , measured with the old and the new orchestra shell, is reported in Figures 16 and 17. For RT20 there are only slight differences for frequencies above 1000 Hz. The same result was obtained also for the early decay time EDT although it is not reported. The parameter C_{80} shows more marked differences in the same range of frequencies.
