Thermal Shock Characteristics of Plasma Sprayed Mullite Coatings

P. Ramaswamy, S. Seetharamu, K.B.R. Varma, and K.J. Rao

Keywords mullite, oxidation resistant, plasma spray, thermal barrier coating, thermal shock resistance, zirconia

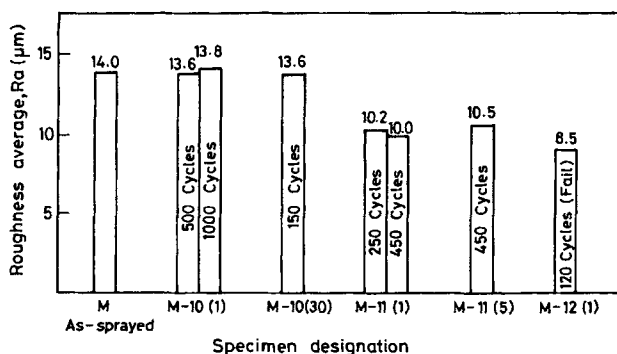
Fig. 1 Roughness average (R_a) values of Mullite coatings (as-sprayed and thermal shock cycled)

All the specimens thermal shock cycled at various temperatures and durations were subjected to surface roughness measurements. The aim of the tests was to determine if the roughness average (R_a) values on the affected zone would suggest any sur-

face degradation. Further, the possibility of the progressive damage caused to the surface at various stages of the thermal shock test can also be explored. The R_a value of the as-sprayed surface was high and measured to be 14 to 16 μm because the particle sizes of the feedstock powders were spread over 100 to 300 mesh. The R_a values of ZrO_2 coatings obtained under similar conditions (unpublished work) made using particles in the range 170 to 300 mesh size were no higher than 5 to 8 μm and were very similar to those of ZrO_2 -based commercial coatings. Figure 1 shows the R_a values at the central region of the coatings where the flame had been focused during the thermal shock tests. The data pertaining to the measurements carried out at various stages of experimentation indicate that considerable smoothing down of the heat affected surfaces occurs when the coatings were exposed to 1100 °C and above. The smoothing down appears to occur within a few tens of thermal shock cycles from the start of the cycling. The heat affected zone of sample M-11(1) after 450 cycles does not exhibit further smoothing down than that shown by sample M-11(1) after 250 cycles. However, the failed region in sample M-12(1) from where the coating has spalled exhibited a greater degree of surface smoothness than any other region. This was expected because of the higher temperature of the test and the higher degree of damage causing local melting. Negligible changes occur in the R_a values of the specimens subjected to 1000-200 shock cycling. It should be noted that the maximum temperatures encountered by the coated surfaces of the diesel engine components do not extend beyond 800 °C. The use of mullite coatings for diesel engine applications has been demonstrated by Yonushonis (Ref 13). Thus,
