# A Study of Grinding Damage in Magnesium Oxide Single Crystals

B. G. KOEPKE, R. J. STOKES

*Honeywell Corporate Research Center, Hopkins, Minnesota, USA*

The sub-surface and surface damage produced by alumina and diamond grinding wheels has been studied as a function of material removal rate. Sub-surface damage is characterised in all cases by a discrete, dense layer of dislocations adjacent to the machined surface. The depth of the layer increases with material removal rate.

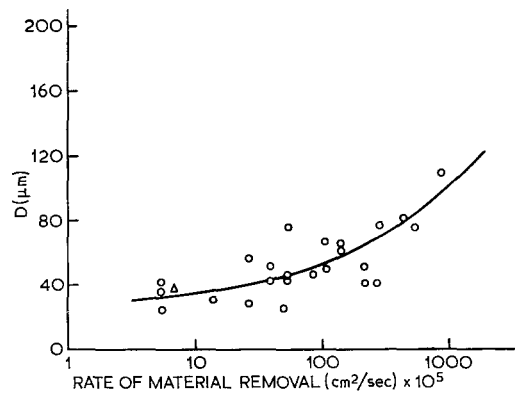
Since the depths of the damage layer at low rates of material removal were constant over the surface of any given specimen, the average depth,  $D$ , could be taken as a parameter to indicate the response of the material to the conditions generated at the tool-workpiece interface during grinding. Figs. 4 and 5 are plots of  $D$  against the rate of material removal,  $dV$ , for the 46 grit alumina wheel.

Figure 4 Depth of damage as a function of rate of material removal for crystals ground wet with a 46 grit alumina wheel. ○, single pass cuts; △, multi-pass 12  $\mu\text{m}$  cuts.

A number of interesting points arise in connection with these figures. First, comparison of figs. 4 and 5 shows that crystals ground dry exhibited deeper damage than crystals ground in flowing coolant at all but the lowest material removal rates. Secondly, the depth of the damage

layer after multiple cuts at a given material removal rate is the same as if only a single pass had been made at the same rate, i.e. the damage is not cumulative. Thirdly, there is a lower limit to the depth of damage which by extrapolation in figs. 4 and 5 appears to be about 30  $\mu\text{m}$ . Thus a 12.7  $\mu\text{m}$  (0.0005 in.) cut generates a damage layer approximately three times its depth, whereas a 50  $\mu\text{m}$  cut generates a damage layer less than its depth at slow feed rates. This should be contrasted with the observations of Marshall and Shaw [11] who noted that the depth of the deformed layer in annealed SAE52100 steel was only about one-half the depth of cut for 12.7  $\mu\text{m}$  cuts.

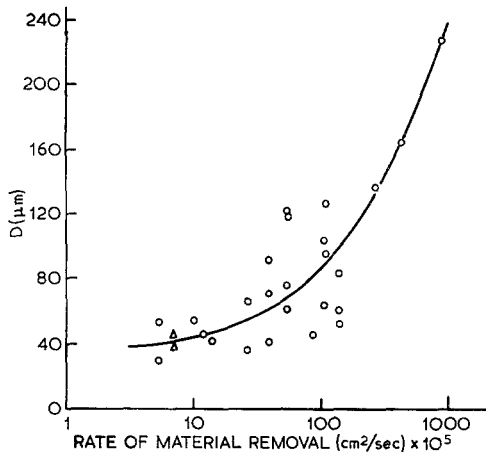
Figure 5 Depth of damage as a function of rate of material removal for crystals ground dry with the alumina wheel. ○, single pass cuts; △, multi-pass 12  $\mu\text{m}$  cuts.

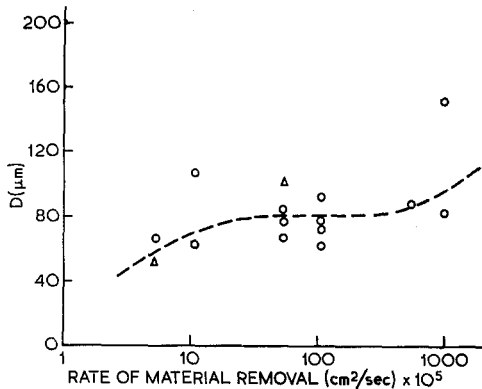
The depth of damage in crystals ground with the 100 grit diamond wheel is plotted in fig. 7 as a function of the rate of material removal. Included on the plot are data from specimens ground with a single pass and specimens ground to 50  $\mu\text{m}$  using multiple 12.7  $\mu\text{m}$  cuts. Within the

Figure 7 Depth of damage as a function of rate of material removal for crystals ground wet with the diamond wheel. ○, single pass cuts; △, multi-pass 12  $\mu\text{m}$  cuts.

Referring to fig. 7, it is concluded that the depth of damage resulting from grinding with the 100 grit diamond wheel does not show any simple relationship to the rate of material removal. It does appear that the depth of damage is greater when material is removed at the highest rate.

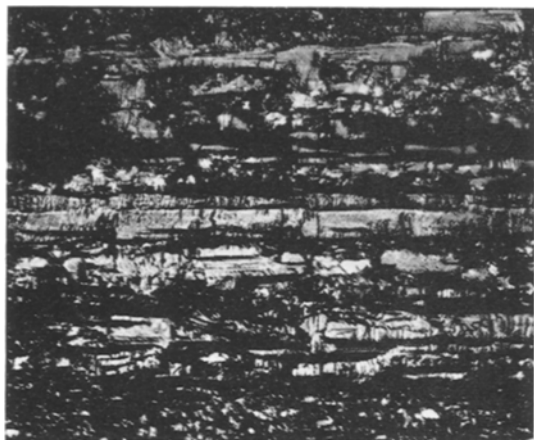
Surfaces ground with the diamond wheel at all rates of material removal were quite rough. In every case, the mechanism of removal involved brittle cleavage fracture. An example is shown in fig. 9. The white areas on the micrograph are cleavage facets parallel to the ground surface. The amount of cleavage fracture apparent on surfaces ground with the diamond wheel was found to increase with the rate of material removal. At no time did a surface ground with the diamond wheel show signs of burnishing.

Figure 9 As-ground surface of a crystal ground wet with the diamond wheel at a medium rate of material removal ( $d = 12.7 \mu\text{m}$ ,  $V = 0.42 \text{ cm sec}^{-1}$ ) ( $\times 160$ ).

In the case of the diamond wheel, the configuration of the cutting points on the surface of the wheel and the closed structure of the wheel itself (fig. 2b) result in material being gouged out by the individual diamond particles. The material is removed very efficiently by cleavage fracture (fig. 9) at all rates of material removal. Under these conditions there is little dissipation of energy in the form of plastic work during chip-formation and the grinding temperature at the crystal surface is not raised drastically.
