# Some Aspects of the Fracture of Boron-Aluminium Composites

P. W. JACKSON, A. A. BAKER\*, D. M. BRADDICK  
*Rolls-Royce Ltd (Aero-Engine Division), Old Hall, Littleover, Derby, UK*

A variety of mechanical tests has been performed on boron-aluminium composites. The fracture behaviour has been studied using both conventional metallography and the scanning electron microscope. The relationship between the structural characteristics of the composite, the mechanical properties and mode of testing, and the observed fracture behaviour are discussed.

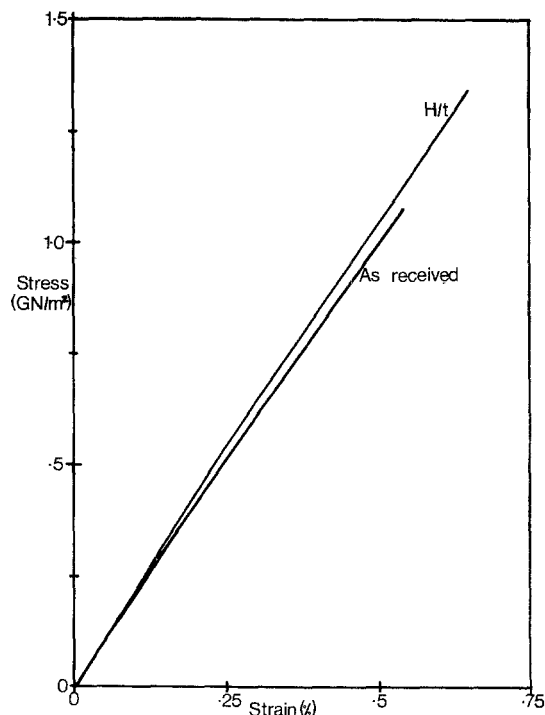
Two specimens in each condition were necked down to give a parallel gauge length of  $\sim 20$  mm and width  $\sim 6$  mm. Stress/strain to failure curves were then obtained using the 10 mm extensometer. Typical curves are shown in fig. 3. The UTS values are given in table I and appear in reasonable agreement with predictions based on "rule of mixtures" and also well within the spread of results reported in the literature [6-8].

Figure 3 Longitudinal stress/strain behaviour.

The effects of these characteristics are shown quite clearly in the mechanical test results and in the resultant fracture behaviour. The near-linear longitudinal stress-strain behaviour, with a slight reduction in slope once the matrix yield stress has been exceeded, is illustrated in fig. 3 and follows the pattern to be expected from a fully continuous elastic fibre in a ductile matrix. The longitudinal tensile strength levels obtained in the samples suggest that a high proportion of the original fibre tensile strength is being utilised, confirming that the fabrication process has been

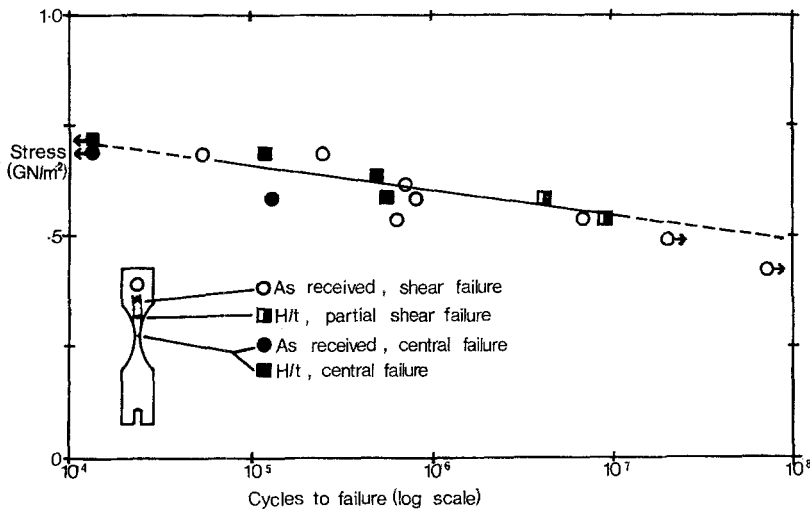
Figure 11 Reversed bending fatigue.

Testing was performed in reversed bending at constant stress, using the 50 Hz electromagnetic vibrator apparatus previously employed on aluminium matrix composite studies [17, 18]. Both as-received and heat-treated samples were evaluated. The specimen shape and individual mode of failure are indicated in fig. 11 (inset), along with the S/N curve constructed from the results. The nearly flat curve obtained agrees well with previously reported data on B-Al composites [7, 8], although the present results are at a slightly lower stress level and in addition there is no noticeable tendency for the heat-treated composites to give slightly inferior results.

The lower stress/high endurance specimens, particularly the as-received samples, tended to fail in a manner involving considerable shear cracking of the specimen, as illustrated on the inset sketch in fig. 11. The propagation of fatigue shear cracks through the matrix near a specimen surface is shown in the longitudinal taper section of fig. 12.
