Mechanism of breakdown in the interface region of glass reinforced polyester by artificial weathering

A. BLAGA, R. S. YAMASAKI

Building Materials Section, Division of Building Research, National Research Council of Canada, Ottawa, Canada

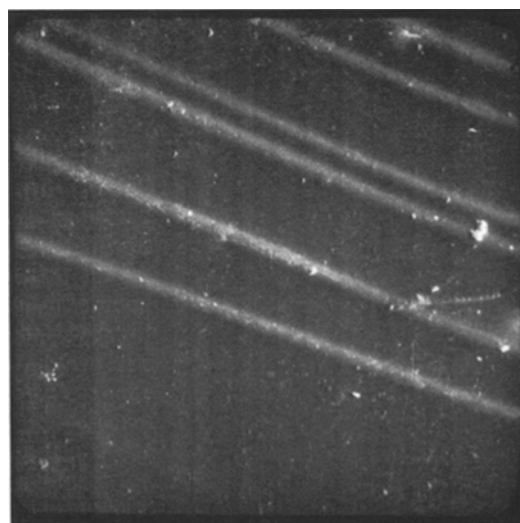
Figure 4 GRP sheet aged for 12 cycles in the Weather-Ometer ($\times 360$).

After a few days of ageing the resin layer above the superficial filaments formed ripples or round ridges (Fig. 4) in resin-rich as well as in glass-rich regions. These ripples are indicative of a permanent set resulting from plastic flow under the influence of radial compressive stresses. The ease of formation of these ridges depends upon the proximity of the filament to the surface, since the time of formation ranges from a few days for glass-filaments very near the surface

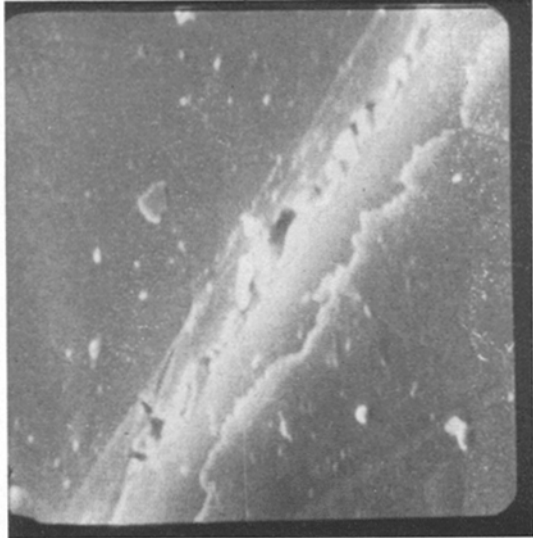
Figure 6 GRP sheet aged for 15 cycles in the Weather-Ometer ($\times 2900$).

stresses. However, the observed cracks or fractures display features that are indicative of a particular set of predominant stresses. The most frequently observed features were those of fractures produced by predominantly axial shear stresses (Figs. 6 to 8, 15 and 17). Another frequent failure occurring in resin-rich regions is rupture of the resin above the ridging superficial fibre produced by predominantly radial tensile stresses (Fig. 5).

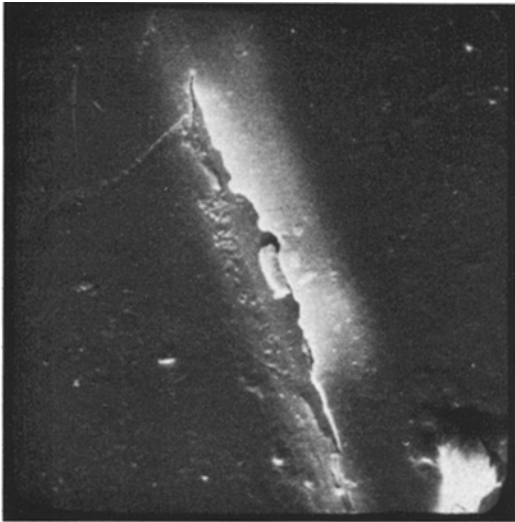
Figure 16 GFRP sheet weathered outdoors at Ottawa for 880 days ($\times 1300$).

Observations show that breakdown features in artificial weathering were qualitatively similar to those found in the GRP sheets weathered outdoors [1]. For example, rupture at a ridging filament of a GRP sheet weathered outdoors for 880 days (Fig. 16) showed features similar to those observed in the Weather-Ometer after 4 days' exposure (Fig. 5). Fig. 17 displays a site at a single filament of an outdoor-weathered surface where the failure appears to have been produced by predominantly axial shear stresses, thus showing similarity to a corresponding failure produced by artificial weathering (Fig. 8). Furthermore, the micrograph shown in Fig. 18 shows fracture features in a multi-filament region (880 days outdoor weathering) that are almost identical with those present in Fig. 9 (150 days in the Weather-Ometer). Similarity in breakdown can be demonstrated for all the other artificial weathering treatments that produced deterioration in the interface region in GRP sheets. However, there are differences
