Failure mode and interface chemistry of localized coatings on brass

J. E. CASTLE, Z. B. LUKLINSKA, M. S. PARVIZI

Department of Metallurgy and Materials Technology, University of Surrey, Guildford, UK

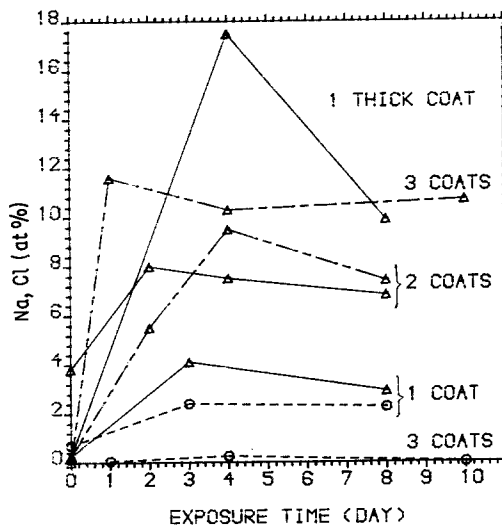
Figure 6 Chloride and sodium concentration on metal side of interfaces exposed in the lap-shear test (o sodium, Δ chloride, ct = coating, abr. tr. = surface abraded, ac. tr. = acid treated).

The lacquer-side of interfaces exposed in the lap-shear test before the testpiece had been exposed to the sodium chloride solution were contaminated with a significant amount of copper oxide (Fig. 5a, Table III). This suggests cohesive failure within the oxide layer on the brass surface. After exposure both interfaces became contaminated with sodium and especially chlorine and the amount of copper oxide transfer diminished. Some zinc was usually found on the lacquer. The chloride concentrations (Fig. 5b) increased with exposure time up to a peak at about 4 days (Fig. 6). The value of this

two possibilities crevice corrosion is an anodic activity and leads to the accumulation of chloride ions within the crevice [4] whilst cathodic disbonding is recognizable by the accumulation of sodium ions [5]. From the results presented in Figs. 6 and 7 it is clear that the system is behaving as an anodic crevice. The localization of anodic activity within the crevice was enhanced by increasing the thickness of the lacquer exactly as would be predicted. After some 4 days the chloride concentration tended to diminish and sodium concentration began to rise. This was most marked on the thin coat and less so on the thick coats. The clear implication is that after this time the intensity of electrochemical segregation within the crevice is fading, either because of an opening of channels within the interface or because of developing porosity across the polymer. The influence of coating thickness supports the latter conjecture. The load to failure declined much less rapidly once the sodium concentration began to increase.

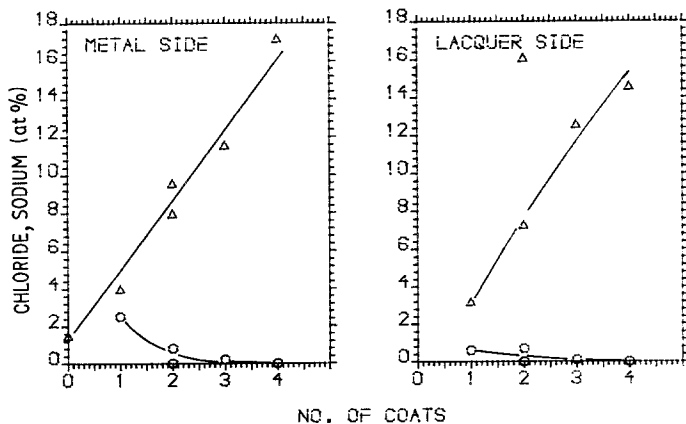
Figure 7 Peak concentration of chloride and sodium relative to coating thickness (\blacktriangle chloride, \circ sodium).

peak concentration increased with coating thickness (Fig. 7), and appeared to be independent of surface preparation. Both the lacquer-side and the metal-side of the failed interface had similar concentrations. By contrast the sodium concentration decreased with coating thickness (Fig. 7), and increased with time of exposure instead of peaking at 4 days. No difference in surface analysis was found that could explain the difference in adhesion to the acid etched and the abraded surfaces.
