# Fracture surface characterization of epoxy-based GFRP laminates

Fractographic investigation has been carried out on glass fabric-epoxy composite laminates using scanning electron microscopy. Focusing on the flexural failure of lap shear specimens, some unique fracture features have been identified, and their likely origin suggested and explained. The influence of voids, present in the matrix, on the appearance of the fracture surface has been illustrated.

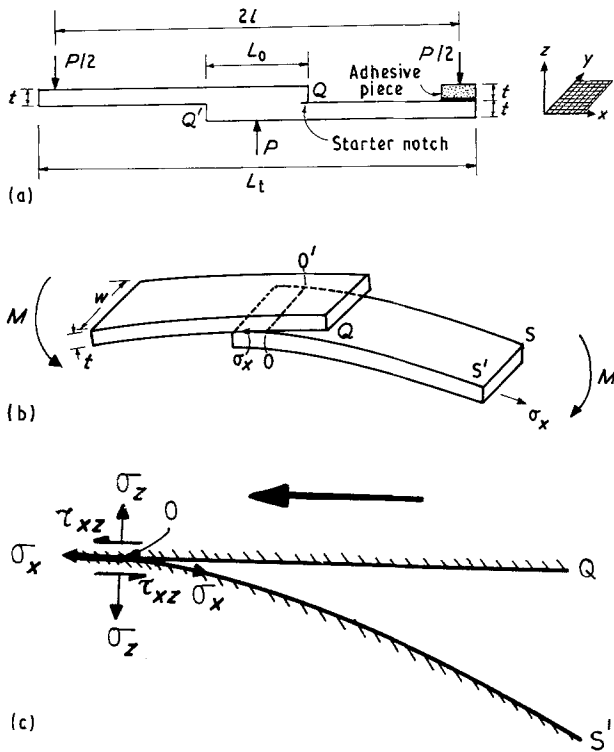
Figure 1 Illustrations of (a) geometry and loading configuration, (b) failure pattern, and (c) the state of stress ahead of the advancing failure front (O) of the lap shear specimen. XY is the plane of lamination.

When subjected to three-point flexural loading (Fig. 1a), apparently the lap shear specimen may be expected to fail in shear along the plane QQ'. Assuming simple bending, the state of stress operative there may be thought to be pure shear, because this plane is located exactly at the mid thickness position of the

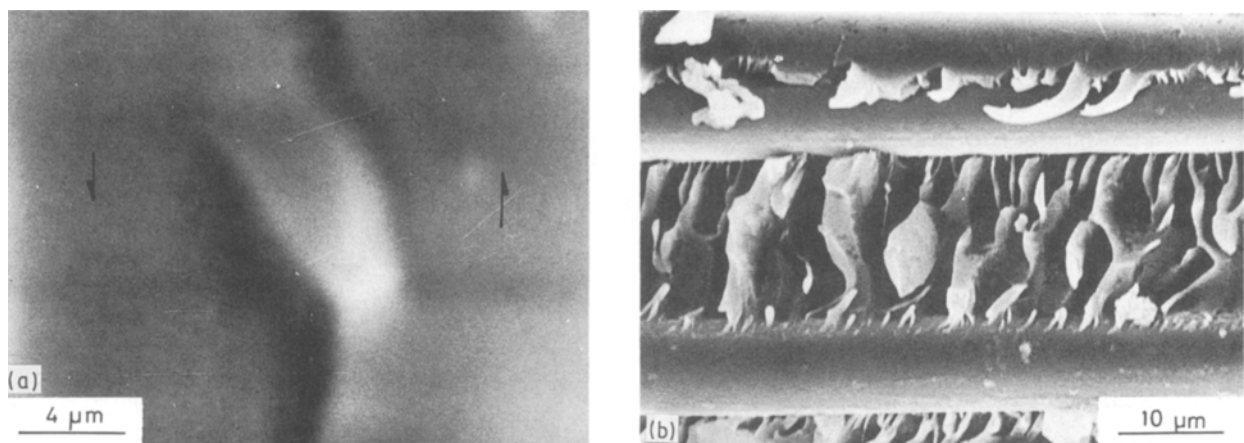
Figure 2 SEM fractographs from lap shear specimen failed in flexure illustrating (a) incipient cusp and (b) tied zones.

overlapped section. That a shear field was active in effecting the interlaminar failure along QQ' was evident from the common occurrence of shear cusps [3] in the interfibre matrix regions of the fracture surface. (Whenever required, the overall fracture direction has been indicated on the illustrations by means of an arrowhead,  $\rightarrow$ , while the broken arrow,  $\dashrightarrow$ , and the half arrow,  $\rightrightarrows$ , have been used to indicate the direction of local crack/fracture propagation and active shear stress respectively.) Although lacking sharpness at this high magnification, Fig. 2a is significant for documenting one such cusp formation just at the point of inception. But the myriad of rivers present at the resin-rich portions of the fracture surface, bore testimony to the existence of a tensile (transverse) stress too, in action at the failure front. It is to be appreciated that an intermediate configuration of the specimen during the failure process can be represented schematically as shown in Fig. 1b. Evidently, the bending action as shown introduces an axial tensile stress,  $\sigma_x$ , along the crack face OS'. An exaggerated view (shown schematically in Fig. 1c) of the crack tip region is helpful in understanding the actual state of stress operative there. Although the bending action introduces only axial stress, in reality, because of the well known "notch effect" [5] operative at the crack tip, a transverse tensile stress ( $\sigma_z$ ) comes into play. It is this  $\sigma_z$  that has actually caused the development of tensile failure features, like rivers, on the fracture surface. Further, the lower face OS' bends more than the upper face OQ. This would tend to effect a strain difference between these two faces, resulting in the development of a shear stress,  $\tau_{xz}$ , active at the crack tip O. The occurrence of shear cusps in the interfibre matrix owes its origin to this  $\tau_{xz}$  only. The deduction, based on fractographic evidence, that lap shear specimens under flexure actually fail in the mixed mode, is thus upheld by a qualitative analysis of the state of stress active at the progressing failure front. Further, the failure scheme envisioned (Fig. 1b) strongly suggests a peel type of fracture [3]. And in fact, the occurrence of typical peel fracture features like tied zones were quite common on the fracture surface (Fig. 2b).

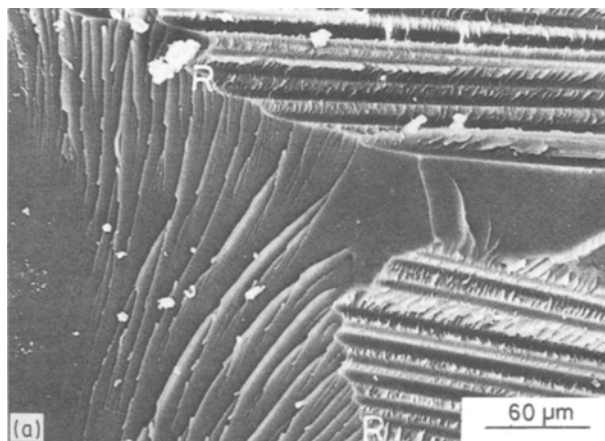
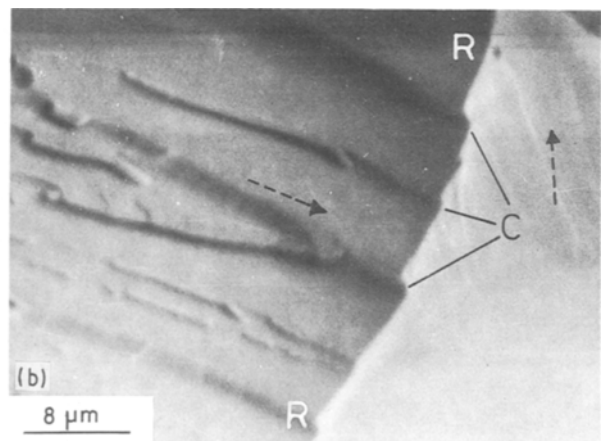
Figure 3 Fractographs showing (a) a ridge and (b) a ridge with same face-direction scarps found in lap shear failure.

ridges on the interlaminar fracture surface is perhaps expected. Although Fig. 3a beautifully brings out the “rivery” (confluent towards the ridge) and the “smooth” surfaces across the ridge (R–R), the micro-mechanism of ridge formation [3] is more clearly revealed in Fig. 3b. As is evident from the river direction, a crack front was progressing, under the action of the notch-induced transverse tension ( $\sigma_z$ ), from left to right along the general peel plane (OO’S’S’ in Fig. 1b). The feathers [3] on the face of the cusp (right) in Fig. 3b testify to another crack front moving along it (the cusp face) under the influence of the shear stress field ( $\tau_{xz}$ ) set up ahead of the former crack tip. The ridge (R–R) was formed (Fig. 3b) when the transverse tensile crack front advancing from the left met the pre-existing fracture on the cusp face. However, Fig. 3b can claim originality for capturing the same face-direction scarps, e.g. C, located on a ridge. Because the ridge formation mechanism is established, their unique location proves beyond doubt the proposition [3] that same face-direction scarps originate due to “a combination of tensile and shear stresses”.

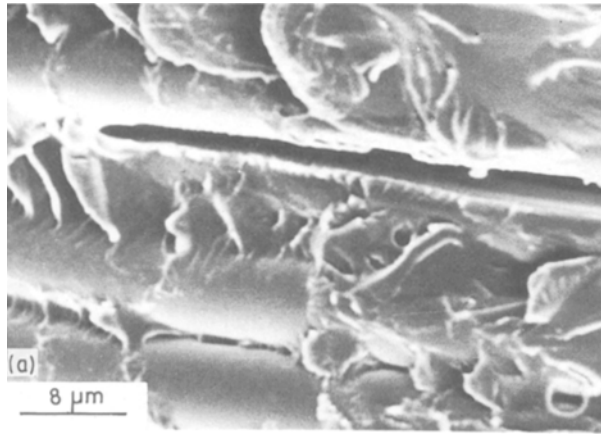
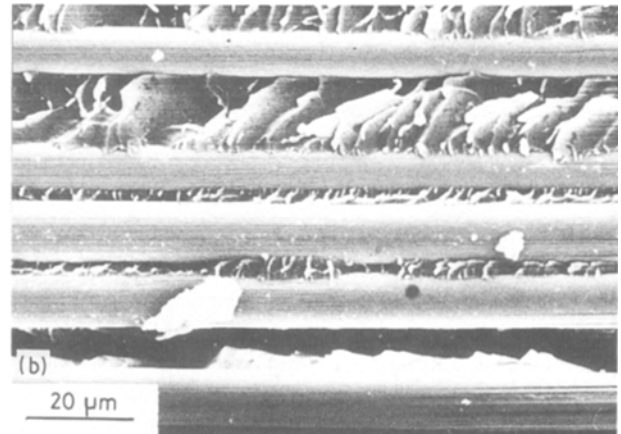
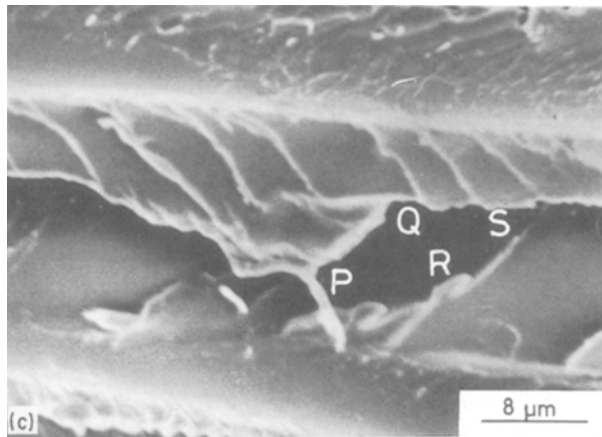
Figure 4 Photographs of (a) interfibre separation and (b) the typical appearance of faceted morphology as well as (c) two mating facet faces (PQ and RS).

Fig. 4a to c, taken from the interlaminar fracture surface of the same lap shear specimen, exhibit the different aspects of a unique failure feature hitherto perhaps not emphatically reported. It is essentially characterized by separation of two axial fibres due to failure of the resin band in between (Fig. 4a). It is also interesting to note how the separation is arrested. The term *interfibre separation* will henceforth be used to describe this particular phenomenon. Such a failure can be brought about only by the action of a tensile stress, active on the general peel plane (say OO’S’S’ in Fig. 1b) in a direction perpendicular to the specimen axis, i.e. along the  $y$ -direction. In order to explain the origin of this stress we have to consider the peeled lower half of the specimen (Fig. 1b) to constitute a cantilever fixed at the crack root and subjected to a bending moment,  $M$ , at the free end. Because the thickness of this cantilever beam was very small compared to its width ( $t/w \approx 0.125$ ), the proper approach would be to analyse the system as a “wide” beam [6] subjected to bending. Consequently, this would mean bending under plane strain conditions which leads to development of a stress,  $\sigma_y$ , in the same plane of, but in

a direction perpendicular to the axial stress introduced by the bending action. The magnitude of this separating stress  $\sigma_y$  is  $\nu\sigma_x$ , where  $\nu$  is the Poisson’s ratio of the beam material. Because  $\nu$  is normally very small,  $\sigma_x$  has to be considerably large in order that the magnitude of  $\sigma_y$  becomes sufficient for effecting the separation. Appreciating that OO’S’S’ (Fig. 1b) is the plane of highest tension, it is evident that the maximum value of  $\sigma_x$  is encountered just at the crack tip O. The probability of any interfibre separation to take place is, therefore, highest at the tip O, which is also the point of maximum  $\sigma_y$ . The fact that evidence of interfibre separation was found only on the lower fracture surface, namely OS’ in Fig. 1b, and not on the upper countersurface, namely OQ, supports the above contention. However, the concept of development of a  $\sigma_y$  alone cannot account for the origin of the *faceted* (*sawtooth*) morphology of the failed resin band encountered at some locations of interfibre separation (Fig. 4b). In addition, it is to be appreciated that the beam is actually subjected to a system of biaxial tensile stress comprising  $\sigma_x$  and  $\sigma_y$ , which gives rise to a system of shear stress,  $\tau$ , having a maximum magnitude at an angle of  $45^\circ$  (Fig. 5) and acting on a plane containing  $\sigma_x$  and  $\sigma_y$ . When the magnitude of this stress,  $\tau$ , exceeds the shear strength, the material may actually fail in shear (as opposed to the cusp formation phenomenon where the actual failure is caused by the resolved tensile component of the existing shear field [3]), giving rise to the faceted appearance of the cleaved faces. Faceted morphology was generally noticed when the interfibre resin band had a rather long, defect-free stretch; and such cases were comparatively rare. Normally the resin band contained many voids [4] which acted as stress raisers and precipitated a tensile failure under  $\sigma_y$ , rather than under shear. Fig. 4c shows two mating facet faces, e.g. PQ and RS, at a higher magnification. It is to be noted that both of these faces are approximately at an angle of  $45^\circ$  to the axial direction – a fact that lends credence to the proposed mechanism.

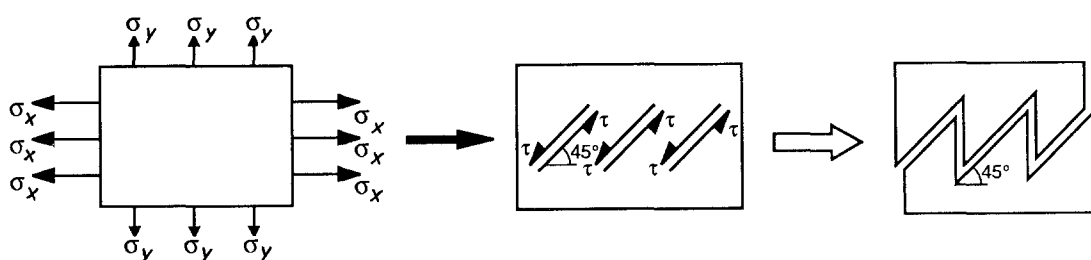
Figure 5 Schematic illustration of the mechanics of formation of faceted morphology during interfibre separation.

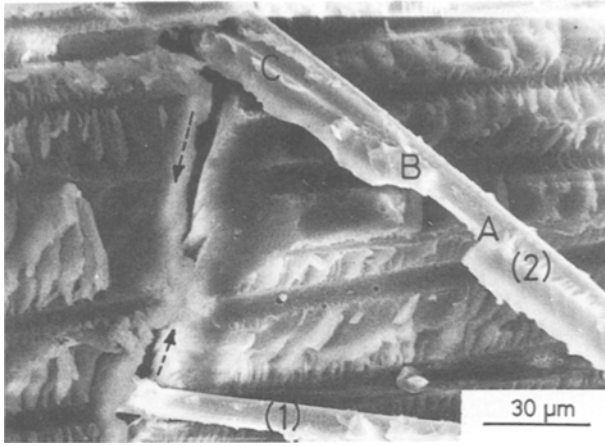
Figure 6 SEM fractograph illustrating in-plane cross cracking in lap shear failure.

Fig. 6 displays another unique interlaminar fractograph encountered in the lap shear specimen. The terminology *in plane cross cracking* is being introduced here to describe this particular aspect of failure,

as no previous report on similar features is available. The unique feature of this fractograph is, evidently, the fibre(s) piercing through the matrix; although the cross crack lying on the general peel plane but grossly normal to the axial direction (evident from fibre imprint), also deserves consideration. Noting that evidence of in plane cross cracking could be seen only on the lower fracture surface (OO'SS' in Fig. 1b), it is understandable (Fig. 7a) that the propagation direction of the cross crack (RR') is commensurate with the operative axial stress  $\sigma_x$  introduced due to the bending action. Further, it is to be noted that because  $\sigma_x$  is maximum just at the tip (O) of the primary peel fracture front, this secondary cross crack is naturally expected to originate very close to the point O (a fact not highlighted in Fig. 7a for the sake of clarity and simplicity). However, in order to understand the origin and significance of the penetrating fibres, it is necessary to invoke the concept of "fibre bridging" [7]. The idea is, during interlaminar failures it is not guaranteed that the advancing crack front will com-

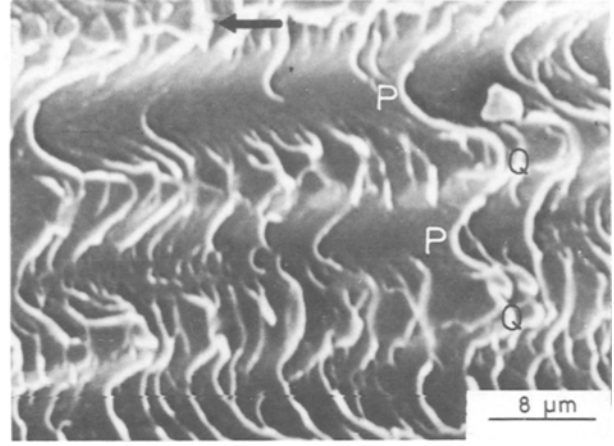
Figure 8 Scanning electron micrographs showing wavy pattern.

The next fractograph (Fig. 8) is from a specimen failed in transverse tension. In view of the overall

direction of progress of the interlaminar failure front, the wavy nature of Fig. 8 suggests that the failure marks (e.g. Q) on the resin bands (elevations) located in between two fibres exhibit a distinct “phase lag” with respect to the failure marks (e.g. P) visible on the fibre imprints (depressions). The implication is, adhesive failure fronts [8] tended to advance faster than the neighbouring cohesive failure fronts; and the relative weakness of the adhesive bond between the fibre and the resin might have been the reason for it.

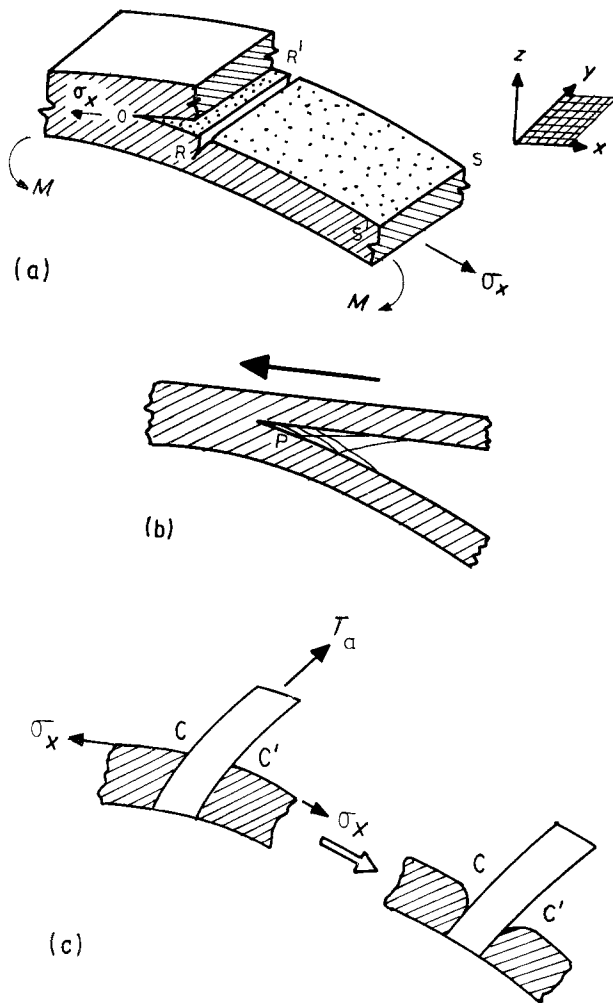
Figure 7 Schematic illustrations of (a) in-plane cross crack (RR') formation during flexural failure of a lap shear specimen, (b) fibre bridging [7], and (c) debonding at the root (P of Fig. 7b) of a bridging fibre. XY is the plane of lamination.

pletely separate all the fibres on one side from those on the other. These unseparated fibres, rooted at both the faces run across or, in other words, bridge the crack opening behind the crack tip. Essentially this is the phenomenon of fibre bridging, as illustrated schematically in Fig. 7b. The base of the bridging fibre (P in Fig. 7b) lies on a plane that is subjected to an axial stress (Fig. 7c) resulting from the bending action, while the fibre itself is subjected to some tension,  $T_a$ , because of the bridging action. The stress situation is made further acute by the stress raising effect of the corners (C and C') at the root (Fig. 7c). As a consequence, the fibre-matrix interface at that location may give way, leading to debonding. This is how the secondary failure is precipitated, which subsequently propagates as the cross crack under the action of the axial stress,  $\sigma_x$ . It is very clear from Fig. 6 that the mating faces of the cross crack tend to converge away from the fibre root. This is a confirmatory evidence to justify the argument that such cracks originate at the fibre roots. Further, little resin attachment to fibre 1 near the root conforms to the envisioned debonding phenomena there. However, considerable resin attachment to fibre 2 at a similar location is apparently incommensurate. In fact, it is the region A-B that had actually suffered from debonding during the inception of the cross crack. Subsequently, the segment B-C was pulled out as the tension,  $T_a$ , continued to build up with the primary peel fracture front continuing to progress ahead of the bridging fibres and, thus, increasing the separation between the primary crack faces. It would be appropriate to close this topic on in-plane cross

cracking with the comment that it is believed [7] that the phenomenon of fibre bridging “causes an elevation in the measured interlaminar fracture energy” and we do actually see now that the in-plane cross cracking can constitute a potential energy absorbing mechanism that may be responsible for this enhancement.

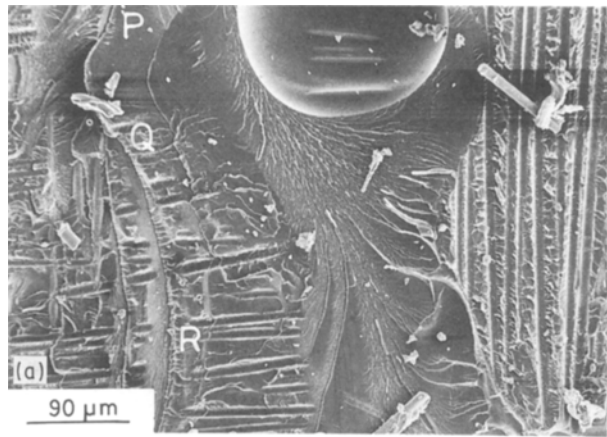
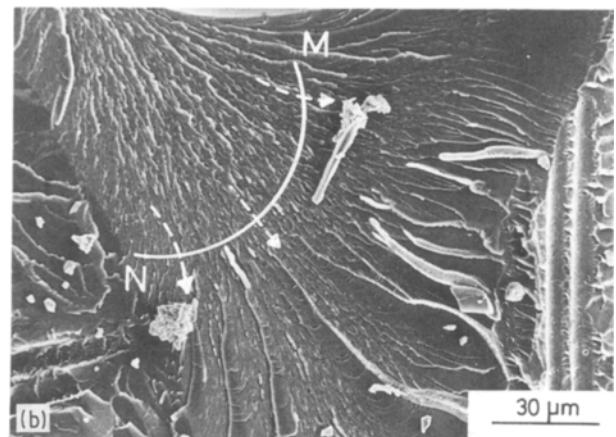
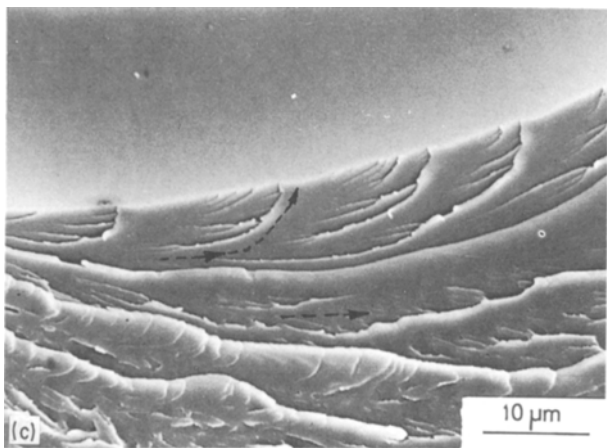
Figure 9 SEM pictures from a specimen failed in transverse tension illustrating (a) typical appearance of the fracture surface in the neighbourhood of a void, (b) well-developed finger pattern progressing with a curvilinear front, and (c) origin of fracture features at the void edge and termination of some of the local crack fronts into the same void.

The presence of a three-dimensional defect in the form of a void inside a stressed solid is known to introduce a stress raising effect around it. The stress is maximum at the edge of the discontinuity, its intensity falling off as one moves away from the edge. The plethora of failure features concentrated in the vicinity of a void is perhaps the reflection of this effect projected on to fractographic evidence. In Fig. 9a, taken from a specimen failed in transverse tension, the concentration of failure features, mainly rivers directed outwardly, testifies to local crack fronts in the neighbourhood progressing away from the void. Note that the void is large and deep enough to reveal the impression of fibres belonging to the lamina beneath the fracture plane. There are, however, two principal features to be observed in this fractograph, namely, the curved lines (e.g. PQR) toward the left and the finger-like pattern [3] just below the void, diverging away from it. A magnified view (Fig. 9b) of the latter clearly reveals how the fracture progressed locally, with a curvilinear crack front indicated by MN. It is also interesting to note how some of these finger-like features develop into a river form before terminating at the regions of fibre–matrix interface. Fig. 9c is noteworthy for capturing these features originating just at the edge of this void. It is known that crack fronts always try to reach a free surface via the shortest route. This micrograph remarkably brings it out by demonstrating how crack fronts close enough to the edge of the void (finding it energetically favourable) took a turn and terminated into that void, from which it had originated. To behave in a similar fashion, crack fronts located (and also directed) away from the void edge would be required to suffer a rather severe bend, which was obviously not favoured; and

they progressed undeviated. The other important feature of Fig. 9a, namely, the curved lines (e.g. PQR) is to be identified as the parabolic feature. It has been suggested [3] that “where an inhomogeneity lies immediately ahead of the advancing crack and in the same plane, a secondary failure may initiate locally at the discontinuity before the main crack reaches it, causing a scarp to form in the shape of a parabola”. The opposite direction of rivers present across a segment PQ (Fig. 10a) provides strong fractographic evidence for substantiating the above mechanism, perhaps for the first time. Fig. 10b concentrates on the lower portions of these parabolic lines. It is particularly interesting to find sudden and segmental discontinuities (e.g. A–B, C–D, etc.) in the otherwise continuous fibre imprints, just at the back of the parabolic lines. Also, the region of the discontinuity (e.g. ABCD) is characterized by a sloping (and grossly planar) surface. At the first instance, an explanation for this discontinuity tends to take shape in terms of broken fibres present during fabrication. However, a critical review rules out this possibility because the

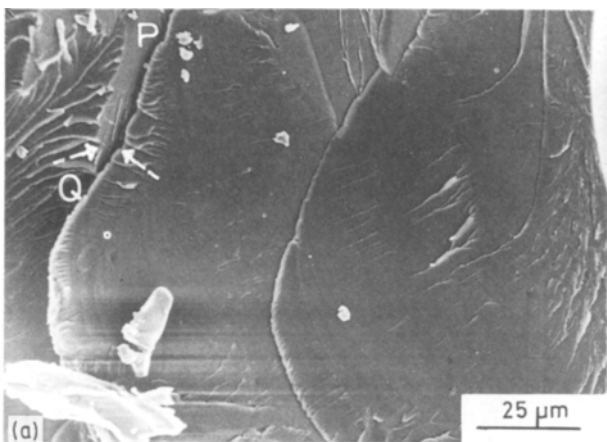
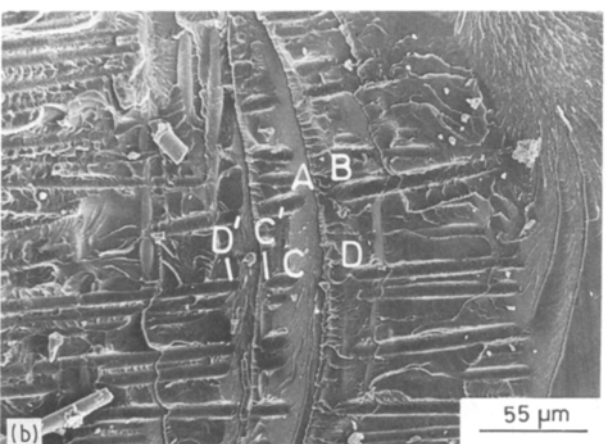
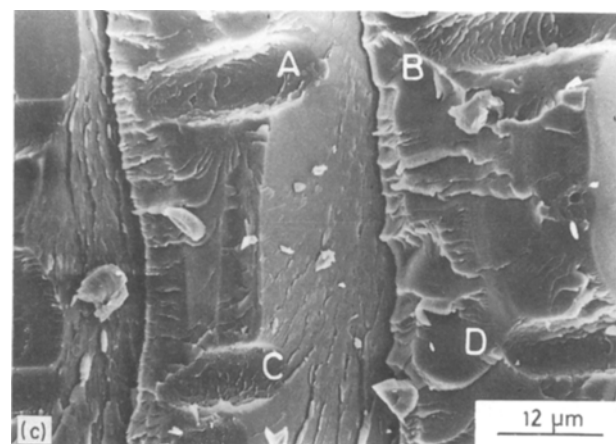
Figure 10 Appearance of (a) parabolic features, and discontinuities in the fibre imprints (e.g. A–B, C–D, etc.) at (b) lower and (c) higher magnifications.

occurrence of successive piecewise breakages (e.g. C–D and C'–D') along the same fibre length, and removal of the broken pieces without disturbing the linear arrangement of the remaining length at all, could be considered anything but realistic. A much more reasonable explanation is presented below with the help of a schematic illustration (Fig. 11) of the situation envisioned to be responsible for the origin of this feature. Fig. 11a represents the longitudinal section (not to scale) of the laminate taken through the centre of the fibres. It is postulated that the approaching crack fronts, responsible for parabola formation, were advancing along the fibre–matrix interface (e.g. J–J' and L–L'). At the point J', however, the crack approaching from the left ceased to continue as adhesive in nature and gently diverted into the matrix (probably because of a localized resin weakness there). Had the crack from the right maintained its usual course, a long overlapping of the two crack fronts would have resulted, bringing in unnecessary and excessive surface creation. This crack also, therefore, was made to divert, in fact more sharply into the resin in order to meet the other crack front at a point K located below the interface. An isometric view of the fractured bottom half of Fig. 11a is shown schematically in Fig. 11b. This view closely simulates the appearance of the actual fracture surface in the region of the discontinuity in fibre imprints, as magnified in Fig. 10c.

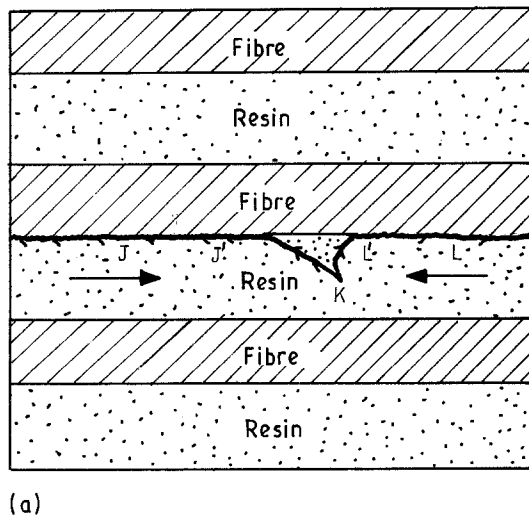
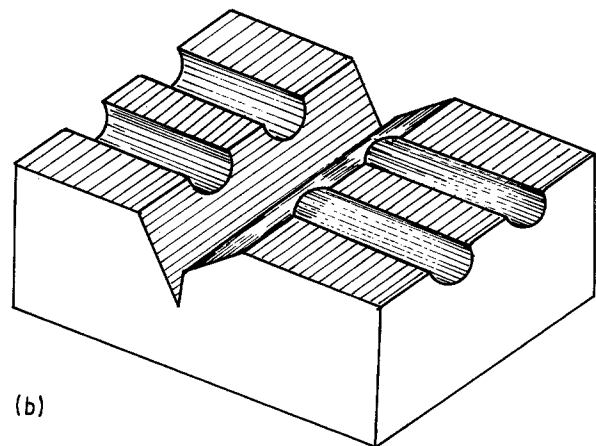
Figure 11 Schematic illustrations of (a) the track of the advancing cracks (J–J' and L–L') that merged to form (b) a discontinuity in the fibre imprints on the fracture surface.

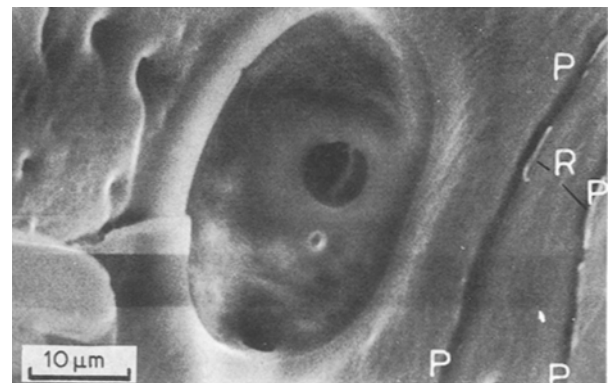
Figure 12 SEM picture revealing the formation of ribbons (R) and stress-induced voids in the vicinity of a large pre-existing void.

Referring to the lap shear specimens failed in flexure once again, Fig. 12 can claim uniqueness for documenting three important features condensed in a single fractograph. Needless to say, all these features owe their origin to the presence of a moderately large central void. The parabolic segments (PP) are quite evident. It is more important, however, to concentrate on the ribbons (R) which result from an overlapping of non-planar crack fronts approaching each other [3]. Because the mechanism of parabola formation has already been established, the occurrence of ribbons on the parabolic segments leaves no doubt about the mechanism of ribbon formation too. The last, but the most remarkable feature consists of the incipient

stress-induced voids of very small size, clustered around the top left corner. Other than stress concentration, a three-dimensional discontinuity in a stressed body also introduces a state of triaxial stress in its vicinity. In fact, stress-induced voids can form only under the action of hydrostatic tensile stress capable of effecting volume dilatation. Viewed in this light, these nascent voids in Fig. 12 bear micrographic testimony to the development of triaxial stress in the neighbourhood of a pre-existing three-dimensional defect.

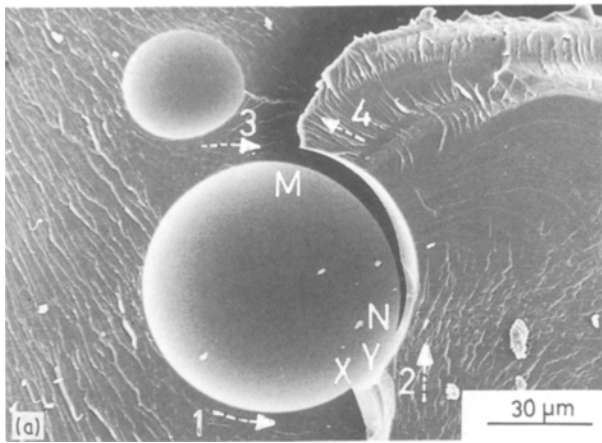
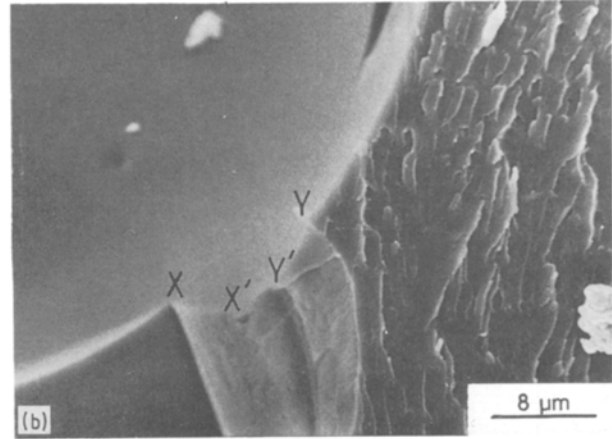
Figure 13 Photographs illustrating (a) cliff (X-Y) formation, and (b) the ledge (X'Y') made visible at high magnification.

It is known that at the microscopic level local crack fronts may progress along different planes and in different directions. A transverse tensile fractograph (Fig. 13a), illustrates the formation of a cliff (X–Y) at the edge of the void, when cut by two such non-planar crack fronts, namely 1 and 2. At higher magnification it is revealed (Fig. 13b) that X–Y is actually not a single cliff, but includes a small ledge (X'–Y') in the middle. The deep notch MN in Fig. 13a, with an overhanging slice of material testifies to a rather long overlap between the two non-planar crack fronts 3 and 4 progressing approximately in opposite directions.
