Stack cracking by hydrogen embrittlement in a welded pipeline steel

Arrays of cracks, parallel to the original plate rolling direction, were produced in a X65 microalloyed steel by hydrogen embrittlement of pipeline sections containing a weldment. A region of the heat-affected zone of the weldment was shown to have a lower yield strength ("soft" zone) than the surrounding material and cracking was concentrated in this through-thickness zone to produce the effect known as stack cracking. *In situ* cathodic hydrogen charging of tensile specimens under load led to failure by linking the rolling-plane cracks with transverse cleavage cracks, which were often initiated at inclusions. All cracking was predominantly by cleavage and failure occurred in tension in short times by hydrogen embrittlement when the applied tensile stress was above about half the uncharged yield stress. The influence of microstructure, hydrogen pressure and tensile loading conditions on the location of stack cracks and the mode of fracture is discussed.

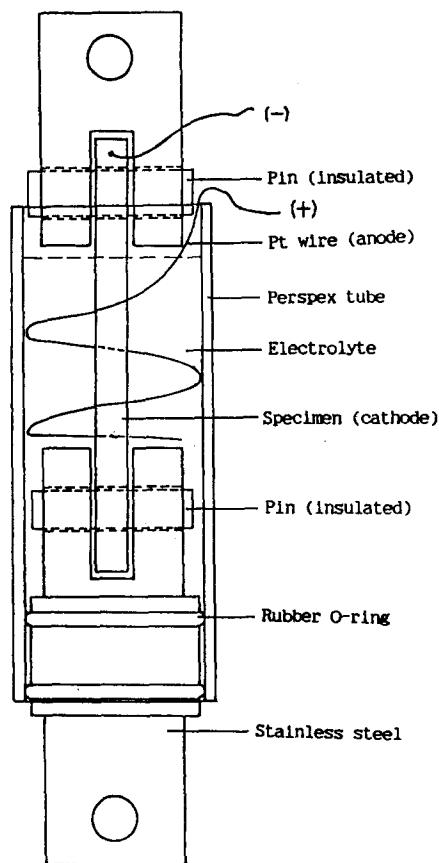
Figure 1 The charging cell.

Cathodic charging experiments were carried out with either load in simple tension applied constantly during charging or without applied load. Fig. 1 shows the charging rig used in the experiment. The specimens were either flat rectangular or flat tensile shaped sectioned transverse to the rolling direction of the plate and across the weld, Fig. 2. Most of the specimens contained a weldment in the mid-section except for a few specimens which consisted entirely of parent

metal. The electrolyte was $1 \text{ M H}_2\text{SO}_4 + 0.4 \text{ g l}^{-1} \text{ A}_2\text{O}_3$ and the charging current density was 10 A m^{-2} .

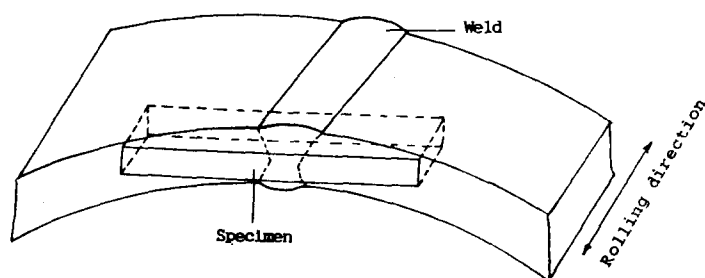
Figure 2 Sectioning of the sample to produce flat specimens.

A number of additional specimens were modified to include geometric and structural variations, i.e. Luder's bands were introduced into some flat rectangular specimens, while notches and pressed (deformed) zones were formed in some of the flat tensile specimens prior to charging. The deformed (pressed) zone was introduced by compressing specimens between two identical hardened round rods (diameter about 9 mm). Specimens were aligned such that the width direction was parallel to the loading direction. The purpose of introducing this prior deformation was to study the effect of stress concentrations and plastic deformation on the occurrence and characteristics of the stack

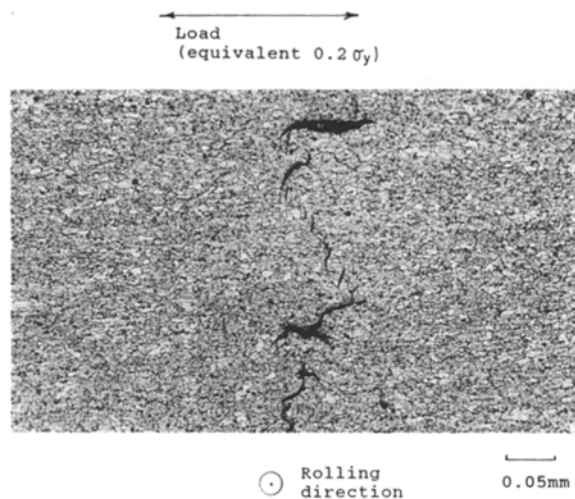
Figure 3 The characteristic array of a stack crack: note the characteristic "S" shape and the finer (vertical) cracks linking the parallel horizontal cracks.

Stack cracks, Fig. 3, occurred most frequently in a region close to the weld, i.e. in the heat-affected zone (HAZ). Close examination revealed that this region was just outside the second HAZ and was actually in a third HAZ, which was revealed by selective etching [11] whereas this was not identified by single-stage etching. Fig. 4 shows the typical stack cracks in relation to the weldment and the HAZ regions in a section of a flat rectangular specimen. The microstructure of this region and the third HAZ retained some of the fibrous nature of the parent metal. Initial optical examination did not show any significant difference in microstructure between the region which was prone to stack cracking and the rest of the third HAZ. However, thin foil TEM examination showed the presence of carbide/cementite films at grain boundaries in this region, Fig. 5. This led to a closer optical examination of this region. Careful etching using two etchant solutions showed that cementite spheroidization had occurred in this region, Fig. 6.

Individual primary cracks (parallel to the plate thickness) had a characteristic "S" shape and were linked by finer transverse cracks as shown in Fig. 3. Some of these cracks were visible on the specimen surface. The cracks were found to propagate both intergranularly and transgranularly. Fig. 10 shows the

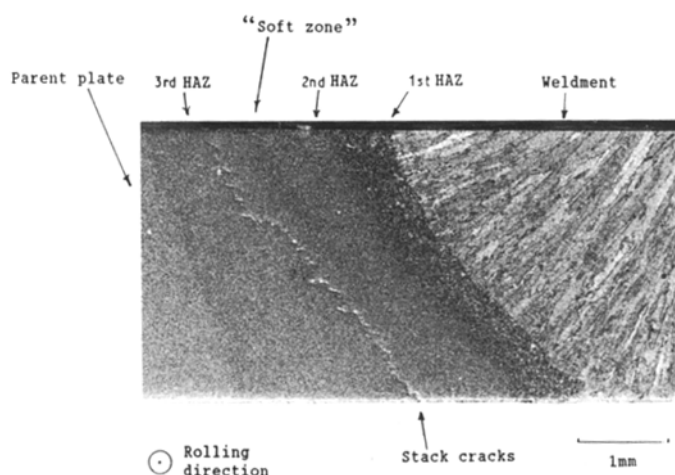
Figure 4 Stack cracks in relation to HAZs and weldment charged without load.

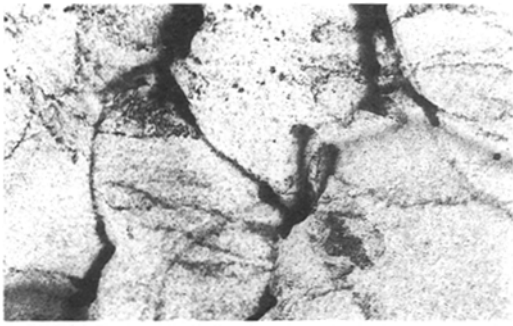
Figure 5 Cementite/carbide films at grain boundaries in the soft zone (spheroidized carbide region) identified in Figs 4 and 6.

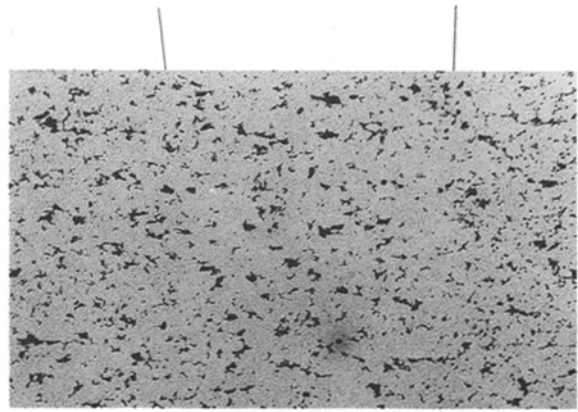
Figure 6 Region of spheroidization as revealed by selective etching with Nital, and followed by a Picral etch [11].

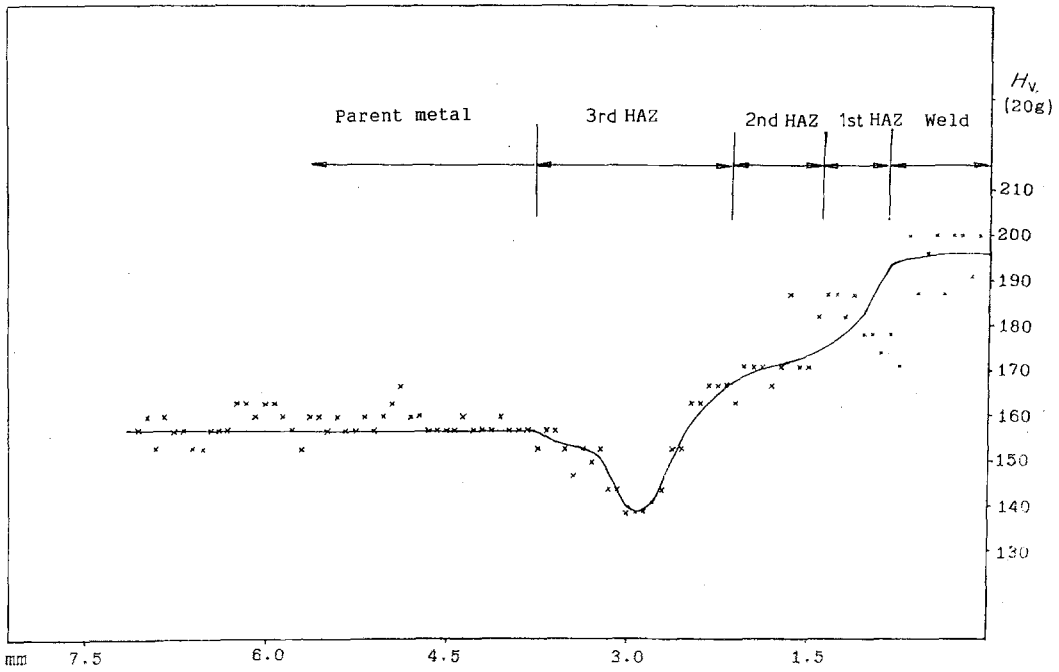
Figure 7 Microhardness profile of the sample in the as-received condition.

Microhardness measurements showed that this region had a lower hardness than the parent metal and the rest of the third HAZ. Fig. 7 shows the microhardness profile of the uncharged specimen; the region with low hardness was about 2 to 3 mm from the weld edge. The tensile strength of specimens containing a "soft" region was also lower than the tensile strength of parent metal specimens.

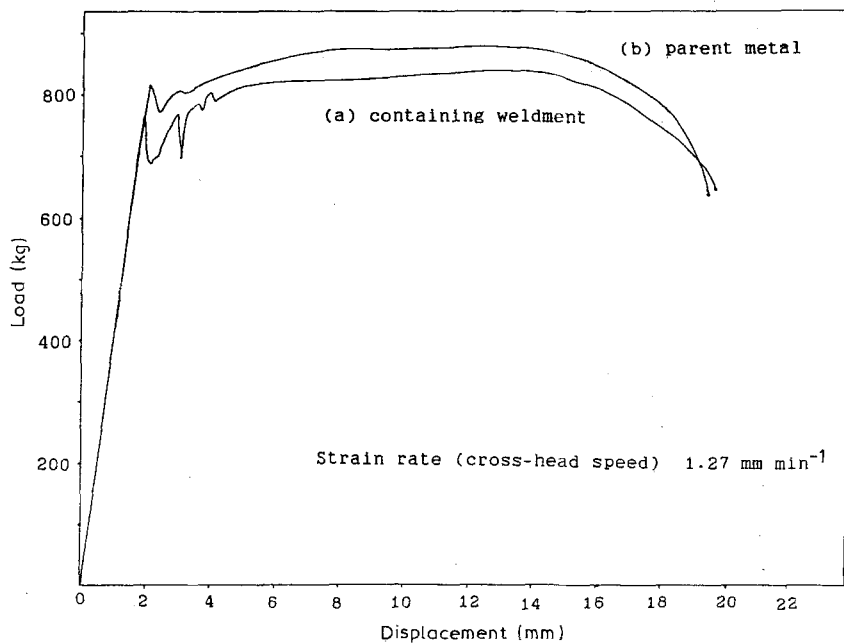
Figure 8 Load-displacement curves: (a) a specimen containing weldment, (b) a specimen consisting entirely of parent metal.

The lower yield and tensile properties of the "soft" region are a consequence of the spheroidized microstructure. Tensile values for uncharged specimens showed that the difference between upper and lower yield stress in specimens containing a "soft" region was greater than in a parent metal specimen, Fig. 8. Such a high yield drop has been ascribed to a low initial mobile dislocation density [12]; such a state could exist in this soft region if dislocations were immobilized by interstitial carbon or nitrogen which migrated during the welding sequence.

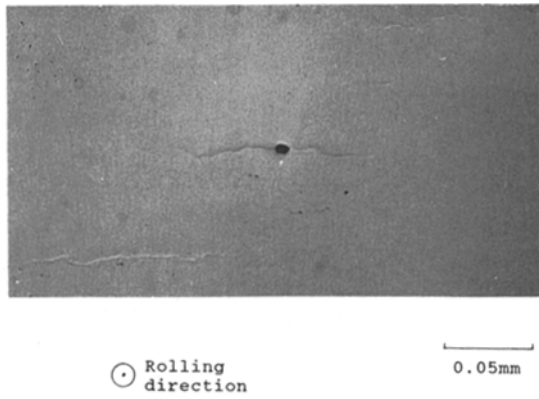
Figure 9 An incipient cleavage crack at an inclusion (charged without load).

The majority of cracks was found to initiate at inclusions, Fig. 9. As expected, very few of these inclusions contained sulphur, because the sulphur content of the steel was very low (0.001%). The majority of the inclusions were identified to be of the oxide, silicate or spinel type [11]. All the inclusions were globular in shape; no elongated inclusions were found although fragmentation (due to rolling) of the inclusions was detected. Most of the inclusions were of the type that were expected to produce tessellated stress [13]; hydrogen will diffuse to, and accumulate at or around, these inclusions and the subsequent pressure build-up will produce cracks.

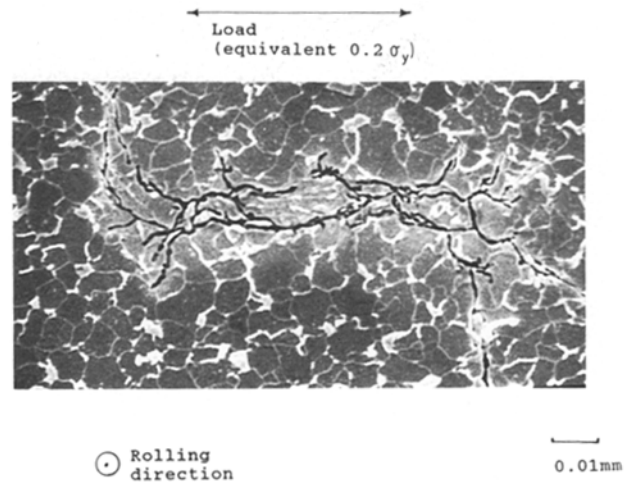
Figure 10 The outline of an individual crack showing intergranular and transgranular crack growth (the inclusions located at the centre of the cracked regions are not visible in this micrograph).

outline of an individual primary (rolling plane) crack revealed by polishing and etching.

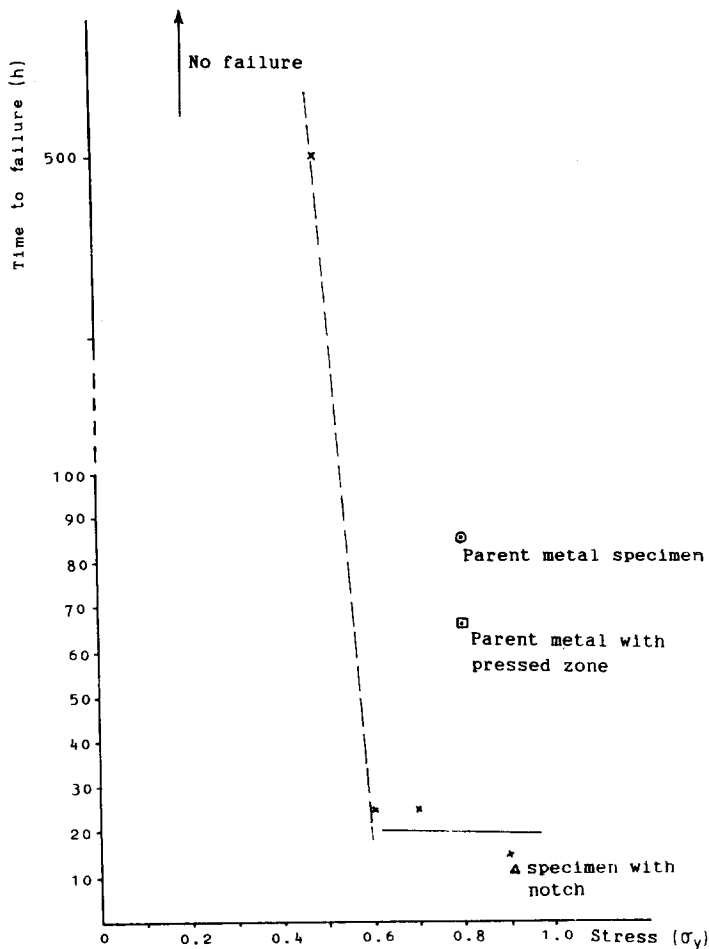
Figure 11 Failure time in relation to applied stress during hydrogen charging (specimens containing a weldment).

Stack crack formation was found to be independent of the applied stress, i.e. stack cracks were found in specimens charged without applied stress and also in specimens which had been stress relieved prior to charging. However, the applied stress level did affect the time to failure as shown by tensile specimens charged at high stresses (0.5 to $0.9\sigma_y$). The time to failure was found to depend on the applied stress and a threshold of stress existed, above which failure occurred after a relatively short exposure time; above this threshold stress the failure time was relatively independent of the applied stress level, whereas below this threshold stress failure occurred only after long exposure times. Fig. 11 illustrates this and identifies a threshold stress of approximately $0.6\sigma_y$.

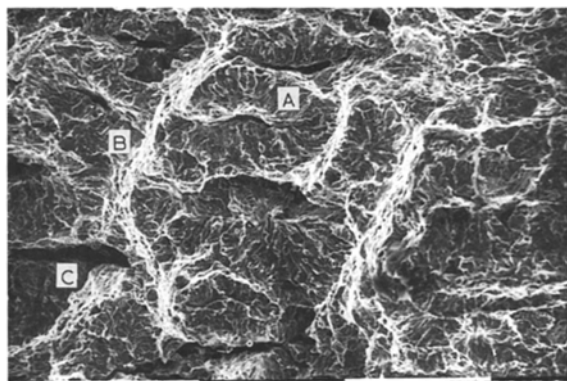
Figure 12 Typical fracture surface on a HE specimen: A, cleavage rosette normal to plane of tensile loading; B, final ligament of ductile (MVC) fracture between cleaved regions; C, rolling plane (primary) stack cracks.

The fracture surfaces (tensile specimens) contained cracks parallel to the plate thickness, Fig. 12. The mode of fracture consisted of cleavage rosettes with microvoids coalescence (MVC) in thin lace patterns

between these rosettes [11]. It is envisaged that molecular hydrogen pressure promoted the formation of the individual cleavage rosettes, including the transverse linking cracks, and final fracture occurred when the remaining ligaments between these rosettes were unable to support the applied load and failed by ductile shearing as manifested by microvoids coalescence. Thus, the final fracture was dependent on the applied stress. This was confirmed by the results of the specimens charged at $0.2\sigma_y$, where failure did not occur even after 1500 h charging, and no failure was observed in any specimens charged at low stresses or at zero stress. It was concluded that hydrogen embrittlement damage can be produced by hydrogen pressure alone and will produce severe stack cracking but will not necessarily lead to fracture in these steels.
