# High-temperature mechanical behaviour of multidirectional Nicalon/CAS-II composite

High-temperature mechanical behaviour of Nicalon/CAS-II composite has been investigated. Oxidation of the exposed interfaces along matrix cracks at 1000 °C lowered the longitudinal unidirectional strength to the stress level at which matrix cracking began to occur. The strength of cross-plied composites was also severely reduced in 800 °C air. Transverse plies cracked prior to 0° ply matrix cracking. However, embrittlement did not occur until the matrix in the 0° plies cracked. It was established that oxidation does not take part in crack growth parallel to the fibres, except adjacent to exposed edges. Neither does oxygen enter 90° ply cracks in cross-plied composites in sufficient quantity to produce oxidation embrittlement, at least up to the 0° matrix cracking strain.

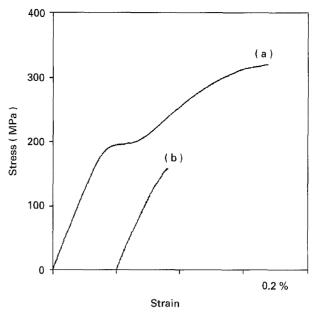
*Figure 1* Longitudinal tensile stress–strain curves of unidirectional Nicalon/ CAS-II composites tested (0.7% strain/h) at (a) 20  $^{\circ}$ C, and (b) 1000  $^{\circ}$ C.

3.1. Tests on unidirectional Nicalon/CAS-II A representative room-temperature longitudinal stress-strain curve for unidirectional Nicalon/CAS-II is shown in Fig. 1, curve (a). Initially, the material exhibits linear elastic behaviour with a modulus closely predicted [33] by the rule of mixtures, up to a strain of approximately 0.15%. This linear elastic part is followed by a region over which the response becomes non-linear, usually attributed to the formation of matrix cracks normal to the direction of applied load, resulting in a plateau on the stress-strain curve. At higher strain levels, above approximately 0.25% strain, the material once again approaches linear behaviour dominated by fibre properties until failure. These results are in good agreement with other tensile data previously reported [18].

fracture of unidirectional Nicalon/CAS-II. The high matrix crack density observed on the specimen edges examined microscopically after fracture, correlates well with the three-stage stress-strain curve of Fig. 1, curve (a). This indicates that the fibres alone contributed to the strength at high strains. Matrix cracks did not propagate through fibres (Fig. 2) because fibre debonding occurred prior to crack propagation through the fibres and/or matrix cracks deflected parallel to the fibres. The fracture surface displayed extensive fibre pull-out, as in Fig. 3. Fibre pull-out lengths up to 1 mm were commonly observed.

At 1000 °C, the composite failure strain decreased to the matrix cracking strain and the behaviour was brittle. The stress-strain curve (Fig. 1, curve (b) remained (almost) linear to failure indicating that the matrix cracking strain was not exceeded. The fracture surface was planar with no fibre pull-out (Fig. 4), characteristic of brittle fracture. This planar fracture surface is indicative of a degraded carbon interphase layer, with a subsequent formation of a strong interfacial bond [14, 15, 17].

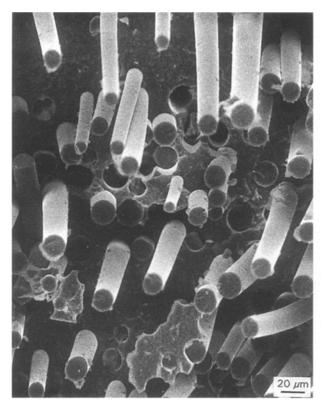
*Figure 3* Fracture surface of a unidirectional Nicalon/CAS-II tensile specimen tested at room temperature.

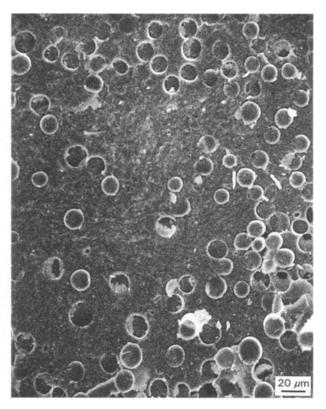
Figure 4 Fracture surface of a unidirectional Nicalon/CAS-II tensile specimen tested in air at 1000 °C (0.7% strain/h).

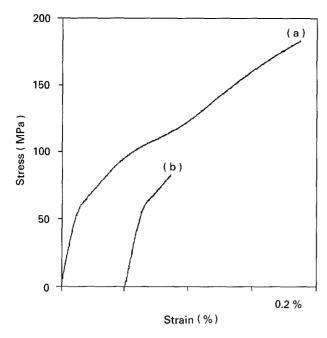
Figure 5 Tensile stress-strain curves of cross-ply Nicalon/CAS-II composites tested (0.7% strain/h) at (a) 20  $^{\circ}$ C, and (b) 800  $^{\circ}$ C.

A typical tensile stress-strain curve for a 0/90 crossply composite is shown in Fig. 5, curve (a). A decrease in the elastic modulus of the composite is observed at about 0.05% strain resulting from the failure of transverse (90°) plies [15]. The curve continues to be approximately linear up to a strain of about 0.15% and then deviates from linearity, as would be expected due to the onset of matrix cracking in the longitudinal (0°) plies. This is followed by the final (almost linear) regime which is governed by fibre properties in the 0° plies.

The stress-strain curves for the tensile tests performed at room temperature and  $800 \,^{\circ}\text{C}$  (Fig. 5) clearly show that strength is again reduced by the presence of high-temperature air, as in the unidirectional case. Specimens failed at  $800 \,^{\circ}\text{C}$  just as the end of the second linear portion of the stress-strain curve was reached (the point where matrix cracking in the  $0^{\circ}$  plies begins [15]). The fracture morphology was similar to that of the unidirectional Nicalon/CAS-II specimens tested at 1000  $^{\circ}\text{C}$ .

Examination of the stress-strain curve obtained from the tensile test performed on cross-ply Nicalon/CAS-II at 800 °C indicates that composite strength is limited by the 0° ply proportional limit point (matrix cracking) and not the 90° ply failure point. Prewo [3] observed a similar tensile behaviour for cross-ply Nicalon/LAS system at 1000 °C in air, including 100 h stress-rupture tests. The embrittlement of the fracture process is apparently not initiated until the matrix in 0° plies cracks upon stressing, allowing penetration of high-temperature air into the interior of the 0° plies.

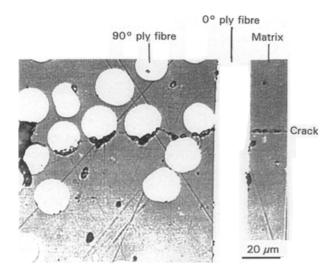
Figure 6 A crack in a cross-ply Nicalon/CAS-II tensile specimen tested at room temperature.

Matrix cracking both in  $0^{\circ}$  and  $90^{\circ}$  plies was extensive. Most cracks in  $90^{\circ}$  plies propagated into the  $0^{\circ}$  plies with fibre bridging (Fig. 6). A fibrous, tough composite fracture of the  $0^{\circ}$  plies was achieved in room-temperature control specimens. Thus, as also observed by others [15],  $90^{\circ}$  plies do not severely affect the performance of the  $0^{\circ}$  plies. However, the  $90^{\circ}$  plies do complicate the failure process in that cracking of the  $90^{\circ}$  plies occurs at a lower strain than does the first damage (matrix cracking) in unidirectional material. As Fig. 6 indicates, the cracks in the  $90^{\circ}$  plies can penetrate past the first fibres of the  $0^{\circ}$  plies, possibly exposing them to environmental attack.

Tensile and double torsion test results show that sufficient oxygen for interphase oxidation does not penetrate into cracks running parallel to the fibres. As shown in Fig. 6, the cracks grow predominantly in the fibre-matrix interface. Fig. 18 illustrates that contacts between fibres and matrix must exist along the fibre axis as the 15  $\mu$ m diameter fibres are only slightly extracted from the matrix. These points would be expected to oxidize and fuse near the exposed edges, greatly limiting the ingress of oxygen, much as the oxidation tunnelling process along exposed fibres was shown to seal-off.

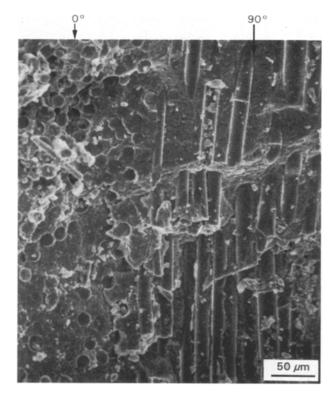
Figure 7 Fracture surface of a cross-ply Nicalon/CAS-II tensile specimen tested in air at  $800 \,^{\circ}$ C (0.7% strain/h).

The fracture surface was planar without any noticeable fibre pull-out as shown in Fig. 7, indicating a higher level of fibre-matrix interfacial strength. Fig. 7 shows that a crack in the 90° ply propagated in a planar fashion through the adjacent 0° ply. The fracture surface of the 90° ply itself is also flatter, compared with the loose fibres on the surface of the room-temperature test in Fig. 8.

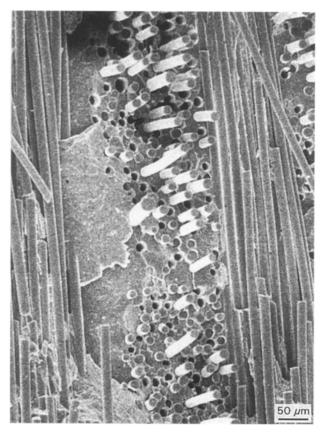
Figure 8 Fracture surface of a cross-ply Nicalon/CAS-II tensile specimen tested at room temperature.

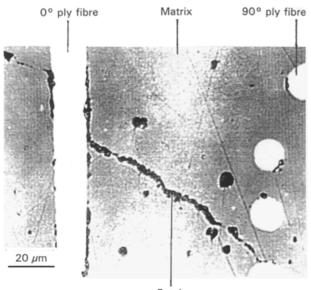
Figure 9 A crack at a depth of about 0.5 mm below an edge of a cross-ply Nicalon/CAS-II tensile specimen fractured at 800 °C (0.7% strain/h).

Microscopic examination and microdebonding tests were performed on an edge of a cross-ply composite tensile specimen fractured at 800 °C. The polished edge (at about 0.5 mm depth in from the as-tested edge) of the fractured specimen revealed extensive cracking in the 90° plies but not in the 0° plies (as opposed to extensive matrix cracking of the 0° plies at room temperature). Most of the cracks in the 90° plies stopped or deflected in the 0° direction upon reaching the fibres of 0° plies. A few of the cracks in the 90° plies propagated to the closest 0° fibres (Fig. 9), interestingly with bridging fibres as in the case of room-temperature fracture.

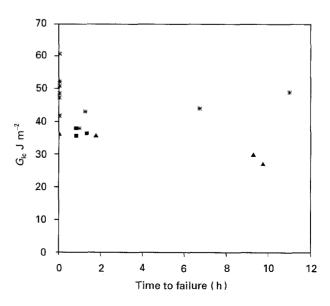
Figure 10 Transverse fracture toughness versus time to failure plot of Nicalon/ CAS-II composite. (\*) 20° C, (■) 800 °C, (▲) 1000 °C.

Transverse fracture toughness,  $G_{Ic}$  versus time to failure (testing time) plot of Nicalon/CAS-II specimens for room temperature, 800 and 1000 °C is shown in Fig. 10. There seems to be no significant effect of test rate on transverse fracture toughness at room temperature. The  $G_{Ic}$  data scatter in the range 38–61 J m<sup>-2</sup> with an average value of 48 J m<sup>-2</sup>. On the other hand, the transverse fracture toughness of Nicalon/CAS-II composite was determined to be lower than 38 J m<sup>-2</sup> for the fracture tests performed at 800 and 1000 °C. Also, the test rate had some effect on the composite toughness at 1000 °C. The average  $G_{Ic}$  measured on the samples fractured in 9–10 h was about 20% lower than that of the ones fractured in less than 2 h. Overall, there is a reduction in  $G_{Ic}$  from about 48 J m<sup>-2</sup>

down to under  $38 \text{ Jm}^{-2}$  as the temperature increases from room temperature to 800 or 1000 °C.

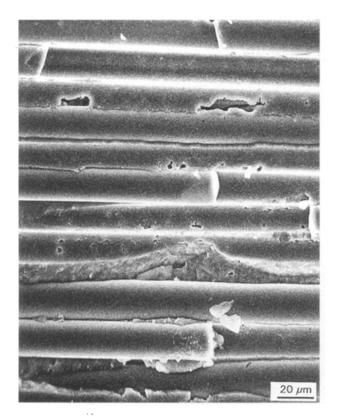
Figure 12 Scanning electron micrograph taken on the planar part in the first half of the fracture surface of a Nicalon/CAS-II double torsion specimen tested at 1000  $^{\circ}$ C in air.

The fracture surfaces of the DT specimens at 1000 °C were examined and found to have three distinct regions, as shown in Fig. 11. The fracture surface near the notch tip was planar, with no noticeable fibre pull-out (Fig. 12). Crack propagation was mainly through the fibre-matrix interface, breaking the fibres bridging the crack surface but without pulling the broken fibres out of the matrix. The profile of the planar fracture surface front was curved and extended further along the bottom face of the double torsion specimen. Also, the planar fracture extended only a little more than half way through the thickness from the bottom side of the specimen.

As noted, high-temperature oxidation of the fibre-matrix interphase causes a planar fracture during crack propagation parallel to the fibres, away from the cut ends. This might be occurring after the crack forms, so that cracking does not propagate through the fibres (Fig. 12), contrary to the fracture close to the cut specimen end at which cracking propagates through the fibres as well as through the matrix and the interphase (Fig. 13). This was also the case for the cracking in 90° plies during tensile testing of cross-ply composites at 800 °C.

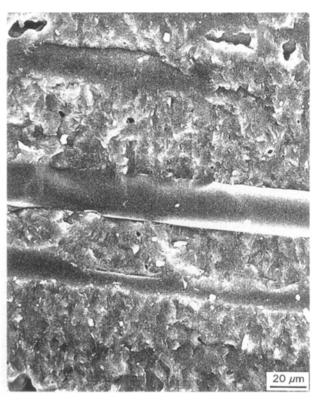
Figure 13 Scanning electron micrograph taken near the end of the fracture surface of a Nicalon/CAS-II double torsion specimen tested at 1000  $^{\circ}$ C in air.

The end of the fracture surface was again planar without any fibre pull-out to a distance of about 1.5 mm from the cut end of the specimen. However, the fracture process was more brittle and the cracking was through the matrix, interphase and also through the fibres, as shown in Fig. 13.

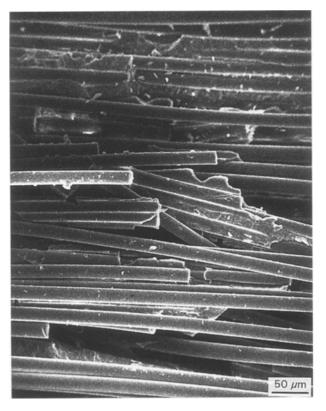
*Figure 14* Scanning electron micrograph taken on the rough part (with debonded fibres) in the second half of the fracture surface of a Nicalon/CAS-II double torsion specimen tested at 1000 °C in air.

The rest of the fracture surface was rough, with debonded loose fibres (Fig. 14), similar to fracture surfaces at room temperature.

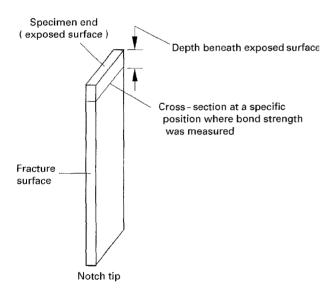
Figure 15 Diagram showing composite specimen fractured in air, test duration: for 10 h at 1000  $^{\circ}$ C, showing where the microdebond-ing measurements were performed.

Microdebonding measurements were performed at the end of the specimen at specific positions along the fibre direction below the cut surface (sketched in Fig. 15). The surface had been exposed to high-temperature air before, during and after the fracture (for over 10 h). The purpose was to investigate the effect of oxidation penetration from the exposed fibre ends. The tests were performed in the central region of the sample (i.e. away from the fracture surface and the other exposed edges).

A significant increase in the interfacial bond strength was observed at depths up to 1.4 mm. The bond strengths were extremely high and either the tested fibres cracked before being debonded or the bond strength exceeded the measurement capacity of the microdebonding apparatus (> 1000 MPa). At a depth of about 1.8 mm beneath the surface, the bond strength reverted to that of the unexposed material

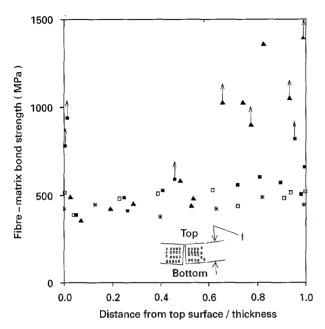
Figure 17 Interfacial bond strength distribution along the crack from top to bottom face for DT specimens fractured  $(1-2 h \log tests)$  at different temperatures (bond strengths with arrows exceeded the measurement capacity of the apparatus). (\*) 20 °C, ( $\Box$ ) 600 °C, ( $\blacksquare$ ) 800 °C, ( $\blacktriangle$ ) 1000 °C.

Fibre-matrix bond strength distributions along the crack between the two (top and bottom) surfaces of the DT specimens tested at temperatures of 20,600,800 and 1000  $^{\circ}$ C are given in Fig. 17. No significant change in fibre-matrix bond strength was

observed from 20-600 °C. The most significant increase in the interfacial strength was observed at 1000 °C. However, a critical observation is that oxidation was effective only half way across the fracture surface from the bottom side, while the bond strengths on the other half were similar to those of control composites (except for the oxidized fibres very close to the top surface exposed to the environment). The results for the fracture at 800 °C were similar in nature but with lower increases in bond strength.
