# Damage behaviour of silicon nitride for automotive gas turbine use when impacted by several types of spherical particles

Spherical particle impact damage and strength degradation phenomena of silicon nitride by several types of spheres were analysed in comparison with chipping fracture behaviour reported in the literature. It was found that steel and partially stabilized zirconia (PSZ) particles caused Hertzian cone cracks, resulting from the elastic response of the material in accordance with the Hertzian cone crack theory. In contrast, alumina and sialon particles induced both median-radial crack systems at low impact velocity range and Hertzian cone cracks at high impact velocity range. The critical impact velocity for strength degradation,  $V_c$ , correlated with the hardness of the spheres and target ceramics, and  $V_c$  for Hertzian cracks and median cracks were higher than that for chipping fracture.

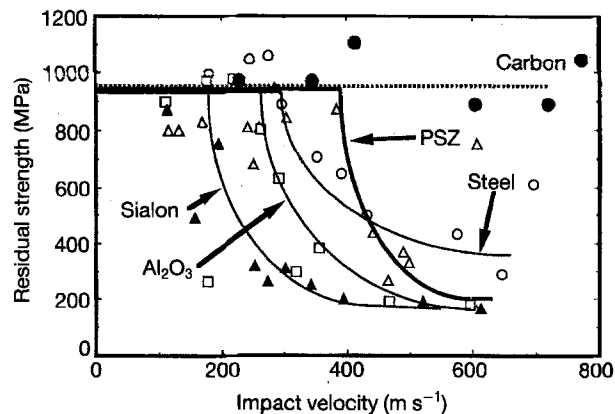
Figure 1 Residual strength of target after impact indicating critical impact velocity for strength degradation: (○) steel, (△) PSZ, (□) alumina, (▲) sialon, and (●) carbon.

Fig. 1 shows the residual strength of the specimens after impact in relation to the impact velocity. Strength plots were connected in order to extrapolate the average strength level. An examination of the fracture surfaces revealed cracks initiation, and the results are shown in Fig. 2a–e. With the steel spheres, a Hertzian cone crack (Fig. 2a) was initiated in strength degraded specimens. The critical impact velocity,  $V_c$ , for strength degradation and also for Hertzian cone crack initiation was  $330 \text{ m s}^{-1}$ . With the PSZ spheres (Fig. 2b), the  $V_c$  for strength degradation was  $383 \text{ m s}^{-1}$ .

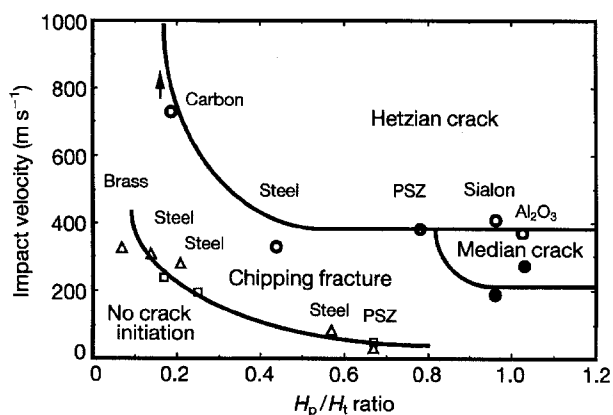
Figure 4 Response behaviour in relation at  $H_p/H_t$  and impact velocity: (○) Hertzian cracking, (●) median cracking, and (△, □) chipping cracking from Tsuruta *et al.* [6].

Response behaviour (Fig. 4) resulting in strength degradation due to crack initiation has been shown to be related to the contact situation using the hardness ratio between the spheres and the target,  $H_p/H_t$ , [2, 3, 6, 15]. The  $H_p/H_t$  ratio [3] determines the response behaviour. Elastic response occurred when the ratio was less than 0.8, and both elastic–plastic and elastic

A comparison with results from the literature [6] is shown in Fig. 4. As reported in the literature [6], chipping caused a half size Hertzian cone crack, when the whole sphere was impacted within the target. Contact behaviour differences causes a different stress
