# Effect of the surface treatment on the room-temperature bonding of Al to Si and SiO<sub>2</sub>

N. HOSODA, Y. KYOGOKU, T. SUGA

*Research Center for Advanced Science and Technology, The University of Tokyo, Meguroku Komaba, Tokyo, Japan*

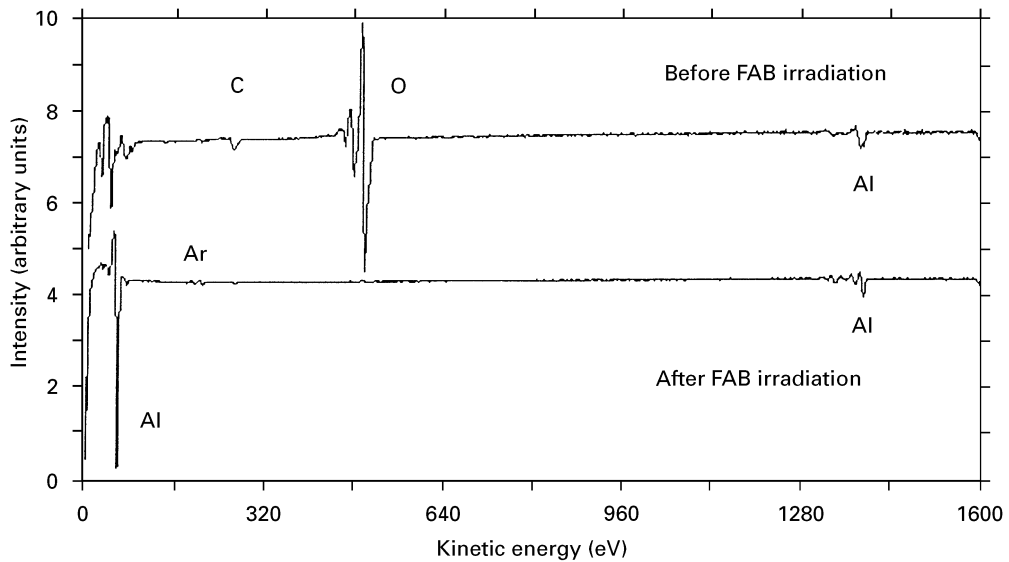
Figure 2 Auger electron spectra of the Al surface before and after FAB irradiation.

The Auger electron spectra of both Al and Si surfaces unsputtered and sputter cleaned by a FAB for 600 s are shown in Figs 2 and 3. Oxygen and carbon are found on the surfaces of Al and Si. These two impurities were removed by sputter cleaning with fast argon atoms. Subsequently, argon was found on the sputter-cleaned Al and Si surfaces. The amounts of Ar atoms on the Al and the Si surfaces were about 0.5% and 1%, respectively. Ar was driven into Si more than into Al. Ar was also detected by electron spectroscopy for chemical analysis on the SiO<sub>2</sub> surface after the tensile test. Ar is able to exist stably on the SiO<sub>2</sub> surface by FAB irradiation. It indicates that the joint produced by SAB contains Ar at the interface.

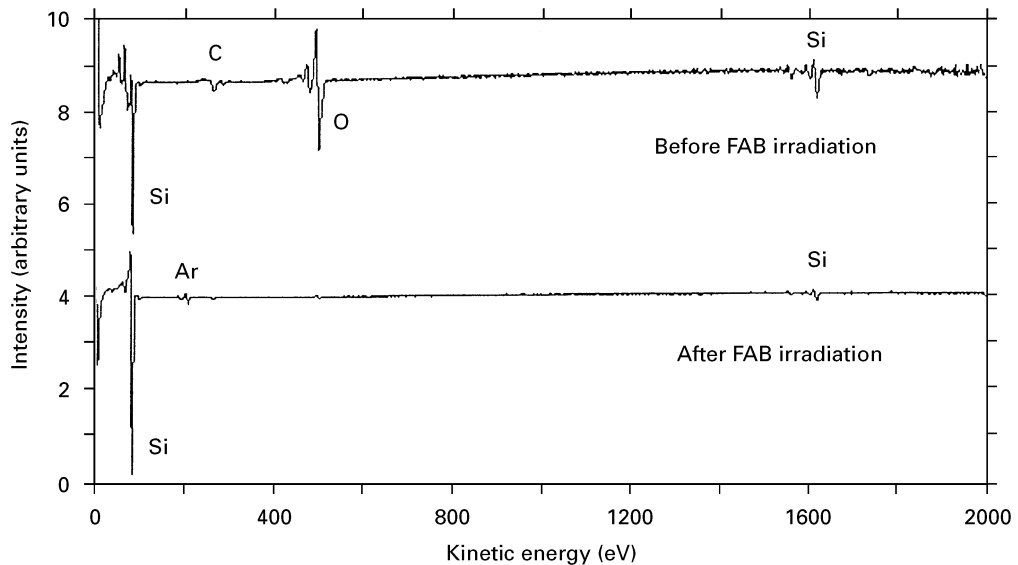
Figure 3 Auger electron spectra of the Si surface before and after FAB irradiation.

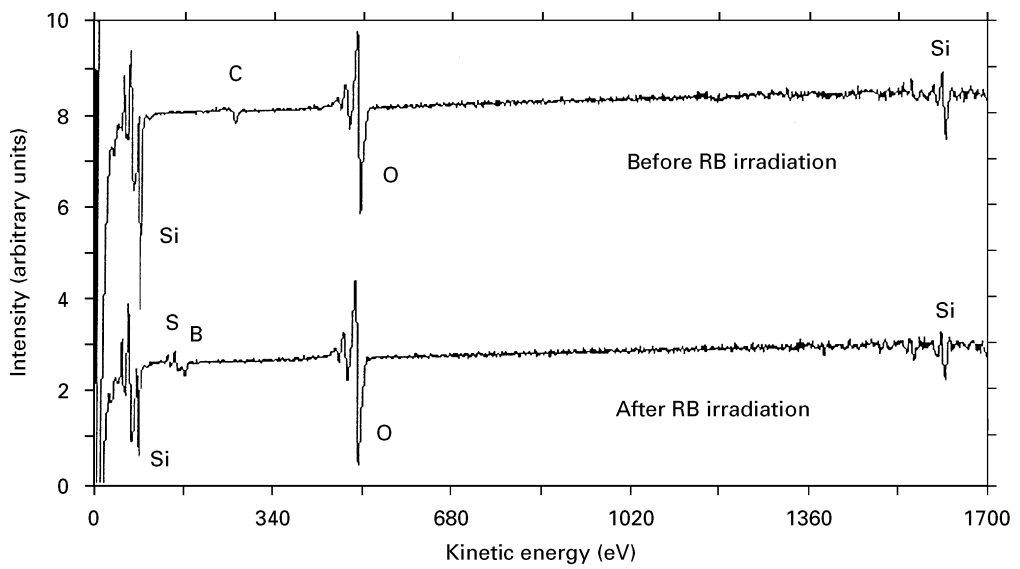
Figure 4 Auger electron spectra of the Si surface before and after RB irradiation.

The Auger electron spectra of Si surfaces with and without RB irradiation are shown in Fig. 4. Oxygen and carbon were present on the surface of Si. After RB

irradiation at 400 W for 4.2 ks, carbon was removed, but oxygen increased slightly, and sulphur and boron were found on the surface. It is possible that the increase in oxygen was due to the adsorption of H<sub>2</sub>O which occurred in the chamber during RB irradiation. The Auger electron spectrum of the Si surface which was sputter cleaned by FAB before RB irradiation, with and without RB irradiation, are both shown in Fig. 5. Ar was removed from the Si surface by RB irradiation. Sulphur and boron were not detected on either Si surface. Therefore, it might be concluded that these two impurities came from the oxide native layer of Si surfaces.

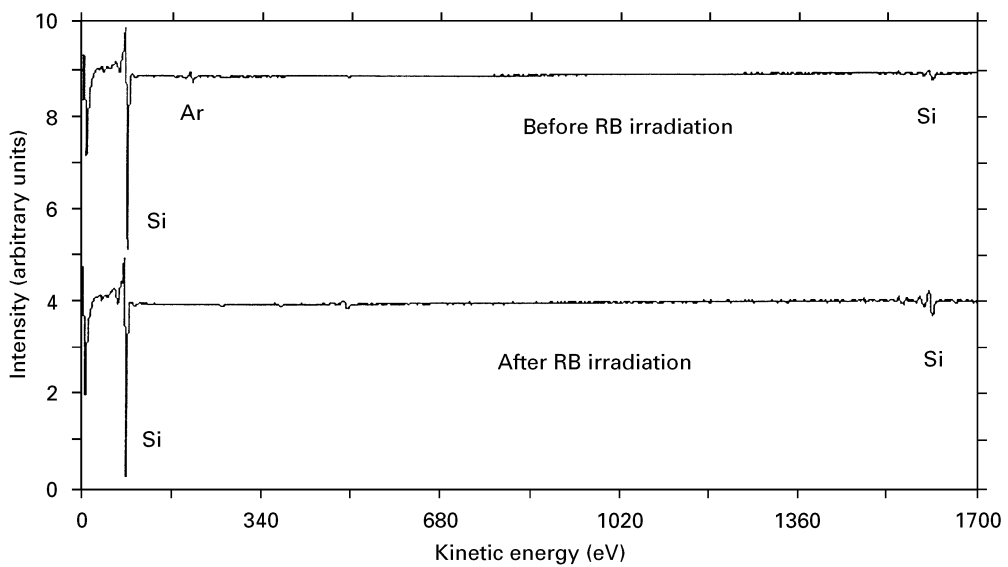
Figure 5 Auger electron spectra of the sputter-cleaned Si surface by FAB before and after RB irradiation.

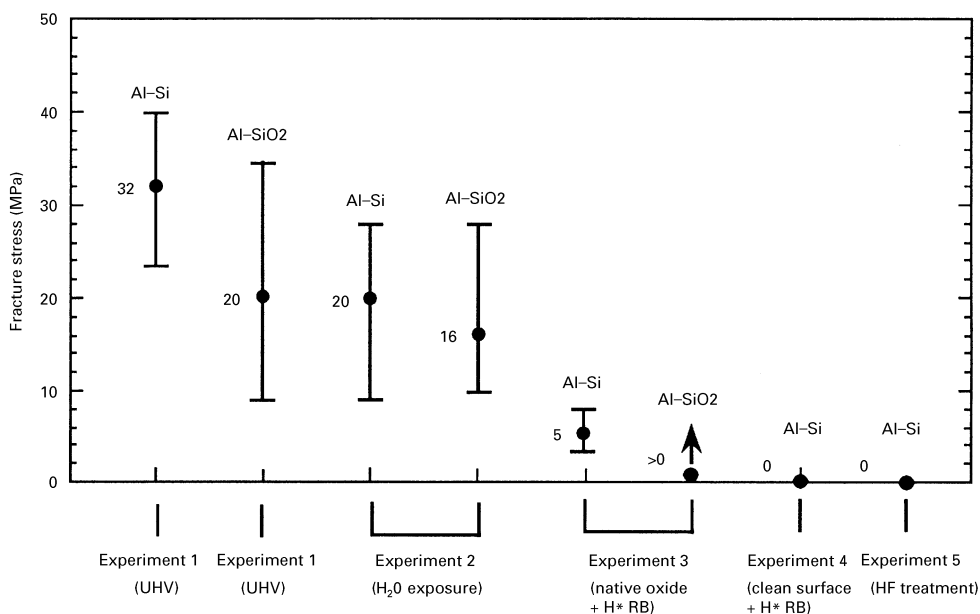
Figure 6 Fracture stress of the Al-Si and the Al-SiO<sub>2</sub> joints for various bonding conditions. (●) average.

fracture stresses per contact area, were compared with each other using average values of the fracture strengths in Fig. 6. The horizontal axis shows various experiments as listed in Table I. The direct bonding of Al to Si produced by surface activation with FAB irradiation immediately before bonding has the highest value of the fracture strength at about 32 MPa (experiment 1). A fracture of the Al-Si joint occurred on the Si side. This means that the strength of the interface was higher than 32 MPa. The bonding strength of Al-SiO<sub>2</sub> (fused silica) joints was lower than that of the Al-Si joints. The observation by scanning electron microscopy showed that the fracture occurred at the interface of the Al-SiO<sub>2</sub> joint. The bonding strength of the Al-Si joints was weakened from 32 to 20 MPa by the activated surfaces exposed to residual gases, of which the main residual gases were H<sub>2</sub>O molecules as in Table II. The reactions of H<sub>2</sub>O on the Si and the Al surfaces are known to be as follows. H<sub>2</sub>O dissociates into H and OH on the Si(100) surface at 300 K [6]. Adsorption of water on clean Al(1 1 1) at

300 K is dissociative too. Adsorbed hydroxyl species can be produced at 300 K by prolonged water exposure [7]. In the case of our experiments, it is considered that adsorbed hydroxyl species exist on both sides of the Al and the Si surfaces. The bonding strength of the Al-Si joint that contained hydroxyl species at the interface would be closer to the bond strength of an Al-SiO<sub>2</sub> joint. The fracture mode of this joint was different from that of the direct bonding of Al-SiO<sub>2</sub>. The dimple pattern of Al existed on the Si surface and the fracture started from near the interface into the Al side. The bonding strength of the Al-SiO<sub>2</sub> joint with exposure to residual gases was not changed much. It decreased slightly from 20 to 16 MPa.
