Fractographic study of high-density polyethylene pipe

High-density polyethylene (HDPE) pipe is now being used as an alternative to medium-density polyethylene (MDPE) for gas, water, sewage and waste-water distribution systems. Laboratory tests appear to show that HDPE is more able to suppress rapid crack propagation (RCP), whilst remaining sufficient resistance under the operational circumstances that lead to the type of slow crack growth observed in service failures. There have been many fractographic studies on MDPE pipe materials, actual pipe and fittings, but little on HDPE. A fractographic study of the type of HDPE pipe in current production has been undertaken. For these tests, whole pipe sections were subjected to either static or dynamic internal (water) pressurization fatigue loading. Failure mechanisms are discussed based on the fracture morphologies resulting from these tests. A further argument for good resistance of HDPE pipe to RCP is suggested. © 1998 Chapman & Hall

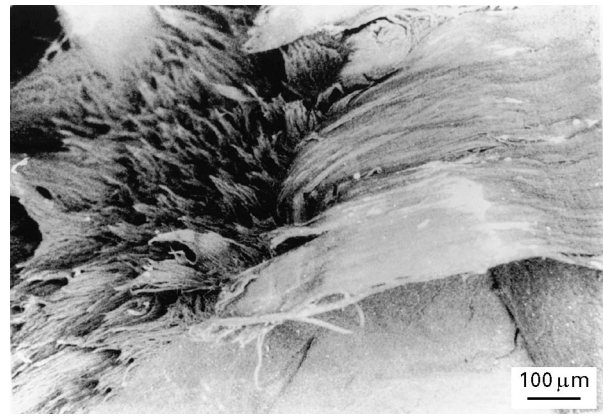
Figure 3 Scanning electron micrograph showing bands A and B at higher magnification.

Fig. 2 show the three bands at higher magnification. Band A (as shown in Fig. 3) is a fragmented membrane of fibres which extends from the edge of the notch and overhangs on to band B. Band B consists of short drawn fibres pointing generally towards the crack propagation direction. It has been reported that this band is the result of slow crack growth and is normally considered to be a brittle failure [6], but the actual surface is more complex and three-dimensional [9]. Fig. 4 shows a higher magnification view of band C. The fibres are, in fact, highly drawn and oriented towards the crack propagation direction as suggested above. The ends of the fibres are pulled down from the material matrix. This highly deformed area is reported to be caused by the accelerated crack propagation before the final catastrophic rupture of the material [13]. The final yielding of the remaining material

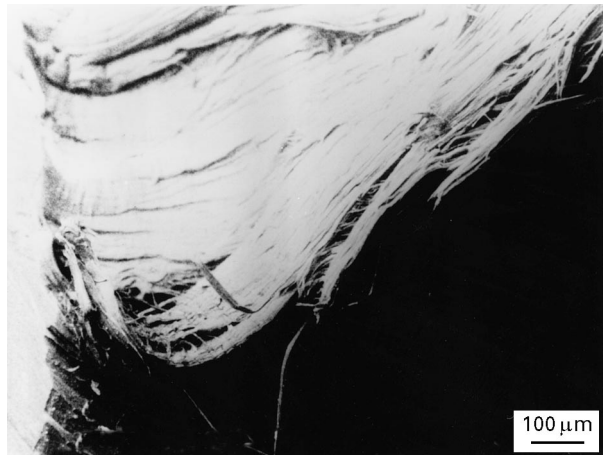
Figure 4 A higher magnification view of band C showing the highly drawn fibres with their ends pulled out of the material matrix.
