Low velocity response of a complex geometry pultruded glass/polyester composite

M. WISHEART, M. O. W. RICHARDSON*

This paper describes an investigation into the low velocity impact response on complex geometry sections taken from a pultruded glass/polyester product. The empirical impact behaviour of the system was evaluated using instrumented falling weight impact testing (IFWI) in conjunction with ultrasonic C-Scan, optical microscopy and thermal depley techniques to detect delamination, matrix cracking, and fibre breakage. © 1999 Kluwer Academic Publishers

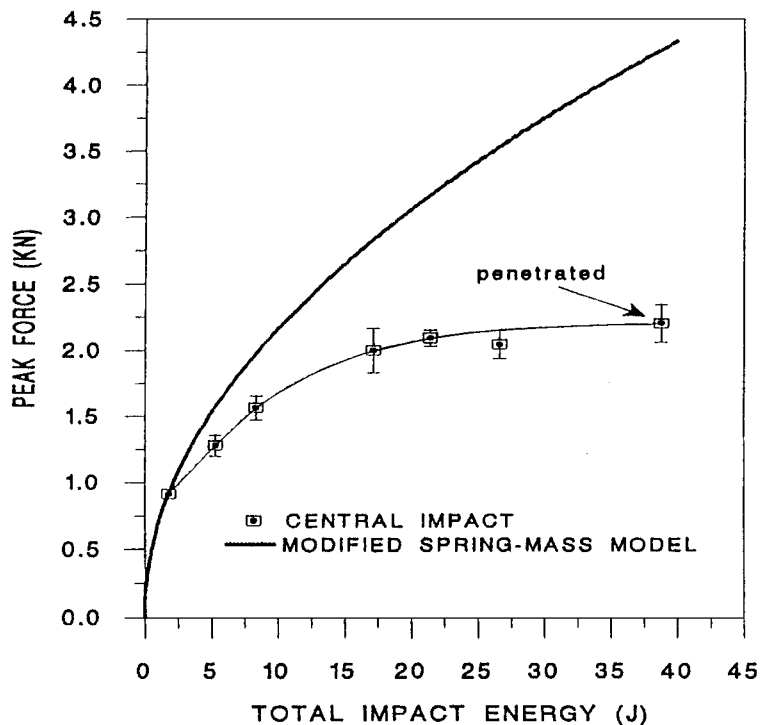
Figure 5 Peak force versus TIE for the central impacts from the three-box section and modified spring-mass model prediction.

Fig. 4 contains the force-deflection and force-time curves for all the impacts in the 21 J TIE set of three-box series of tests, showing a high vibration content but also a very repeatable response. Fig. 5 shows a steady rise in

peak force up to 8 J, a less steep rise between 8 J and 21 J and a flattening off thereafter, to the 38 J tests which penetrated the upper skin. With respect to the modified spring-mass model predictions, it is clear that only lowest energy impact approached an elastic response.

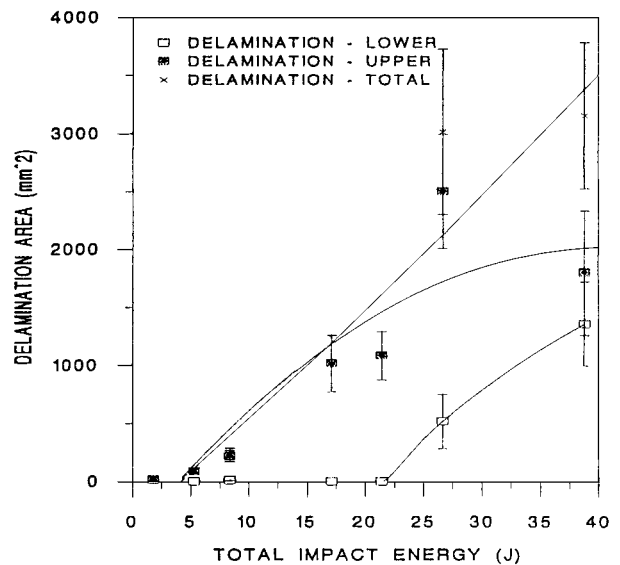
Figure 7 Upper interface delamination area versus lower CFM crack length (a) and delamination areas versus TIE for the central impacts from the three-box section.

Fig. 7b shows that upper interface delamination growth was relatively linear with TIE up to 21 J, at which point lower interface delamination was initiated which then increased linearly to penetration. The upper interface delamination, which was first detected at 5 J, was usually accompanied by a vertical (transverse) or inclined (shear) UD crack at or near its edge. (Fig. 6). The shear cracks in the UD layer, induced by the high shear forces generated by the double skin/web section, initiated lower interface delamination as shown in Fig. 8.

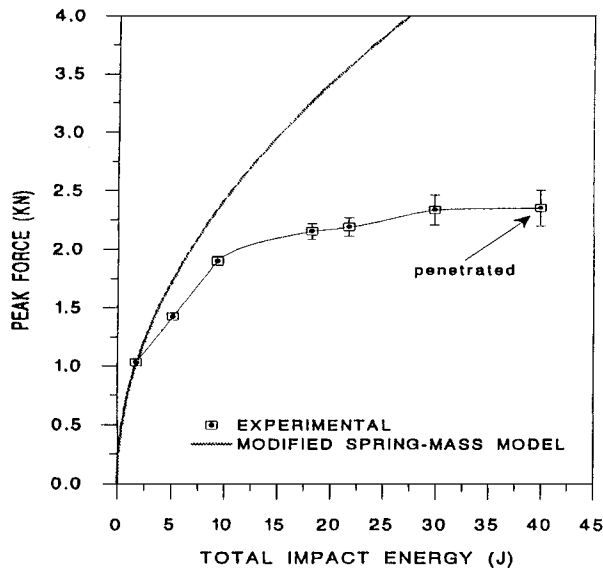
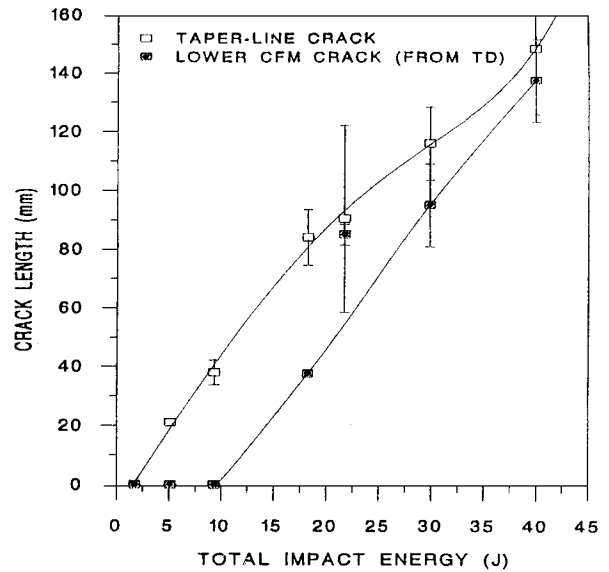
Figure 11 Peak force (a) and crack lengths versus TIE for the intermediate impacts from the three-box section.

Fig. 11a shows the peak force rising linearly to 9 J, flattening off thereafter at approximately 2.2 kN with penetration occurring for 38 J TIE tests. Only the lowest

The upper interface delamination grew at a greater rate above 18 J (Fig. 13) whilst thermal depley showed that lower CFM cracking was first observed 9 J and 18 J (Fig. 11b). Due to the taper, the lower CFM crack could not be observed visually. The lower CFM crack, induced a UD matrix crack, which further promoted the propagation of the upper interface delamination. Lower CFM crack growth and greater rate of upper interface delamination correspond to the reduction in stiffness present in Fig. 11a between 9 J and 18 J TIE.

The non-symmetry of structural and damage response was also seen on the impacted surface. Little damage was induced on the CFM layer under the impactor on the side furthest from the web up to 22 J, but on the stiffer side nearest the web, shear cracking occurred and this side of the impact site collapsed at 18 J, which contributed to the flat curve above this TIE in Fig. 11a.

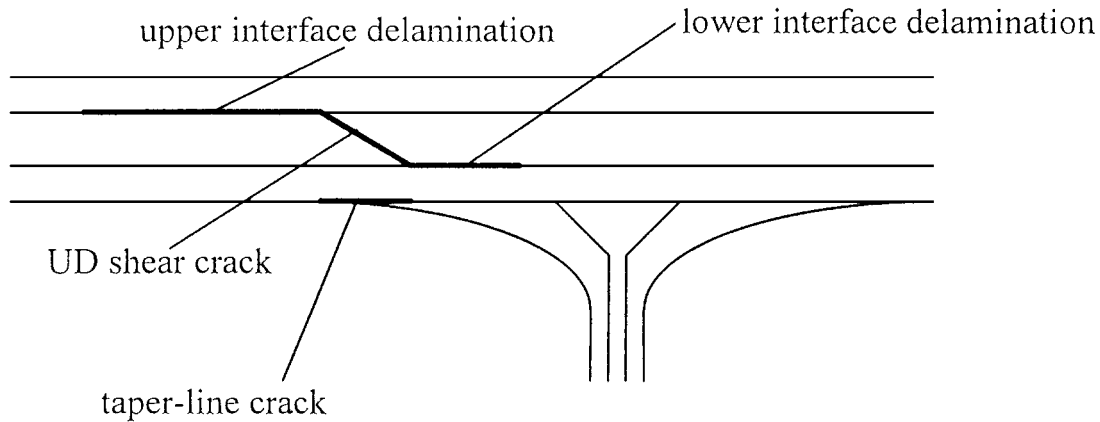
Figure 12 Damage progression in the intermediate impacts from the three-box section.

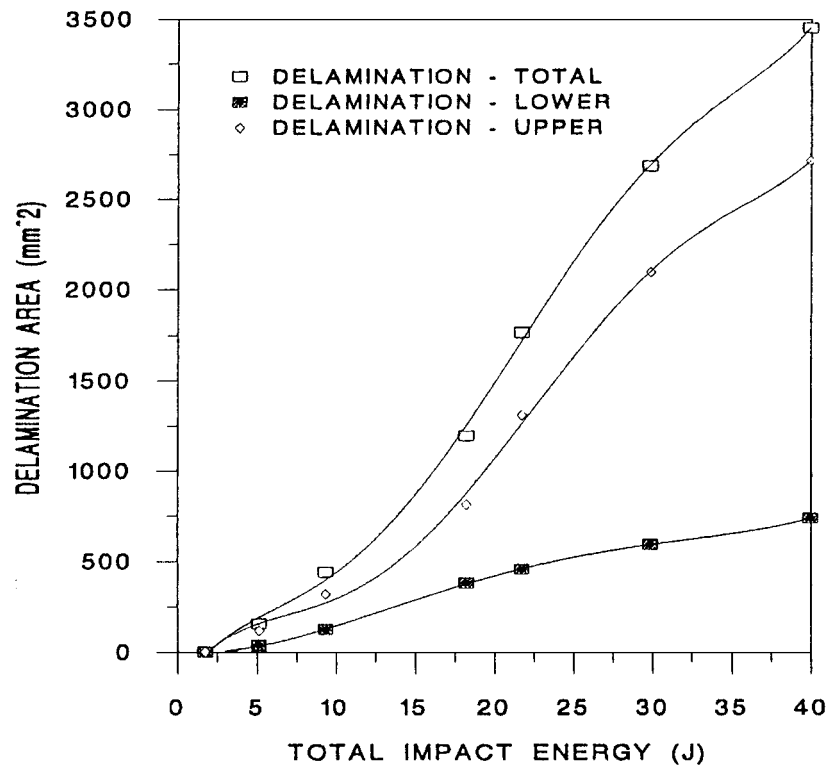
Figure 13 Delamination areas versus TIE for the intermediate impacts from the three-box section.

area of lower interface delamination was much lower than the upper (Fig. 13). The delaminations were initiated by a single shear crack in the UD layer under the impactor at approximately 45° pointing down towards the web (Fig. 14). The UD shear crack was present in the 2 J test specimens but with little or no associated delamination. Due to the non-symmetrical geometry and the much stiffer response on the web side of the impact site, high shear stresses were developed which initiated the shear crack and upper and lower interface delamination.
