The effect of material defects on the fatigue behaviour and the fracture strain of ABS

R. MARISSEN*[‡]

DSM Research, P.O. Box 18, 6160 MD Geleen, The Netherlands; Delft University of Technology, The Netherlands

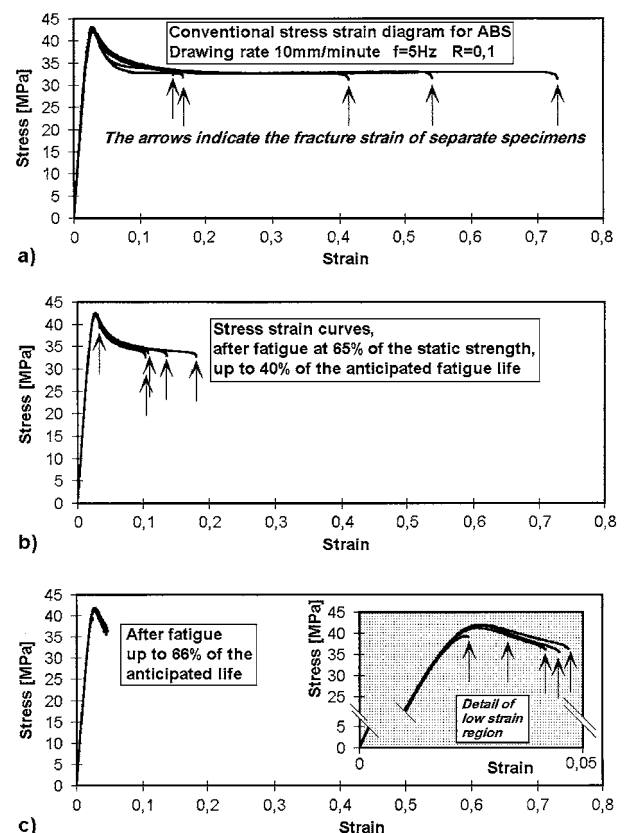
Figure 2 Tensile test results on as moulded, and on pre fatigued ABS specimens.

The results of the tensile tests at a drawing rate of 10 mm/minute are presented in Fig. 2a–c. Note that the scale of Fig. 2a–c is identical. It is clearly observed that pre-fatigue has a significant effect on the fracture strain as measured. Another observation is that all curves in Fig. 2a have about the same shape. Only the strains at break, where the curves end are different. There is a significant scatter in fracture strain. The tensile curves in Fig. 2b reveal a similar shape again, but with an earlier end of the curves and also with a significant scatter of the fracture strain. This trend proceeds further in Fig. 2c with an even larger decrease in fracture strain. One specimen in Fig. 2c even failed before displaying a load drop. Pre-fatigue obviously causes a severe embrittlement in tensile tests.

show a low strain anyhow. But it may cause earlier cracking in a monotonic tensile test. Anyhow, the SEM micrographs indicate that the defect particles are also important for the fracture behaviour in the static tensile test. Fig. 2 indicates that there is only one parameter to be influenced: the fracture strain! The observed scatter in the fracture strains can now be explained by the very local character of the fracture process. Fracture indeed occurs at the tip of the cracks, initiated from defects. On the other hand, the shape of the stress strain curve is a consequence of global material behaviour, it is a material property and not influenced by defects. The defects determine to which strain up to fracture the intrinsic stress-strain curve is followed.

The stress strain curves in Fig. 2b and c support the above argument. Fatigue up to 40% of the anticipated fatigue life, (from Fig. 3) already causes some crack initiation and crack growth. These micro cracks act as large defects and cause a reduction of the fracture strain in the subsequent tensile test. Again, with a similar shape of the stress strain curve. The SEM micrograph of Fig. 15 actually shows those fatigue cracks as small circles on the fracture surface. Further magnification in the area of the circles shows the same typical features as discussed before for pure fatigue fracture surfaces (therefore not presented here). The micrograph in Fig. 15 is obtained from the specimen in Fig. 2b, which showed a fracture strain of 10%. Fig. 2c indicates that pre-fatigue up to 66% of the anticipated fatigue life causes an even more reduced fracture strain in the subsequent tensile test. This is of course related to even larger fatigue cracks. It can be concluded that for fatigue cycling of ABS at 65% of the static strength, at least 60% of the fatigue life is spent during growth of micro cracks. Considering that the cracks in Fig. 15 will have spent some cycles, for growing up to the observed size, and that growth rates of small cracks are small, the portion of the fatigue life spent during growth of micro
