Failure paths at copper-base leadframe/epoxy molding compound interfaces

Black-oxide and/or brown-oxide layers were formed on the surface of copper-base leadframe sheets in hot alkaline solutions, and then the oxide-coated leadframe sheets were molded with epoxy molding compound (EMC). The molded bodies were machined to form sandwiched-double-cantilever-beam (SDCB) specimens, and the adhesion strength between oxide-coated leadframes to EMC was measured in terms of critical energy-release rate (G_{IC}) using SDCB specimens. Results revealed that untreated leadframe and Cu_2O -coated leadframe showed almost no adhesion to EMC, however once a continuous CuO layer formed on the leadframe surface (brown oxide) or on the Cu_2O layer (black oxide), G_{IC} increased to around 80 J/m^2 . A study of failure surfaces based on the scanning electron microscopy (SEM), glancing-angle X-ray diffractometry (XRD), Auger electron microscopy (AES), electron dispersive spectroscopy (EDS), and atomic force microscopy (AFM) analyses indicated that the failure path was closely related to the surface condition of leadframe prior to molding with EMC. © 2002 Kluwer Academic Publishers

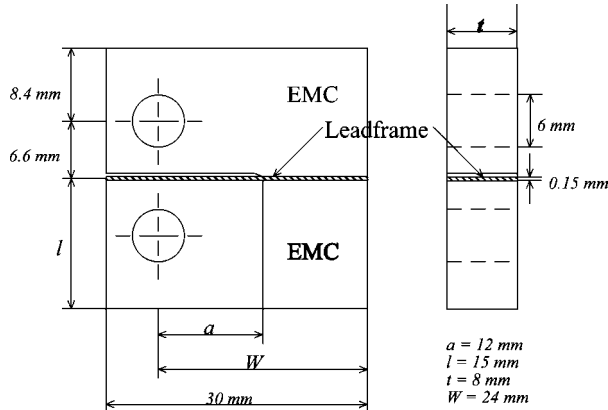
Figure 1 A schematic diagram of the sandwiched-double-cantilever-beam (SDCB) specimen.

After the formation of surface oxides, leadframe samples were compression-molded with EMC at a pressure of 6.5 MPa for 15 min at 175°C, and then machined into SDCB specimens as shown in Fig. 1. Pre-cracks were generated through pasting of correction tape on the leadframe surface, which is generally used for eliminating miswritten letters. The EMC used was DMC-20 developed as an encapsulation material for PLCC, VLSI, SOP, and FLAT packages by Dong Jin Chemical Co., Korea. After machining, post-mold curing treatment was carried out at 175°C for 4 h. Since an epoxy is a thermosetting polymer, post-mold curing treatment is needed to complete the polymerization reaction.

The SDCB specimens were employed to measure the adhesion strength in terms of interfacial fracture toughness under nearly mode-I loading conditions. Any homogeneous specimens for the fracture toughness tests can be converted into sandwiched specimens by inserting a sufficiently thin second material layer, and the solutions for energy-release rate, G , for homogeneous specimens are also applicable for sandwiched specimens [11]. According to the table in Ref. [11], the shift of phase angle due to the elastic mismatch, $\omega(\alpha, \beta)$, is about 3° for the EMC-leadframe system when the inter-layer thickness (h) is taken as a characteristic length (\hat{r}).

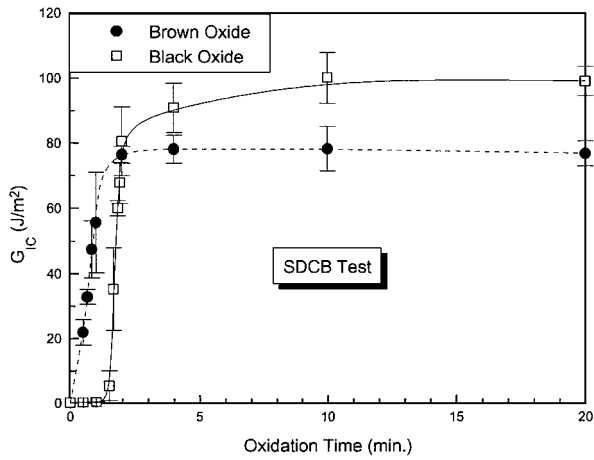
Figure 2 Nearly mode-I fracture toughness of the oxidized leadframe/EMC interfaces as a function of the oxidation time [13].

the results are shown in Fig. 2 [13]. For the leadframe/EMC system, the phase angle at the crack tip is about 3° [13]. Thus, the loading condition was close to a pure mode-I loading with a slight mode-II component (nearly mode-I loading condition).

The pre-cleaned only leadframe showed almost no adhesion to EMC ($G_{IC} \cong 0 \text{ J/m}^2$), but as soon as the brown-oxide layer appeared on the leadframe surface, G_{IC} began to increase with oxidation time. It was observed that G_{IC} increased almost linearly with the oxidation time up to 1 minute and finally reached a saturation value of around 80 J/m^2 at 2 min. It seemed that the G_{IC} variation was remarkably close to the thickening kinetics of the brown-oxide layer, which indicates that the adhesion between the two materials occurs via mechanical interlocking: the acicular CuO needles penetrate into the epoxy resin in the EMC during the

The fracture toughness of leadframe/EMC interfaces was measured by employing SDCB specimens, and the results are shown in Fig. 2 [13]. The leadframe/EMC interface showed almost no adhesion ($G_{IC} \cong 0 \text{ J/m}^2$) for 1 min. However, as soon as the acicular CuO precipitates formed on the Cu₂O layer, the G_{IC} began to increase and reached around 80 J/m^2 at 2 min. Further oxidation increased the G_{IC} gradually so that the G_{IC} reached a saturation value of 100 J/m^2 at around 10 min [13].

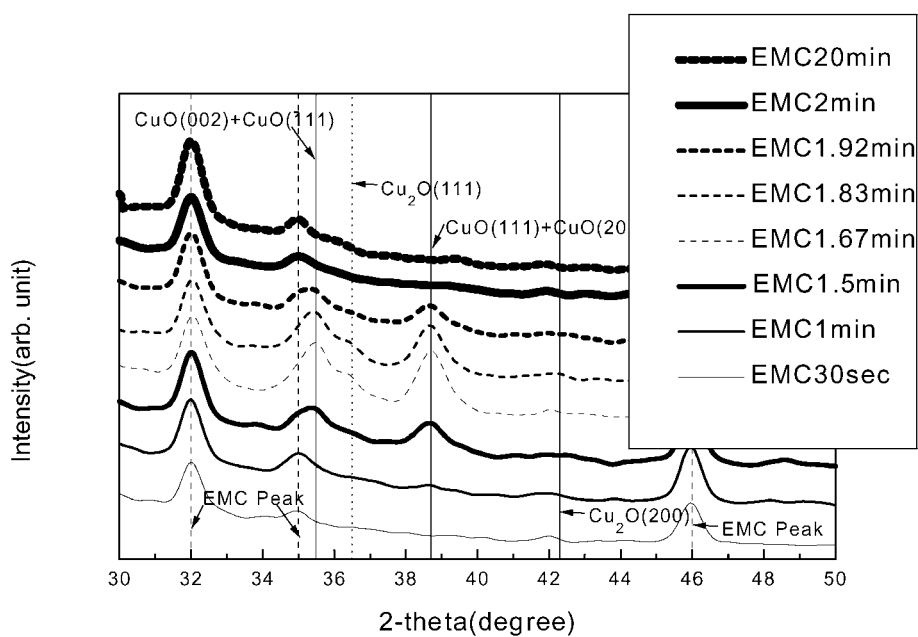
Figure 8 Glancing-angle X-ray diffraction patterns of the separated (a) leadframe side and (b) EMC side. The leadframes were treated in a black-oxide forming solution, and the times indicated in the plots mean oxidation times.

After the fracture toughness testing, the separated leadframe and EMC sides were analyzed by glancing-angle XRD, and the results are presented in Fig. 8. As can be seen in Fig. 8a, the overall trend of separated leadframe side seems to be the same as that of as-oxidized leadframe shown in Ref. [13], but there were some differences. For example, after 2 min the height of the CuO(111) + CuO(200) peak was higher than that of the Cu₂O(111) peak for the as-oxidized leadframe, while the opposite was true for the leadframe side. On the other hand, X-ray analyses on the separated

EMC side revealed that there were only EMC peaks till 30 seconds and the CuO peak began to appear at 1 min and kept increasing till 1.83 min, but finally decreased. This might be ascribed to the detachment of the CuO whiskers from the leadframe surface. It can be confirmed from Fig. 9, which shows the traces of broken CuO whiskers on the separated leadframe side and embedded CuO whiskers on the separated EMC side.

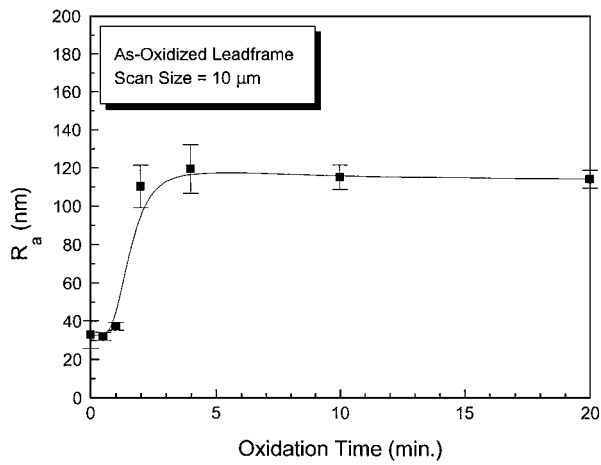
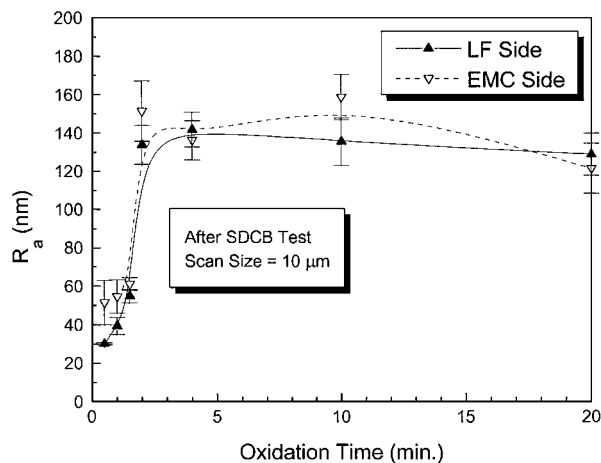
Figure 10 Variations of average roughness of the surface with oxidation time: (a) before molding, and (b) after SDCB test.

AFM analyses were carried out on the as-oxidized leadframe and the separated leadframe and EMC surfaces. The results are shown in Fig. 10. In case of as-oxidized leadframe, since the Cu₂O has a smooth facets as shown in Ref. [13], the average roughness was relatively low when the Cu₂O was dominant on the leadframe surface. However, when the CuO was dominant on the leadframe surface, the average roughness was

relatively high. This may be due to the acicular shape of the CuO as shown in Ref. [13]. Such a roughness change with the surface state of leadframe was well preserved in case of the separated leadframe. Comparing between the as-oxidized leadframes and the separated leadframes, one can readily find out that there is almost no difference in roughness. Such a good agreement may be ascribed to the similar nature of fracture surface.

high and also almost the same as compared to that of as-oxidized leadframe. The reason why the average roughness of separated leadframes for oxidation time is more than 2 min is high may be ascribed to that the failure was occurred in the near the CuO/EMC interface.
