Microstructural evaluation of fatigue damage in SA533-B1 and type 316L stainless steels

Transmission electron microscopy (TEM) examinations were made on fatigued SA533-B1 low alloy steel and Type 316L stainless steel specimens with the intention to investigate the mis-orientation changes among dislocation cells and the evolution of dislocation structures. Contrary to what might be expected for the cell structures, no clear relationship between fatigue damage and the mis-orientation changes of cell walls (or subgrain boundaries) was found in the fatigued samples of SA533-B1 steel (a bcc structure); however, significant changes of dislocation structures were observed in the fatigued samples of Type 316L stainless steel (an fcc structure). This could be accounted for by their different structures as well as complicated defect structures such as subgrain boundaries, small carbides, and dislocations inhomogeneously distributed in the SA533-B1 steel. It is interesting to note that at room temperature dislocations of fatigued SS316L specimens were observed to arrange themselves on {111} slip planes, in contrast, at 300°C the dislocations tend to move from their slip planes into subgrain

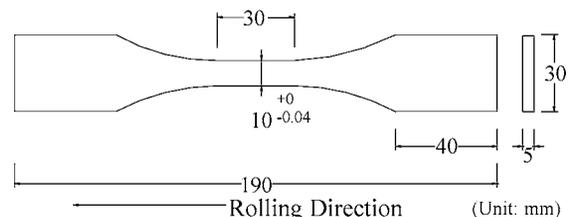
Figure 1 Dimensions of a fatigue specimen.

The high-cycle fatigue specimens of a plate type with a gauge length of 30 mm were prepared and tested according to the ASTM Specification E466. Fig. 1 shows the dimensions of the test specimen. Before testing, all the specimens have been well polished as per the recommendations of ASTM E466. Fatigue tests were performed with a 100 KN MTS 810 close-loop servohydraulic machine under load control with a sinusoidal wave form or under strain control with a triangular wave; stress ratios ($\sigma_{\min}/\sigma_{\max}$) or strain ratios ($\varepsilon_{\min}/\varepsilon_{\max}$) were set at 0.2 or -1 at room temperature or 300°C. The steel specimens were loaded in the rolling direction. The test conditions and results are summarized in Table III. A digital video camera and an *in situ* optical microscope with a magnification of 20× were used to monitor crack initiation.

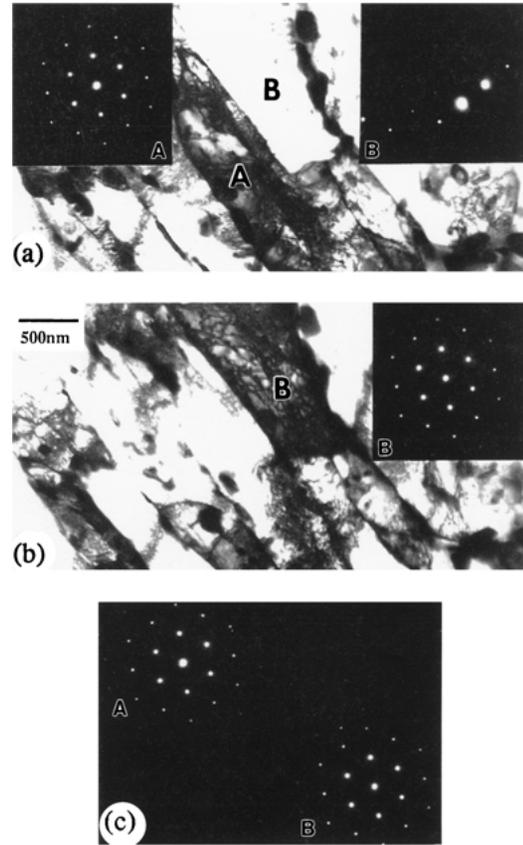
Figure 2 Demonstration experiments showing the procedures of measuring three angular deviations (θ_y , θ_z and θ_x): (a) TEM bright-field image with inset diffraction patterns showing grain A very close to [111] zone axis, while grain B close to [111] zone axis. (b) TEM bright-field image after tilting grain B through θ_y and θ_z to the beam direction very close to [111] zone axis. θ_y and θ_z were measured as 5° and 0.2°, respectively. (c) Superimposed diffraction patterns (very close to [111] zone axis) from grain A and grain B for measuring θ_x . θ_x was measured as 0.4°. Scale bar in (a) apply to (b) as well.

As analyzed in the previous section, the mis-orientation θ between adjacent cells (i.e., subgrains) should be measured by applying the three-dimensional formula of $\sqrt{\theta_x^2 + \theta_y^2 + \theta_z^2}$. The significant contributions of two angular deviations (θ_y and θ_z) to mis-orientation were confirmed by the demonstration experiments here, as shown in Fig. 2. Firstly, the grain A is tilted so that its beam direction is very close to [111] zone axis (which can be recognized by the uniform intensity of spots in the diffraction pattern [5]), while grain B close to [111] zone axis, as seen from the inset diffraction patterns in Fig. 2a. Secondly, the values of θ_y and θ_z between adjacent cells were then obtained by tilting grain B to the orientation very close to [111] zone axis, as seen in Fig. 2b. Finally, the angular deviation θ_x was measured from the superimposed diffraction patterns of grain A and grain B, as seen in Fig. 2c. The results indicated that θ_x was measured to be about 0.4°, while $\sqrt{\theta_y^2 + \theta_z^2}$ was about 5°. Apparently, lack of consideration for the contributions of θ_y and θ_z (due to slightly deviated zone axis between adjacent cells) can result in a significant amount of error while measuring mis-orientation θ . It is thus clear that the mis-orientation in subgrains should not be represented only by one angular deviation θ_x obtained from superimposed diffraction patterns.

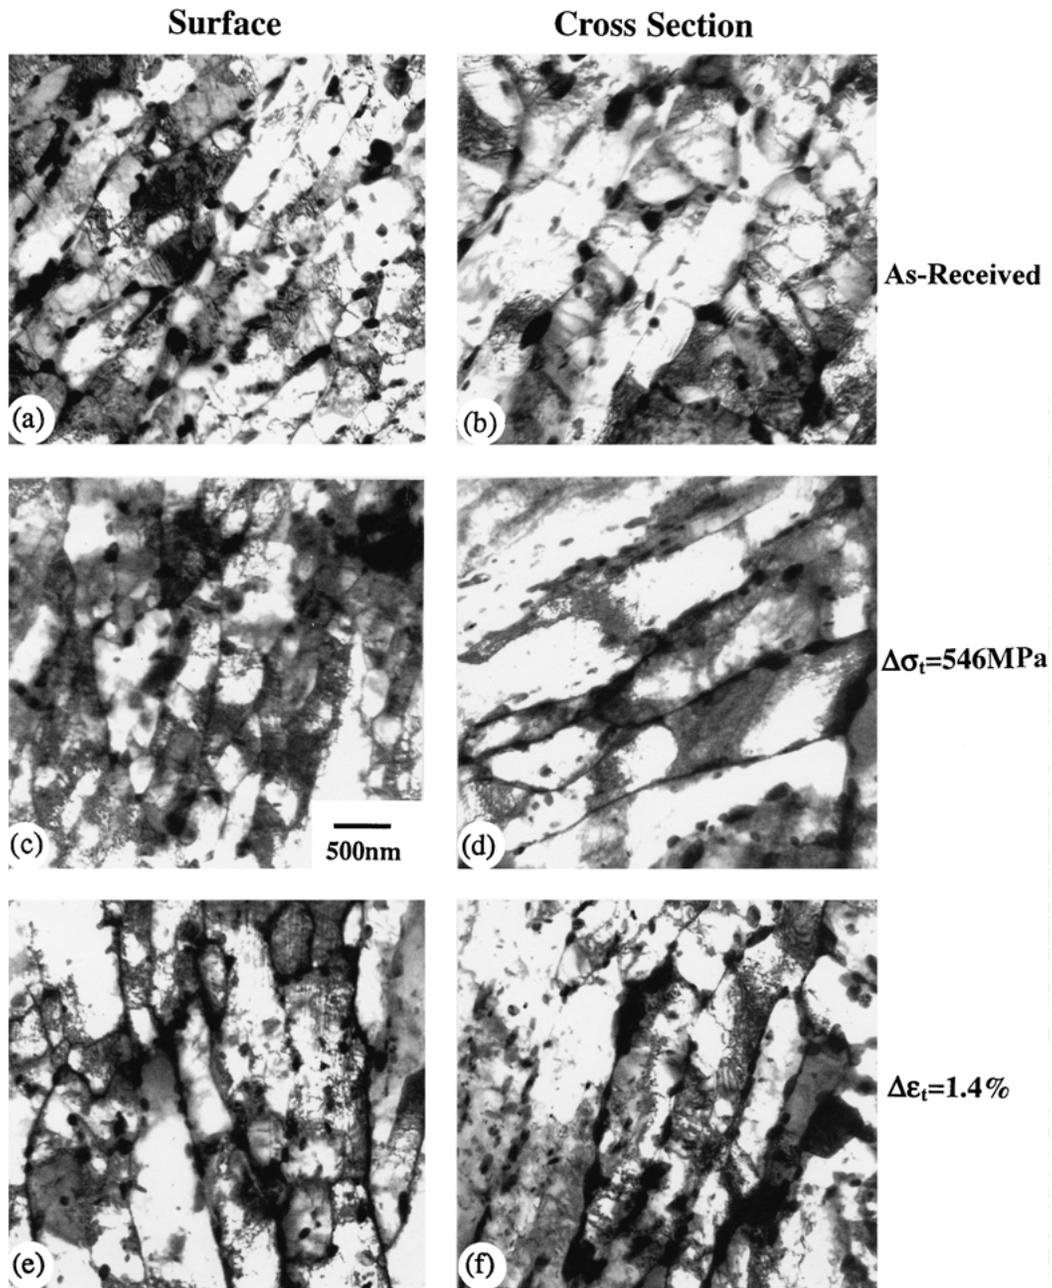
Figure 3 TEM images of SA533-B1 showing no appreciable changes of subgrain structures in (a,b) as-received specimens, (c,d) high-cycle fatigued specimens with $\Delta\sigma_t = 546$ MPa, and (e,f) low-cycle fatigued specimens with $\Delta\varepsilon_t = 1.4\%$. Scale bar in (c) apply to all images as well.

Fig. 3 shows the TEM images with microstructures typical of surface layers and cross sectional layers

from as-received and fatigued SA533-B1 specimens. These specimens were characterized by the complicated defect structures such as subgrain boundaries, small carbides, and dislocations. The characteristic of the subgrain structure was found to be prevalent in the as-received and the fatigued specimens. However, no appreciable changes was observed not only between surface layers and cross sectional layers but also between extremely different fatigue-tested conditions (such as high-cycle and low-cycle fatigue tests), as can be seen in Fig. 3. The mis-orientation θ between adjacent cells was also calculated with a three-dimensional formula of $\sqrt{\theta_x^2 + \theta_y^2 + \theta_z^2}$, as described above. It was found that the mis-orientation θ randomly distributed

from 1° to 5° and no tendency toward a specific value based on more than ten measurements. The results in this work indicated that no discernible changes of microstructures can be identified with the TEM images of fatigued samples owing to the complicated and inhomogeneously distributed defect structures in this kind of alloy steel.

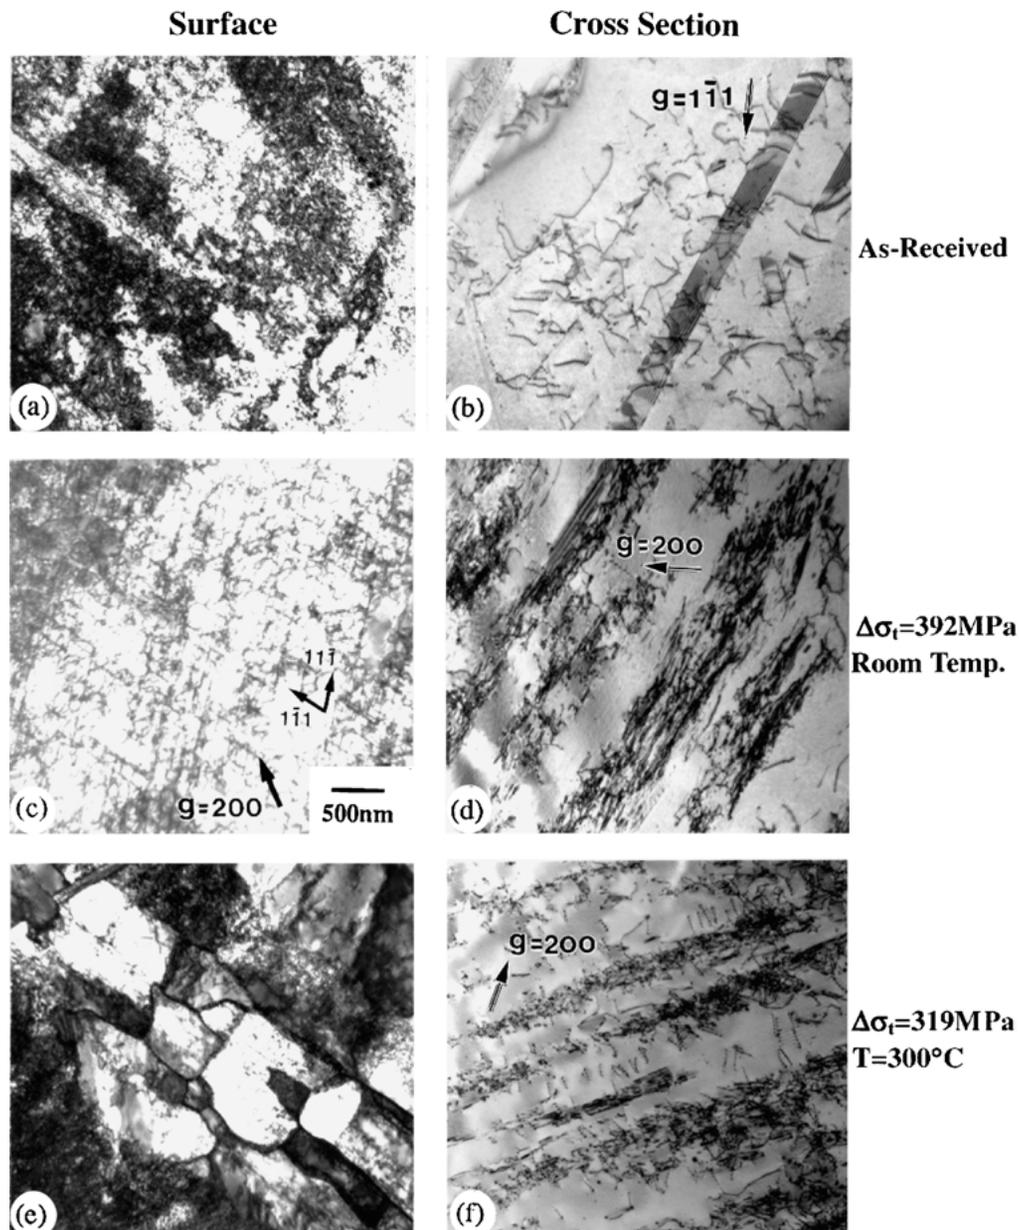
Figure 4 TEM images of Type 316L showing significant changes of microstructures between surface layers (a,c,e) and cross sectional layers (b,d,f). (a,b) as-received specimens, (c,d) fatigued specimens tested with $\Delta\sigma_t = 392$ MPa at room temperature, and (e,f) fatigued specimens tested with $\Delta\sigma_t = 319$ MPa at $T = 300^\circ\text{C}$. Micrographs were taken with the beam direction near to [011]. Scale bar in (c) apply to all images as well.

Although the accumulation of fatigue damage related to the mis-orientation changes of dislocation cell structures has not been discovered in a bcc structure such as SA533-B1, an attempt was made on a material with the fcc structure. We exemplify here the importance of making such observations on Type 316L stainless steel. Fig. 4 shows the TEM images with typical microstructures of surface layers and cross sectional layers from

as-received and fatigued specimens of Type 316L stainless steels. As can be seen in the as-received materials (see Fig. 4a and b) the microstructure of surface layers was different from that of the cross sectional layers, which was caused by surface work-hardening on the plates during rolling as the dislocation density in surface structure is much higher than that of the bulk structure. In the cross sectional layers, planar defects (see Fig. 4b) exhibiting fringe contrast are generally described as stacking faults or microtwins due to their similar contrast. Microtwins, which are closely structurally related to stacking faults, has been fully discussed by Chen and Stobbs [6]. Such thin twins are observed to be distorted and associated with dislocations after fatigue tests, as shown in Fig. 4d and f. It is noteworthy that in the surface layers of fatigue-tested specimens at room temperature, dislocations were observed to arrange themselves on $\{111\}$ slip planes, as illustrated in

Fig. 4c, while at a temperature of 300°C the dynamic recovery occurred, as illustrated in Fig. 4e. This is because the movement of the dislocations (resulting from plastic deformation by surface hard working) from their slip planes into subgrain boundaries (or cell walls) lowers the average strain energy associated with the dislocations [7] and thus tends to lower the effective rate of work-hardening produced by the fatigue test. These subgrain boundaries are clearly demonstrated by the inset diffraction patterns in Fig. 5 showing low-angle boundaries (i.e., the subgrain boundaries are demonstrated by the inset diffraction patterns in each grain which is near to [011] zone under the same imaging condition). The dynamic recovery in Type 316L stainless steel is believed to be connected with the test temperature and dislocation density. The effects of temperature and surface dislocations (both remained in as-received specimens and produced by fatigue tests) on the dynamic recovery need to be clarified by further

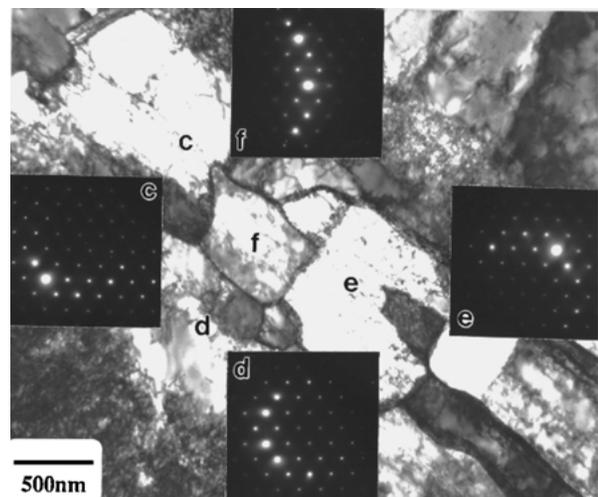
Figure 5 TEM image in Fig. 4e showing subgrain boundaries as illustrated by the inset diffraction patterns in each subgrain which is near to [011] zone under the same imaging condition.

experiments and observations. In this study, however, we have found that the failure mechanism of the fatigue for the Type 316L stainless steel at 300°C might be influenced by the dynamic recovery if the dislocation density in surface layers is sufficiently high as is often the case with commercial alloys.
