Evaluation of fatigue behavior on repaired carbon fiber/epoxy composites

Edson C. Botelho · Mirabel C. Rezende ·
Sérgio Mayer · Herman Voorwald

Abstract The continuous use of structural polymer composites in aeronautical industry has required the development of repairing techniques of damages found in different types of laminates. The most usually adopted procedure to investigate the repair of composite laminates has been by repairing damages simulated in laminated composite specimens. This work shows the influence of structural repair technique on mechanical properties of a typical carbon fiber/epoxy laminate used in aerospace industry. When analyzed by tensile test, the laminates with and without repair present tensile strength values of 670 and 892 MPa, respectively, and tensile modulus of 53.0 and 67.2 GPa, respectively. By this result, it is possible to observe a decrease of the measured mechanical properties of the repaired composites. When submitted to fatigue test, it is observed that in loads higher than 250 MPa, this laminate presents a low life cycle (lower than 400,000 cycles). The fatigue performance of both laminates is comparable, but the non-repaired laminate pres

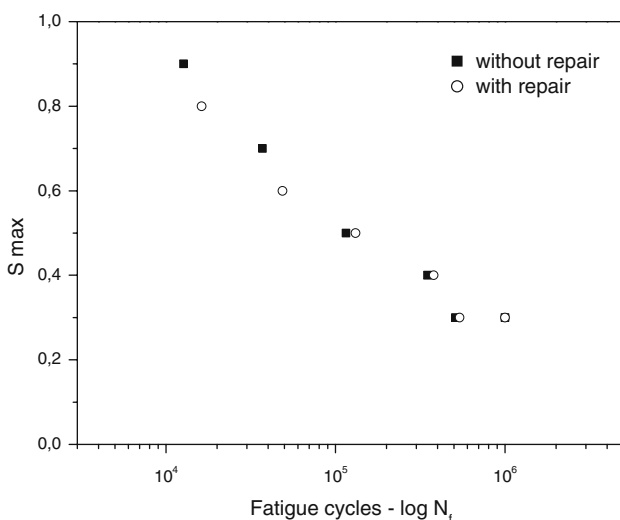
Fig. 8 Fatigue performance for normalized maximum fatigue stress in function of fatigue cycles

Figure 8 shows the comparison of the fatigue performance based on the relationship between the normalized fatigue stress and the fatigue cycles. The fatigue performance of the non-repaired composites is comparable to the fatigue performance of repaired laminates. The lowest fatigue performance is found for the repaired laminates due probably to the following factors: the repaired area and the resin-rich area inside the laminate. As the fatigue performance based on the normalized and absolute applied stress gives different results and conclusions, it is important for structural and material engineers to consider both approaches.

According to Figs. 7 and 8, it is observed that both laminates present a similar behavior.
