Failure behavior of coated nickel-based superalloy under thermomechanical fatigue

Abstract Thermomechanical fatigue (TMF) is a major life limiting factor for gas turbine blades. In this study, the failure behavior of NiCrAlY overlay coated nickel-based superalloy M963 was investigated under out of phase (OP) TMF. All tests were carried out under mechanical strain control with a cyclic period of 200 s. Results revealed that the fatigue life of high velocity oxygen fuel spraying (HVOF) coated specimen was longer than that of air plasma spraying (APS) coated one, but shorter than that of bare superalloy M963 at a given strain range. It was found that cracking process in the APS coating was different from that in the HVOF coating, which was shown by the sketches to understand the crack initiation and propagation behavior.

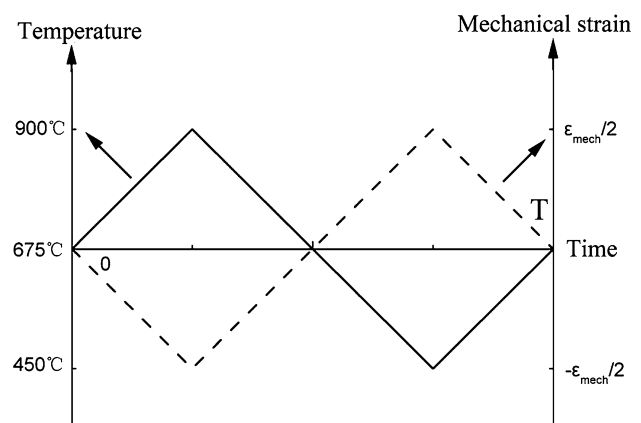
Fig. 2 Cycle shape in terms of temperature and mechanical strain versus time under OP TMF

The TMF tests were performed on a MTS810 closed-loop servohydraulic testing machine with computer control. A high-frequency induction generator was used for heating. Cooling was mainly achieved by thermal conduction into the water cooling specimen grips and forced by blowing compressed air. Axial strain measurements were obtained using a self-supporting extensometer which has a gauge length of 16 mm and was supported with ceramic rods. Temperature control was conducted with a thermocouple spot-welded in the middle of the gauge length. A triangle waveform was used for both thermal cycling and mechanical cycling. OP TMF, in which the tensile strain is at a maximum when the temperature is at a minimum [6], are found to be the most damaging factor on the loading edge of a gas turbine blade from repeated turbine starts and stops and cause the highest damage [13]. OP TMF tests were carried out in the temperature range of 450–900 °C with a cyclic period of 200 s under mechanical strain control. In this study, a mechanical strain amplitude of 0.35% was applied, with a strain ratio $R = -1$, as shown in Fig. 2. A series of interrupted tests at $\Delta\varepsilon_{\text{mech}}/2 = 0.35\%$ were carried out to analyze the crack propagation and calculate the crack density. After the TMF tests, metallographically prepared section of longitudinal section (cutting from fracture surface or in the middle of the specimen parallel to the loading direction) as well as the fracture surfaces were observed using a scanning electron microscope (SEM).

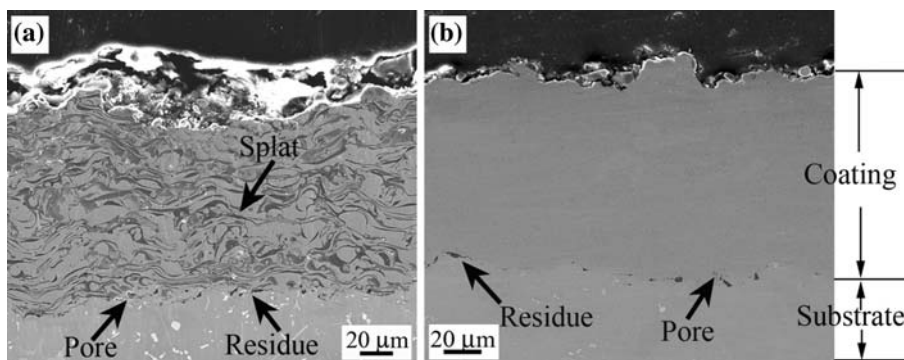
Fig. 3 The microstructure of as sprayed condition coating processed by **a** APS and **b** HVOF

The microstructures of the coating in as sprayed condition are shown in Fig. 3. It can be seen that many splats appear in the APS coating, the surface of coating and the interface are uneven, and pores or residue are found in the interface, as shown in Fig. 3a. However, the HVOF coating looks just like an entire smooth block although pores or residue are also found in the interface (see Fig. 3b). It is believed that

the different microstructures between APS and HVOF coating will lead to different fatigue lives and fracture mechanisms.

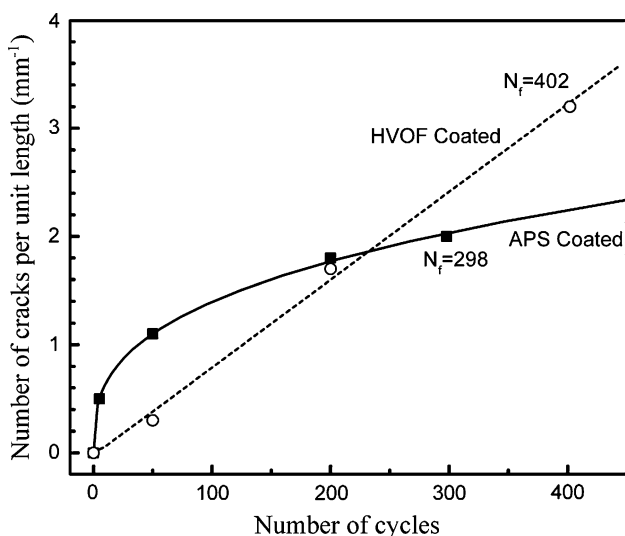
Fig. 6 Crack density in coating as a function of number of cycles for coated M963 under OP TMF, at $\Delta\epsilon_{mech}/2 = 0.35\%$

Generally, cracks mostly originate from the surface of the coating, but their propagation is different according to the experiment results. To reveal the crack evolution, it is necessary to measure the crack density in the coating with increasing the number of cycles. In this study, the crack density is defined as the crack number per unit length at the 10 mm longitudinal section. Therefore, fatigue tests of some specimens were interrupted after cycling at a total mechanical strain of 0.35% for 50 cycles and 200 cycles, respectively. Along with the failed specimens, the crack density in the coating of the interrupted specimens in the longitudinal section was measured. The 10 mm investigated section is below fracture surface at the fracture specimens, while it is in the middle of the interrupted specimens gauge, and the orientation of statistic cracks is perpendicular to loading direction. The plots for the crack density in the coating versus number of cycles are shown in Fig. 6. It can be seen that during the first 0–50 cycles the number of cracks increases very fast in the APS coating. After about 5 cycles there are five cracks in the whole longitudinal section of the coating, and two of them have arrived at the interface and the other cracks have passed through half of the coating. Eleven cracks have been found in the coating after 50 cycles and all have grown up to the interface. After 50 cycles, the growth rate of the crack density decreases in the APS coating. At about 200 cycles the crack density in the coating is similar to that in the failure specimen and it reaches saturation. But only three

cracks were observed in the HVOF coating after 50 cycles. The growth rate of the crack density in the HVOF coating is distinctly lower than that in the APS coating at the beginning of the test and the crack density increases linearly.

specimens after 200 cycles as shown in Fig. 8. It can be seen that cracks are much longer in the substrate of the APS coated specimen than that of the HVOF coated specimen; i.e., the damage of APS coated specimen is more serious. Compared Fig. 6 to 7, it can be seen that the crack density in the substrate is higher than that in the coating in coated specimens. When the coating cracks, most of the imposed forces are transferred to the substrate. When the cracks arrive at the interface between the coating and substrate, it is thought that there is little load in the coating, and most of the applied forces are imposed on the substrate [21]. Therefore, the high stress acts on the substrate, and this causes more cracks to originate in the substrate.

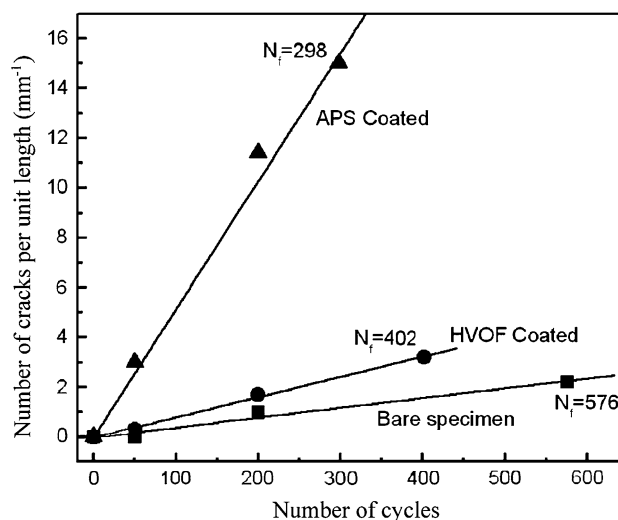
Fig. 7 Crack density in substrate as a function of number of cycles for coated and bare M963 under OP TMF, at $\Delta\epsilon_{mech}/2 = 0.35\%$

The fracture of the specimen is ultimately determined by the failure of the substrate. Therefore, it is important to count the crack density in the substrate which has similar definition as the crack density in the coating. Along with the failed specimens, the crack density in the substrate at the longitudinal section of the former fatigue specimens interrupted was counted. The curve for the crack density in the substrate versus number of cycles is shown in Fig. 7. It can be seen that the crack density in the substrate of the APS coated specimens is the highest and the crack density in the bare specimen is the lowest among three specimen conditions. It seems from Fig. 7 and Table 1 that the higher the crack density is, the shorter the fatigue life will be.

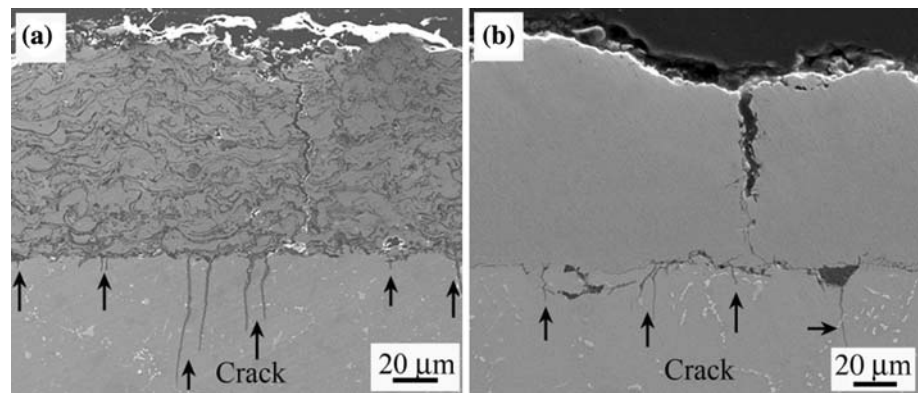
Fig. 8 Microstructure of the longitudinal section of coated specimen for 200 cycles. **a** APS. **b** HVOF
