# The thermal shock resistance of a joining material of C/C composite and copper

Akira Kurumada <sup>a,\*</sup>, Tatsuo Oku <sup>a</sup>, Yoshio Imamura <sup>a</sup>, Kiyohiro Kawamata <sup>a</sup>,  
Osamu Motojima <sup>b</sup>, Nobuaki Noda <sup>b</sup>, Brian McEnaney <sup>c</sup>

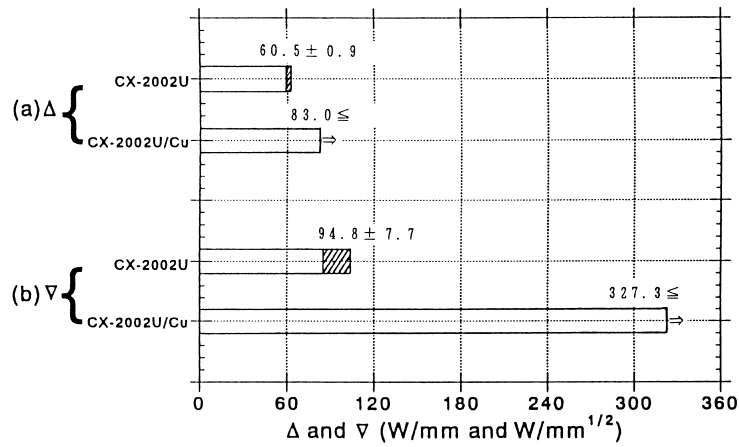
Fig. 4. Values of (a) thermal shock resistance and (b) thermal shock fracture toughness.

kW (71 MW/m<sup>2</sup>) in the thermal shock fracture toughness test, respectively. The CX-2002U/Cu joining material did not fracture even by very severe heating powers of 12.7 kW (449 MW/m<sup>2</sup>) or 10.9 kW (386 MW/m<sup>2</sup>) near the maximum power of the thermal shock test apparatus. Fig. 4 shows values of (a) the thermal shock resistance,  $\Delta$ , and (b) the thermal shock fracture toughness,  $\nabla$ , calculated by the range between the maximum data of "did not fracture" and the minimum data of "fractured". The  $\Delta$  and  $\nabla$  values of the CX-2002U composite on perpendicular to felt surfaces are  $60.5 \pm 0.9$  W/mm and  $94.8 \pm 7.7$  W/mm<sup>1/2</sup>, respectively. When these values are compared with graphites for fusion reactor devices (ETP-10, IG-430U [12]), the  $\Delta$  and  $\nabla$  values are about 70% and about two times those of the graphites, respectively. The  $\nabla$  value of the CX-2002U composite was improved by the reinforcement of carbon fibers. The  $\Delta$  and  $\nabla$  values of the CX-2002U/Cu joining material are over 83.0 W/mm and over 327.3 W/mm<sup>1/2</sup>, respectively. These values are over 1.4 times and over 3.5 times those of the CX-2002U composite, respectively. The high thermal shock parameters of the CX-2002U/Cu joining material are considered to be reinforced by metals which have very high thermal shock properties.
