# Evaluation of hot isostatic pressing for joining of fusion reactor structural components

Hot isostatic pressing (HIP) is a promising technology to fabricate the blanket structure of fusion reactors. HIP joining of solid materials has been selected as a reference fabrication method for the shielding blanket/first wall of the international thermonuclear experimental reactor (ITER). On the basis of experimental results obtained in Europe, Japan and Russia, an evaluation of HIP joining for fusion reactor structural components has been carried out. The parameters of HIP fabrication for copper alloys and stainless steels are given. The results of microscopic observations, X-ray microanalysis, tensile, impact toughness, fracture toughness and fatigue tests are presented. Material science criteria for an estimation of quality for joints fabricated by HIP are discussed. © 2000 Elsevier Science B.V. All rights reserved.

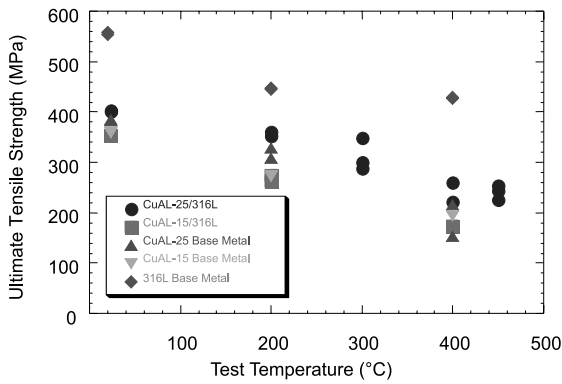
Fig. 6. Ultimate tensile strength of DSCu/316L joints and base metals.

Strength of DSCu/SS joints decreases with increasing test temperature from RT to 400°C (Fig. 6). At 300°C failure occurs in the DSCu closer to the interface, and

with a DSCu strain smaller than the total elongation of DSCu base metal. Numerical calculations carried out in Europe [3] show a high concentration of axial stress in the vicinity of the interface, on the DSCu side. This high stress could explain the brittle fracture of the DSCu alloy near the interface of the DSCu/SS joint. Small values of ductility were observed at test temperatures over 300°C.
