# Radiation effects on laser damage in KU1 quartz glass

P. Martin, A. Morono, E.R. Hodgson\*

## Abstract

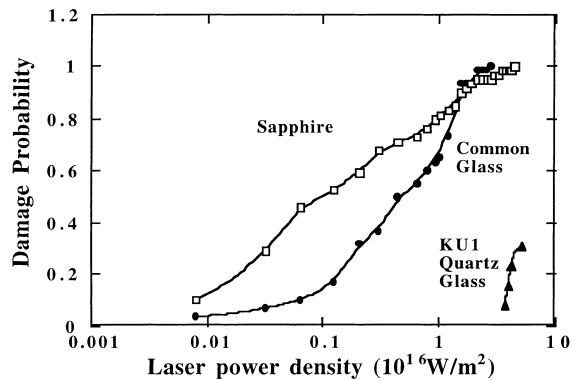
Fig. 2. Damage probability as a function of laser power density for the three unirradiated materials.

Fig. 2 shows the damage probability as a function of laser power density for unirradiated sapphire, common glass and KU1 quartz glass in the range  $1 \times 10^{14}$ – $6.7 \times 10^{16} \text{ W/m}^2$ . As can be seen the probability for laser damage in sapphire is high even at low laser power density, whereas KU1 quartz glass shows a high resistance to laser damage. Sapphire and common glass show 100% probability to be damaged by  $3 \times 10^{16} \text{ W/m}^2$  but at this power density KU1 is not damaged at all. For KU1 it was not possible to reach a probability of damage higher than 30% even at the highest laser power density available.

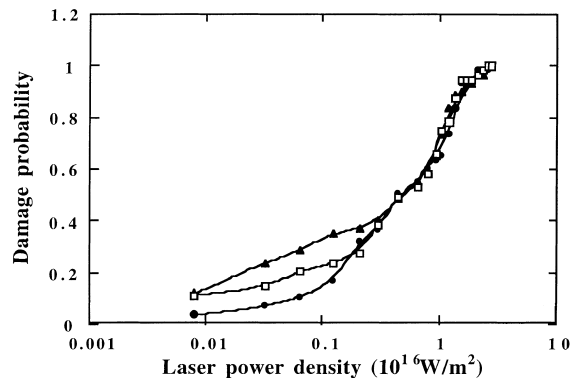
Fig. 3. Damage probability as a function of laser power for common glass unirradiated (○), irradiated up to 0.02 MGy (□) and 0.045 MGy (△).

In Fig. 3 damage probability curves are given for common glass before, during and after irradiation.

Clearly after irradiation the material is more sensitive. The evolution with dose indicates that the increase observed during irradiation is due to the accumulated dose. The results for sapphire are shown in Fig. 4. In this case no radiation effects were observed.

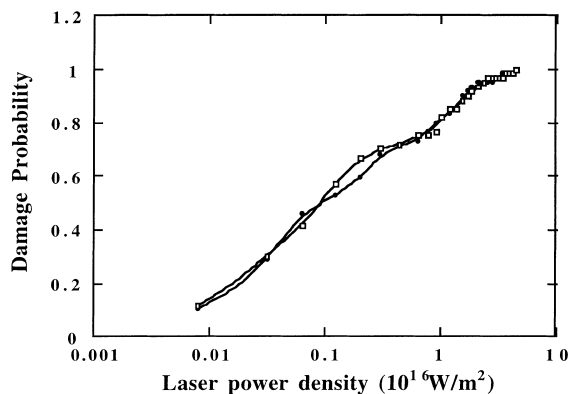
Fig. 4. Damage probability as a function of laser power density for unirradiated (○) and irradiated sapphire up to a dose of 0.045 MGy (□).

The second aspect considered in this work is the effect of the accumulated radiation damage or dose effect. Very different responses have been observed for the three materials. While for sapphire no effect has been seen (Fig. 4), in the case of common glass and KU1 quartz glass marked changes occur. The sensitivity to laser damage increases in the case of common glass (Fig. 3) whereas it decreases in the case of KU1 quartz glass (Figs. 5 and 6). That no effect is observed for sapphire is most probably a consequence of the low sensitivity of this material to ionizing radiation. This is illustrated in Fig. 7, where radiation induced optical absorption spectra for the three materials are given. For common glass by 0.045 MGy considerable absorption is produced. In the case of KU1 even by 10 MGy ( $10^{-6}$  dpa) the absorption is considerably less and restricted to the UV region. At these dose levels the absorption for sapphire is negligible, as may be seen in the spectrum for sapphire taken from Ref. [9] for 130 MGy. This would suggest that the observed changes in the damage threshold for the glass materials are due to purely ionizing radiation. In the case of KU1 radiation

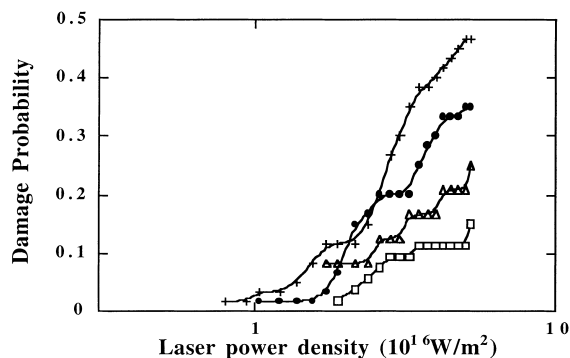
Fig. 6. Damage probability as a function of laser power for KU1 quartz glass in which the exit beam face was roughly polished. The curves are given for the unirradiated (×), irradiated up to 0.02 MGy (○), 0.045 MGy (□) and 20 h after irradiation (△).

As KU1 quartz glass is a candidate material to be used for diagnostic windows, it was irradiated up to 10 MGy. The results for this material can be seen in Fig. 5. After irradiation, sensitivity to laser damage was markedly less and for the highest power, damage probability was reduced to 15%. It is known that the surface condition may notably influence the material sensitivity to laser beam damage due to local electric field enhancement [4]. For KU1 it was observed that the sensitivity to damage is increased when the exit laser beam side was not optically polished, see Fig. 6. Taking advantage of this enhanced sensitivity another similar KU1 sample was irradiated. The results for this sample are shown in Fig. 6, and agree with those obtained for

samples with both sides optically polished (Fig. 5) i.e. radiation decreases the sensitivity to laser damage. The decrease in sensitivity with dose is observable by 20 kGy indicating that the effect is due to ionizing radiation rather than to displacement damage processes. A slight recovery was observed 20 h after irradiation.

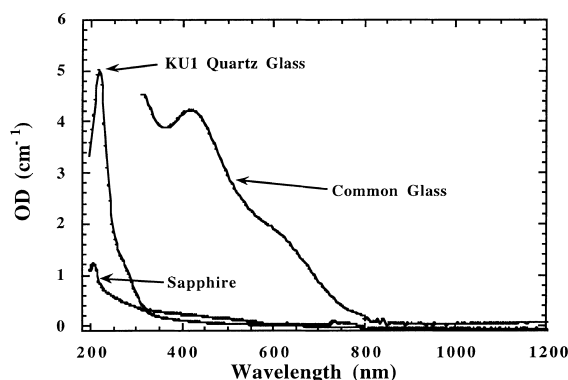
Fig. 7. Optical absorption spectra for common glass irradiated up to 0.045 MGy, and KU1 quartz glass and sapphire irradiated up to 10 and 130 MGy, respectively.
