Surface degradation effects on laser damage in KU1 quartz glass windows for LIDAR applications

For LIDAR applications in fusion devices, surface degradation effects (erosion and deposition of a thin contaminating layer) on laser damage in KU1 quartz glass material has been assessed. To study surface quality effects, roughly polished samples have been examined. For surface deposition effects, thin gold layers were deposited by sputtering on to KU1 quartz samples in order to study the influence of the layer thickness on the laser damage probability. For the thinnest layer of 5 nm a decrease in threshold to produce laser damage by several orders of magnitude is observed, implying a serious risk of breakdown for the laser window from the onset of reactor operation.

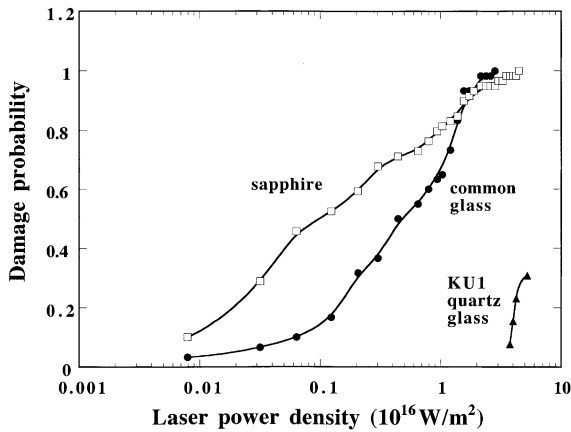
Fig. 1. Damage probability as a function of laser power density for sapphire, common glass and KU1 quartz glass.

The light detection and ranging (LIDAR) diagnostic systems for 'Next Step' fusion devices such as ITER will employ high power laser pulses which must pass through highly transparent windows. The window material used to transmit the laser beam must not only be highly transparent but also highly radiation resistant. If the laser intensity is too high the window material may suffer dielectric breakdown and as a consequence the window may break. Laser damage in transparent materials does not exhibit a sharp threshold with laser intensity, but rather the sensitivity to damage is well characterized by curves representing the probability of damage as a function of laser beam intensity [1]. Fig. 1 illustrates this for common glass, UV grade sapphire, and KU1 quartz glass [2].

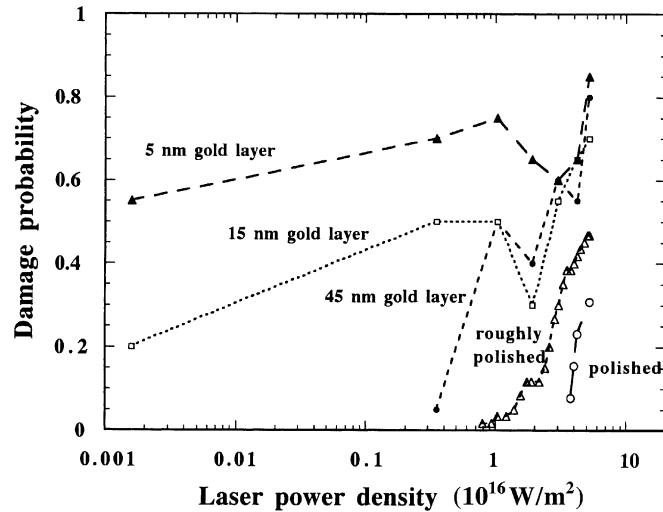
Fig. 3. Damage probability as a function of laser power density for a roughly polished, an optically polished, and three gold metallized KU1 quartz glass samples.

Fig. 3 gives the damage probability curves for the three metallized, the roughly, and the optically polished samples. The probability for laser damage is clearly increased in the case of the roughly polished sample. In the case of the metallized samples the change is far greater with a decrease of at least 3 orders of magnitude in the threshold power density for laser damage being observed. The probability for damage increases as the gold layer thickness decreases. This is clearly shown in Fig. 4 where damage probability is represented as a function of the gold layer thickness for a laser power density of 1.6×10^{13} W/m^2 .

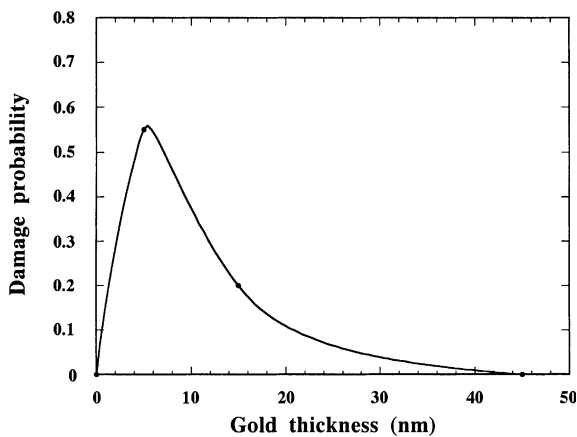
Fig. 4. Damage probability as a function of gold layer thickness for a laser power density of $1.6 \times 10^{13} \text{ W/m}^2$.

It has been observed here that the sensitivity to laser damage increases as the metal layer decreases. Important physical parameters in this process are the thermal conductivity K and the specific heat capacity c_p of both materials [3]. The most probable reason for this inverse behaviour of laser damage is that the temperature reached within the metal layer depends inversely on the heat removed from the laser irradiated area which increases with the layer thickness. The thermal diffusivity of the material is $\chi = K/\rho c_p$, where ρ is the density. The scale length l_D for diffusion of heat during the laser pulse length τ is $l_D = (\chi\tau)^{0.5}$. Values for gold are [5]: $K_{Au} = 318 \text{ W m}^{-1} \text{ K}^{-1}$, $\rho_{Au} = 19.3 \times 10^3 \text{ kg m}^{-3}$, $c_{pAu} = 129 \text{ J K}^{-1} \text{ kg}^{-1}$ (at 25 °C and constant pressure). This gives $l_D = 9.4 \times 10^{-7} \text{ m}$ which is much larger than the thickness of the gold layer ($0.5\text{--}4.5 \times 10^{-8} \text{ m}$), hence the thin gold layer is not capable of removing the heat generated during the laser pulse.

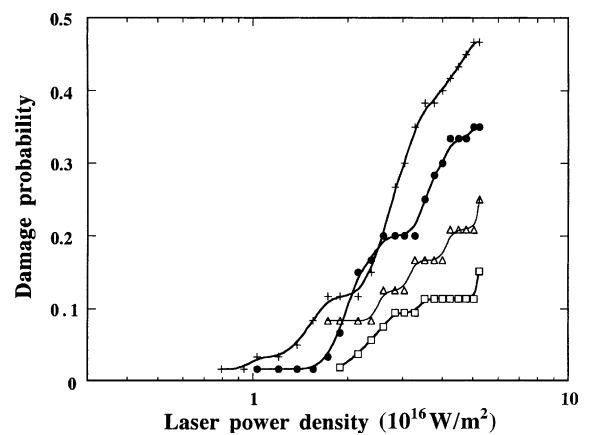
Fig. 5. Damage probability as a function of laser power for KU1 quartz glass in which the exit beam face was roughly polished. The curves are given for the unirradiated (crosses), irradiated up to 0.02 MGy (circles), 0.045 MGy (squares) and 20 h after irradiation (triangles).

Previous work [2] has indicated that in-beam and accumulated dose effects do not produce a decrease in the threshold for laser damage in the case of KU1 quartz glass. Fig. 5 shows the damage probability curves taken from [2] where the combined effect of accumulated dose and surface erosion are given. However, the results obtained in the present work imply that surface degradation, particularly metal layer growth, will be a serious problem for LIDAR windows in future machines where
